## Schedule of Condition

Date: 13<sup>th</sup> May 2025

## B Schedule of Condition Shop Floor

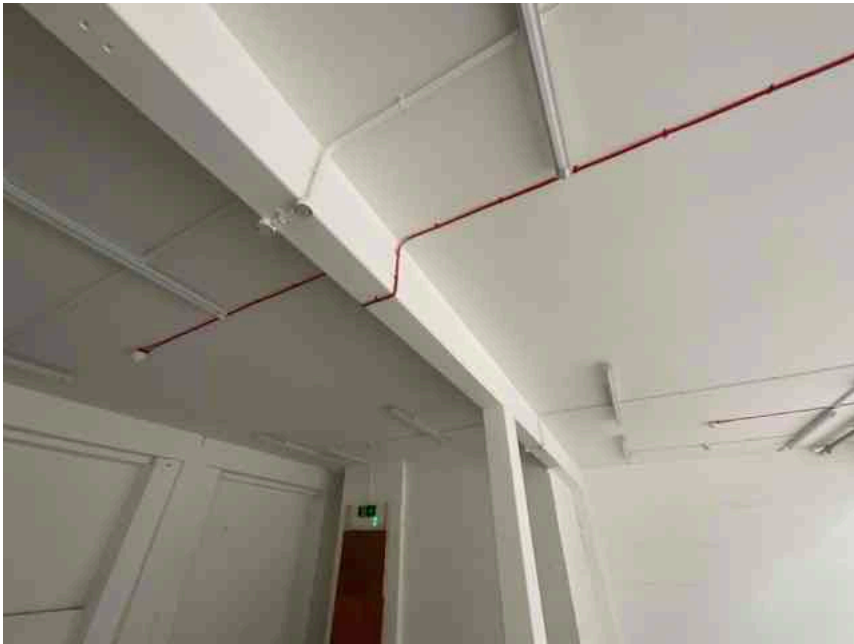
**Photo 1**

A1  
Ceiling

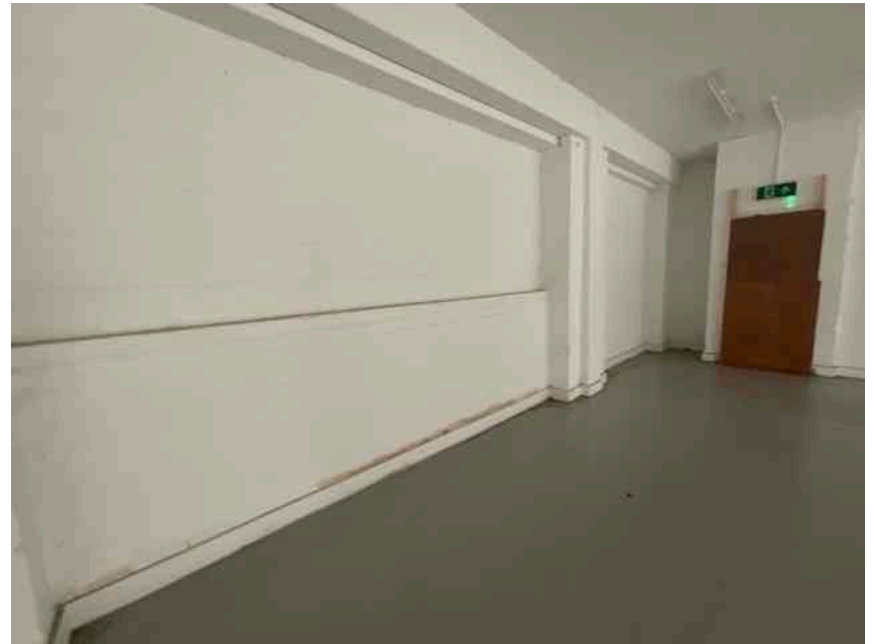
**Photo 2**

A1  
Walls

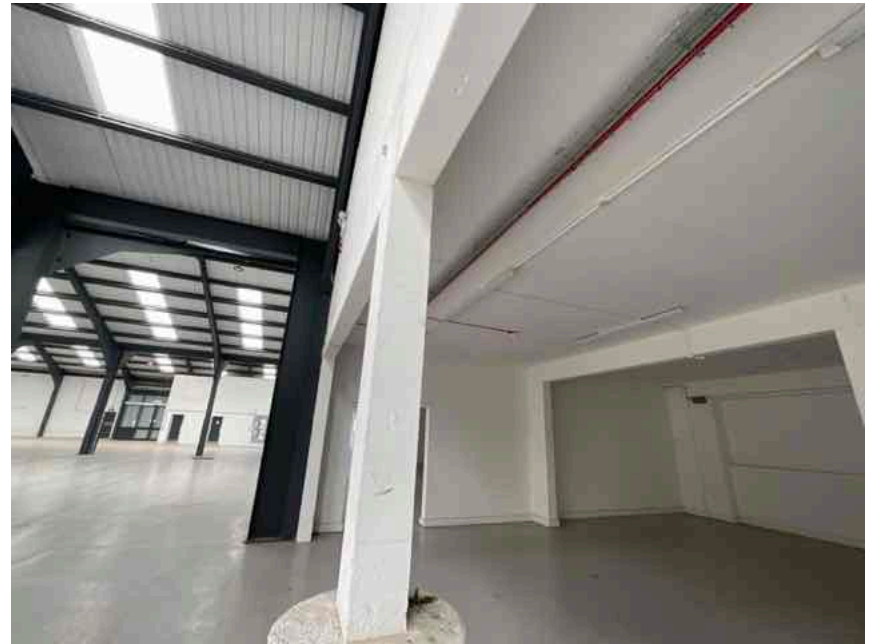
**Photo 6**

A1  
Structure

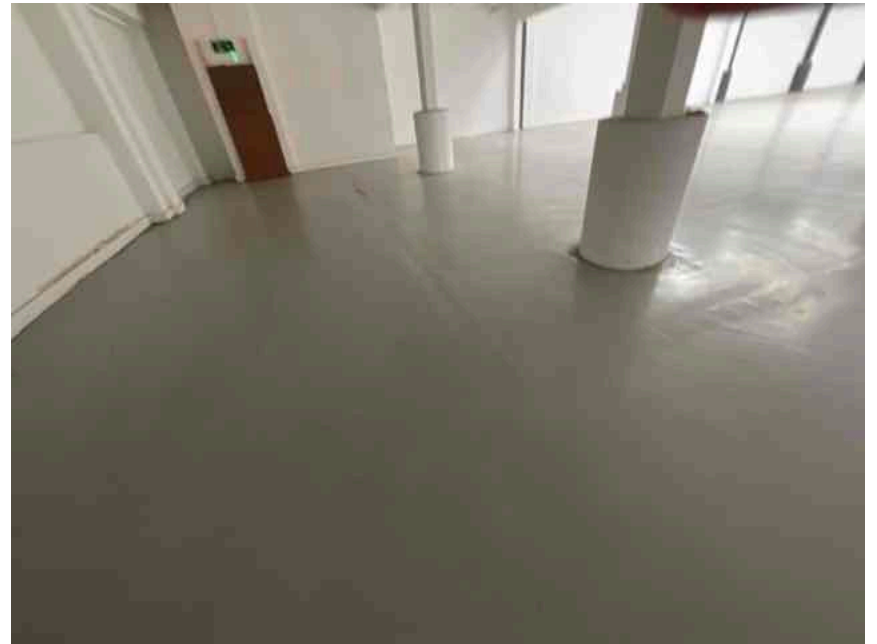
**Photo 10**

A1  
Floor structure

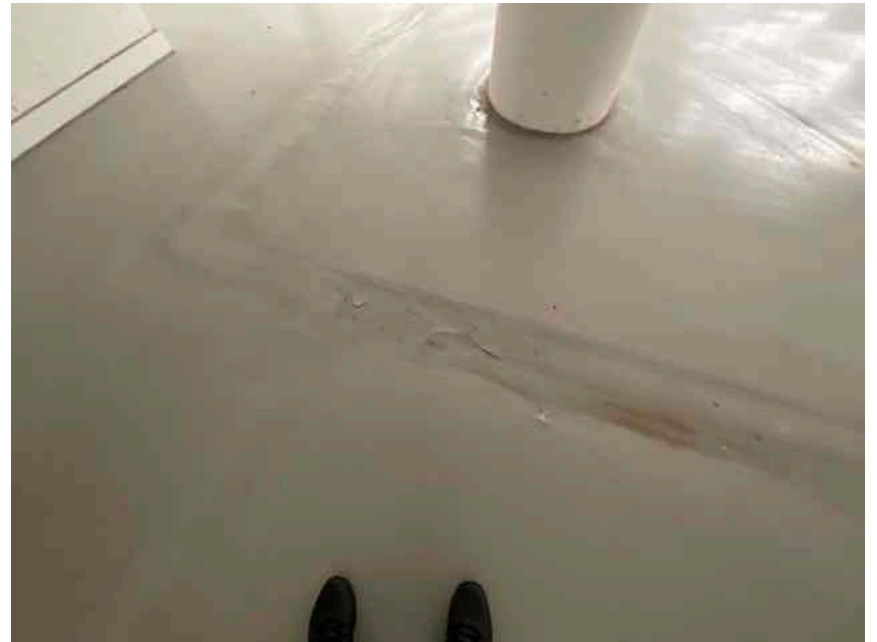
**Photo 12**

A1  
Floor coverings

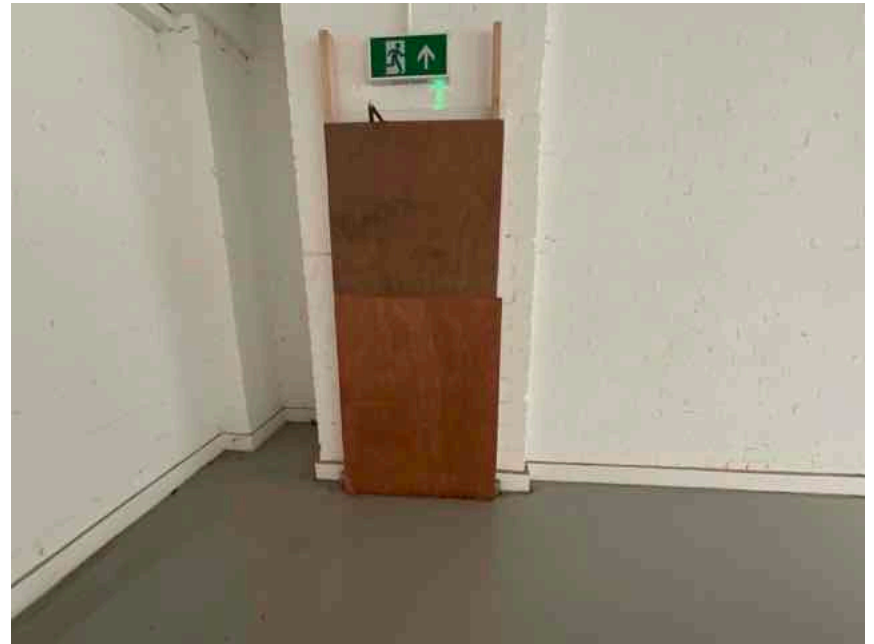
**Photo 14**

Doors	The door is boarded up and could not be inspected	The door is boarded up and could not be inspected	14
<b>A2</b>			
Walls	Block work walls coated in white paint	Generally, in good condition but in need of redecoration.	15 - 16

A1  
Doors

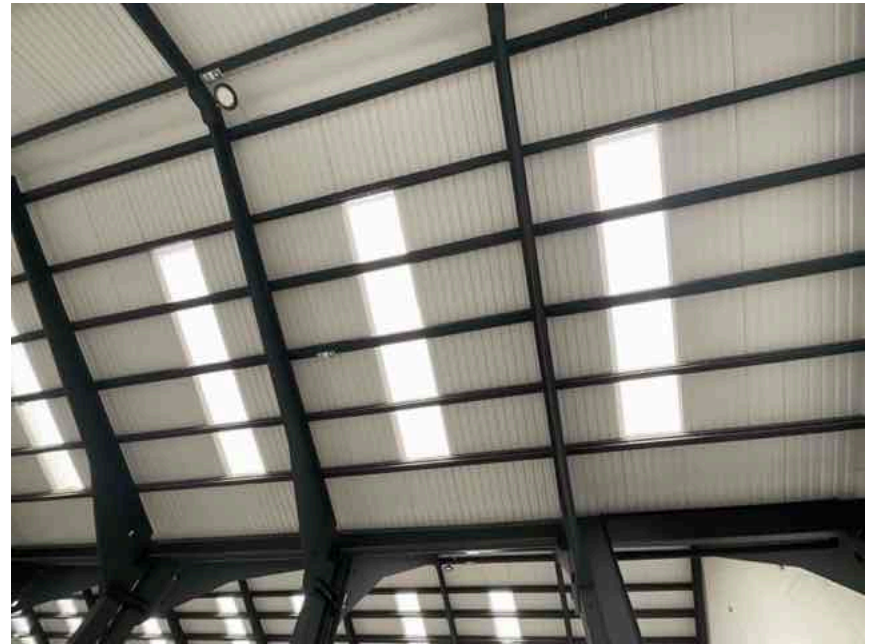
**Photo 22**

A2  
Ceiling

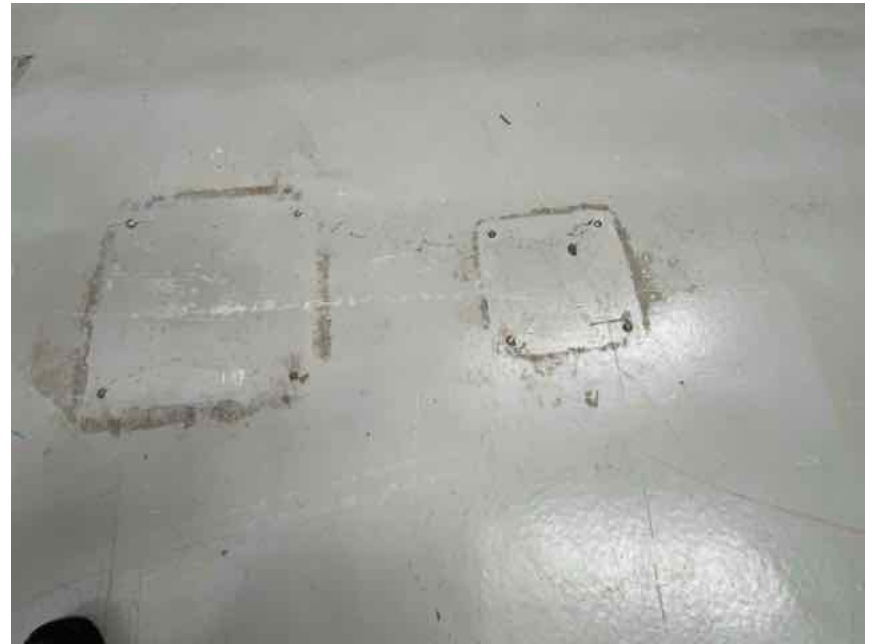
**Photo 26**

A2  
Floor structure

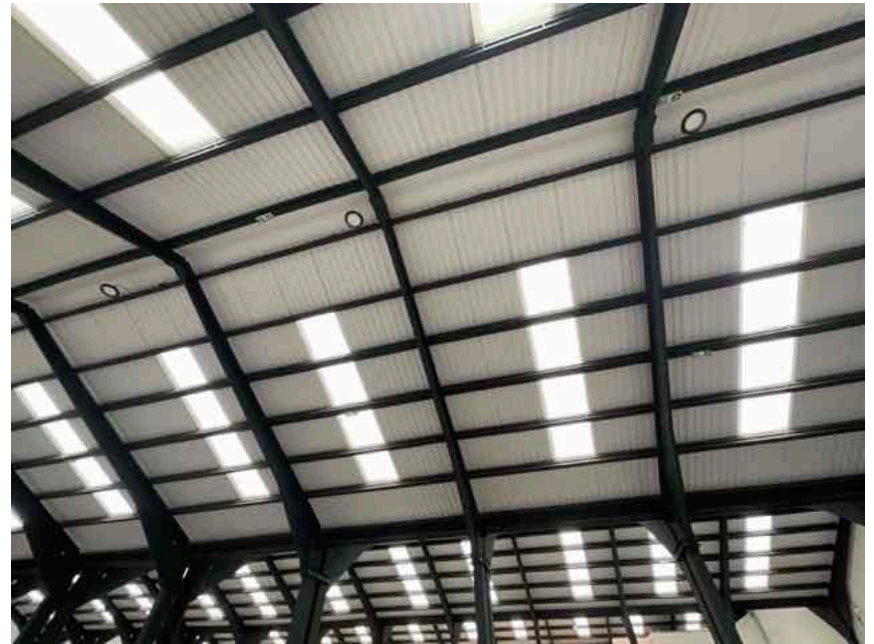
**Photo 34**

Walls	Block work walls coated in white paint.	Generally, in good condition but in need of redecoration.	32
Ceiling	Soffit of roof covering supported off portal frame.	Satisfaction condition.	33 - 34

A3  
Ceiling

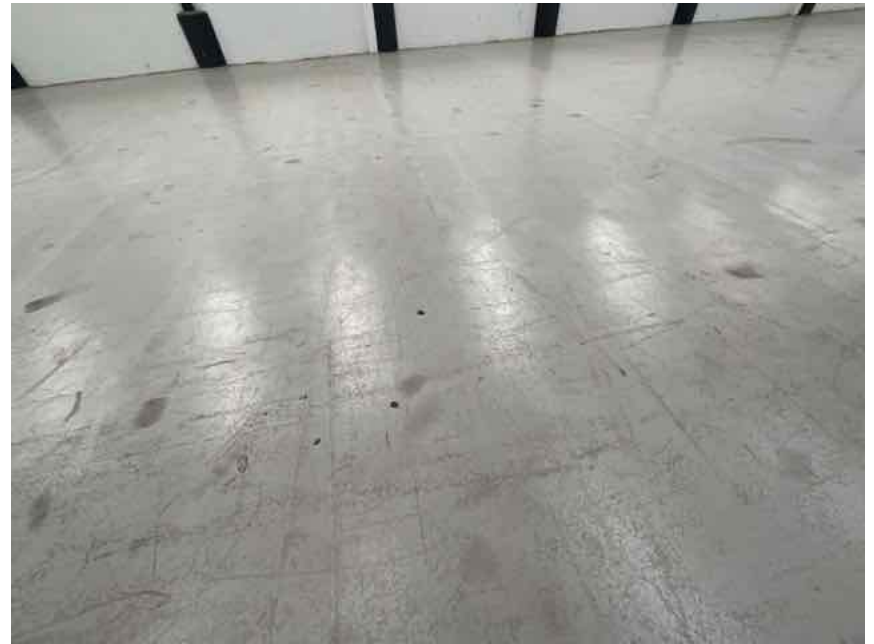
**Photo 42**

A4  
Floor coverings

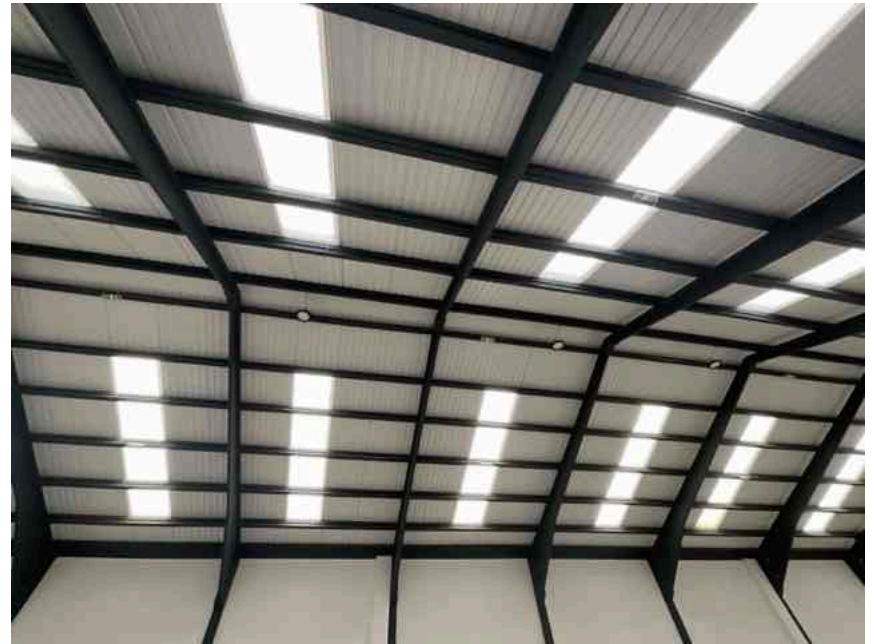
**Photo 46**

Structure	Concrete portal frame.	Generally satisfactory but with rough finishes and detached paint.	45
Ceiling	Soffit of roof covering supported off portal frame	Satisfaction condition	46
Walls	Block work walls coated in white paint	Generally, in good condition but in need of redecoration.	47

A4  
Ceiling

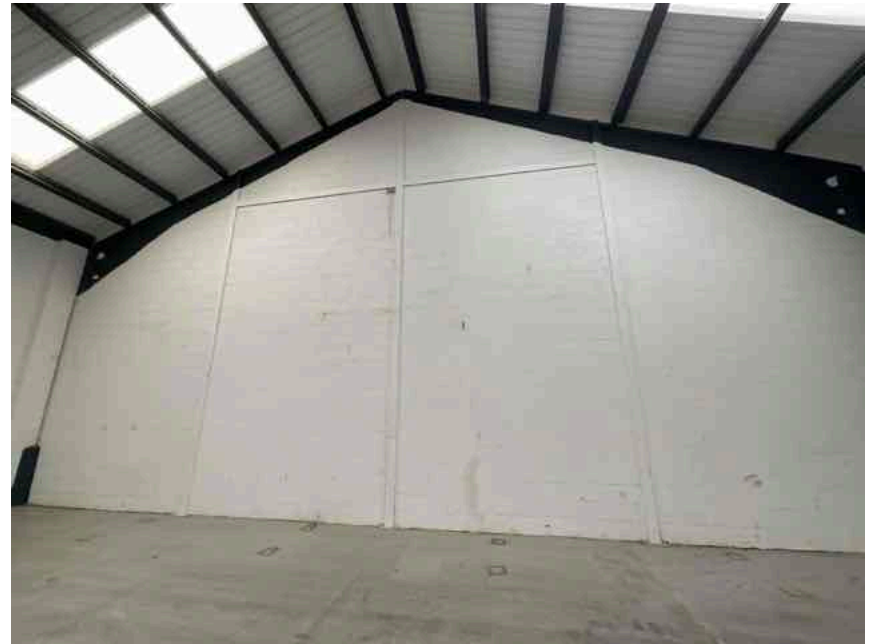
**Photo 58**

<b>A6</b>			
Ceiling	Soffit of roof covering supported off portal frame.	Satisfaction condition.	55 - 56
Walls	Block work walls coated in white paint	Generally, in good condition but in need of redecoration.	57 - 58

A6  
Walls

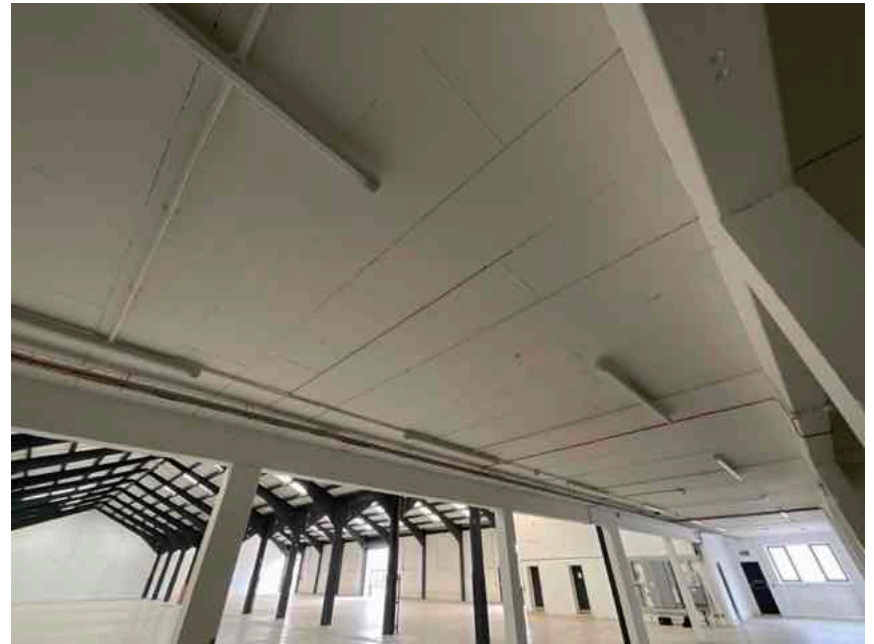
**Photo 70**

B1  
Ceiling

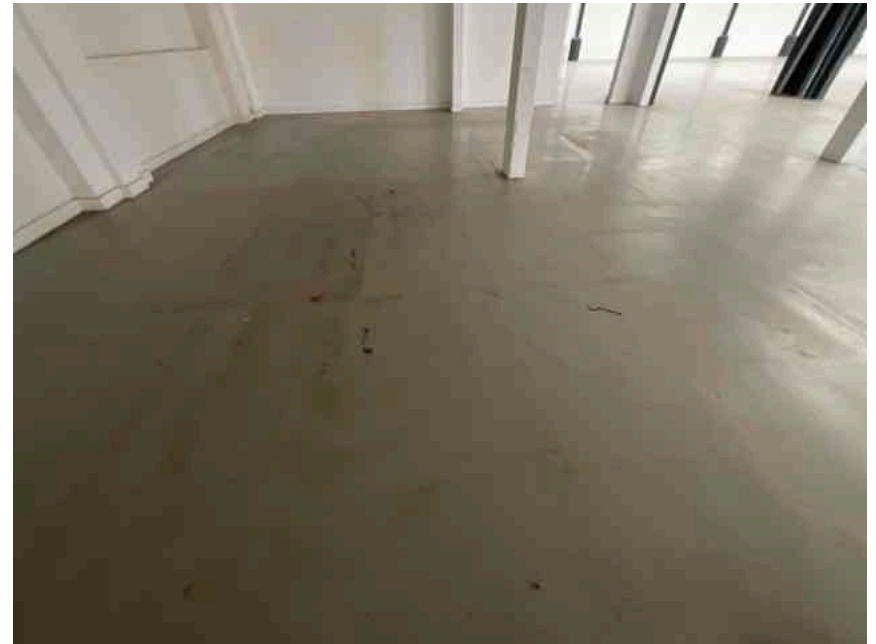
**Photo 74**

B1  
Floor structure

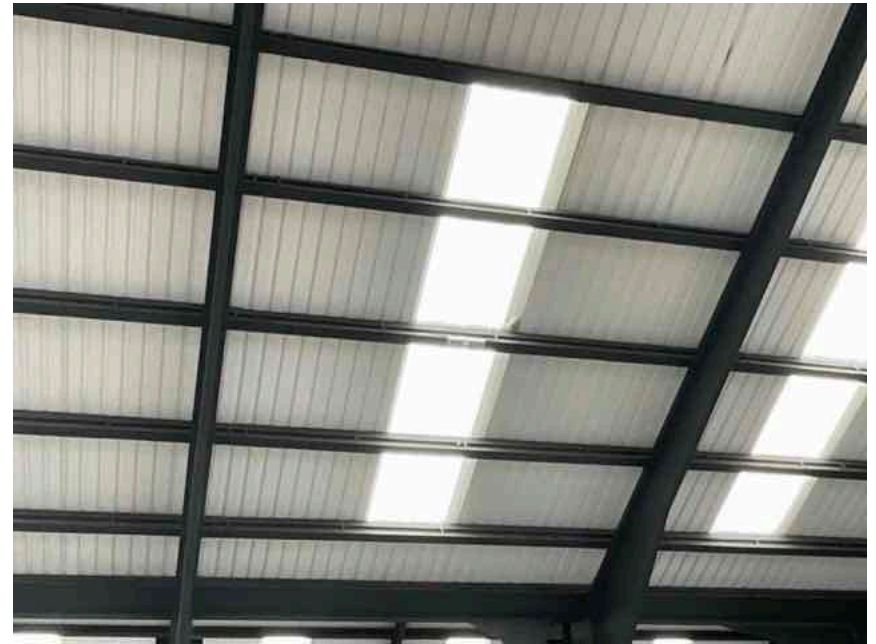
**Photo 90**

<b>B3</b>			
Roof lights	Clear GRP double skin.	Satisfactory and translucent, free from yellowing.	90
Structure	Concrete portal frame.	Generally satisfactory but with rough finishes and detached paint.	91
Floor coverings	Floor paint over surface.	In an aged condition, soiled.	92
Ceiling	Soffit of roof covering supported off portal frame.	Satisfaction condition.	93

B3  
Roof lights

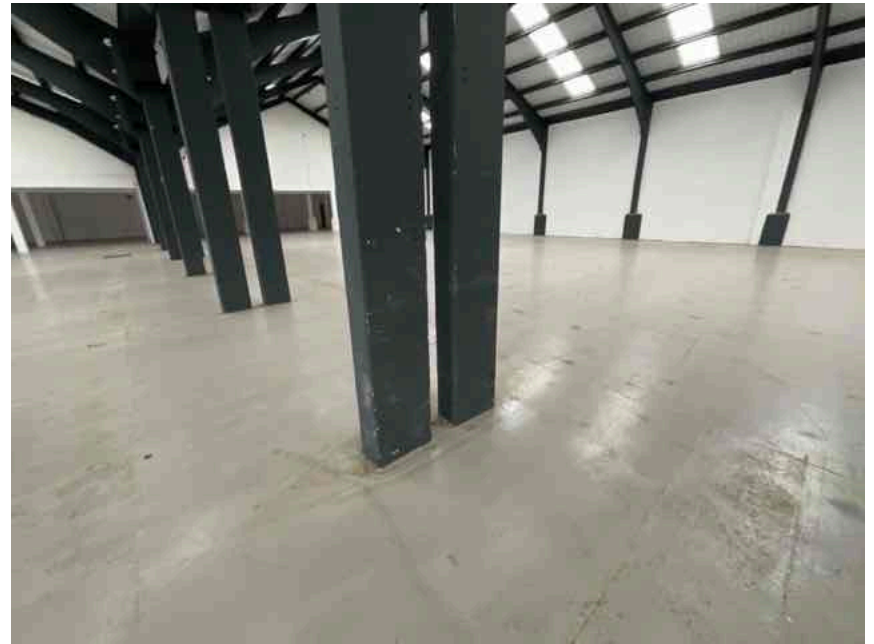
**Photo 98**

B4  
Structure

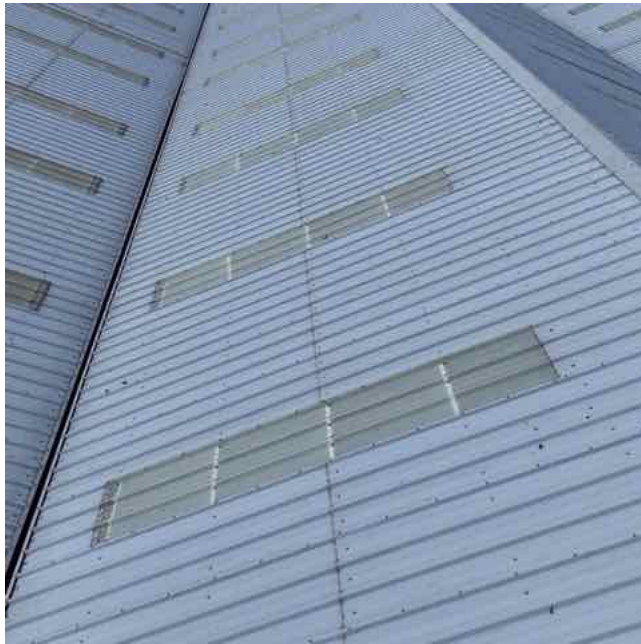
**Photo 1**

<b>Weather Conditions</b>	<b>Sunny and dry</b>
<b>Undertaken by:</b>	<b>Clayton Ayling of Ayling Associates Chartered Surveyors</b>	<b>Undertaken On:</b>	<b>12<sup>th</sup> May 2025</b>
<b>Location</b>	<b>Description</b>	<b>Condition</b>	<b>Photo No</b>
This Schedule of Condition is specific to the lease to which it is appended.			
<b>Roof 1</b>			
Roof covering and Rooflights	<p>Profiled metal sheet roof covering with metal ridge flashings fixed with rivets.</p> <p>The roof sheets have a single lap at half length.</p> <p>Tek screw fixings into purlins.</p>	<p>Cut edge corrosion does not appear to have set in.</p> <p>Dark spots were observed to the surface of the roof sheets in localised areas, most likely either rust spots or bird droppings.</p> <p>Tek screws appear to have deteriorated and screw gaskets are generally cracked.</p> <p>Rooflights appear aged and yellowed, and the gel coat has most likely broken down.</p>	1 - 70

Roof 1  
Roof covering and Rooflights
