## Snagging List

Date: **13<sup>th</sup> May 2025**

## B Snagging List Shop Floor

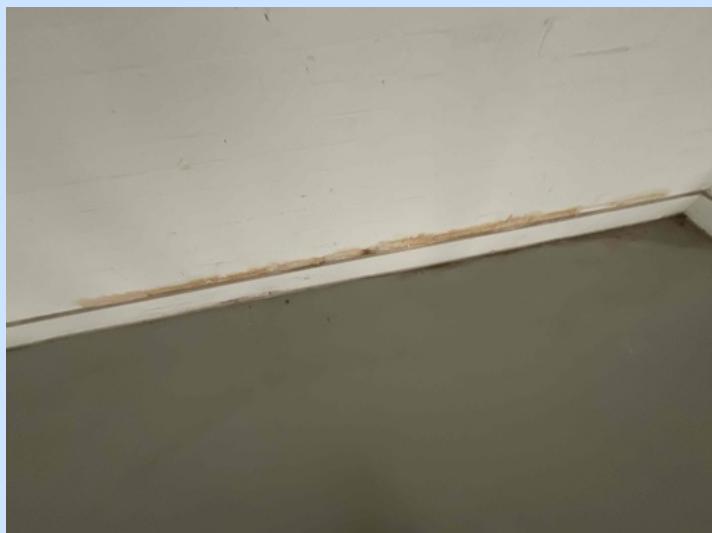
<b>Location</b> A1 <b>Element</b> Walls
<b>Item description</b> Block work walls coated in white paint.	<b>Item condition</b> Water staining indicating rising damp above skirting to east wall.
<b>Work required</b> Further investigation required to confirm existence of dampness.	<b>Notes</b>

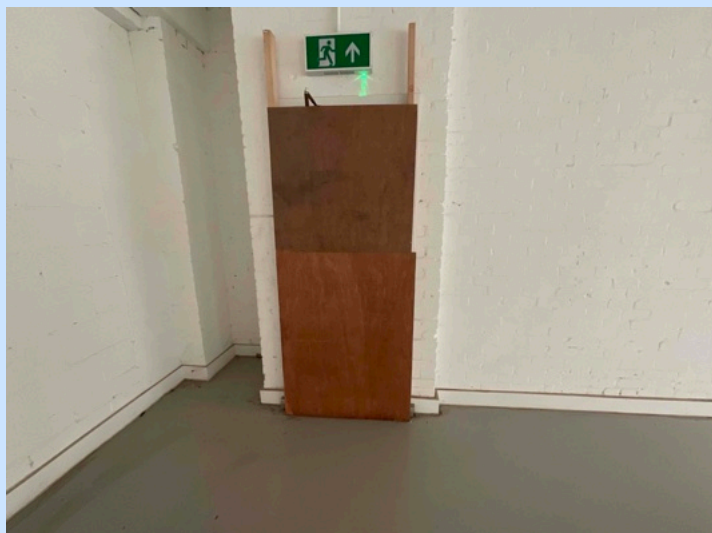
<b>Location</b> A1 <b>Element</b> Doors
<b>Item description</b> The door is boarded up and could not be inspected	<b>Item condition</b> The door is boarded up and could not be inspected
<b>Work required</b> Open up boarding and validate door.	<b>Notes</b>

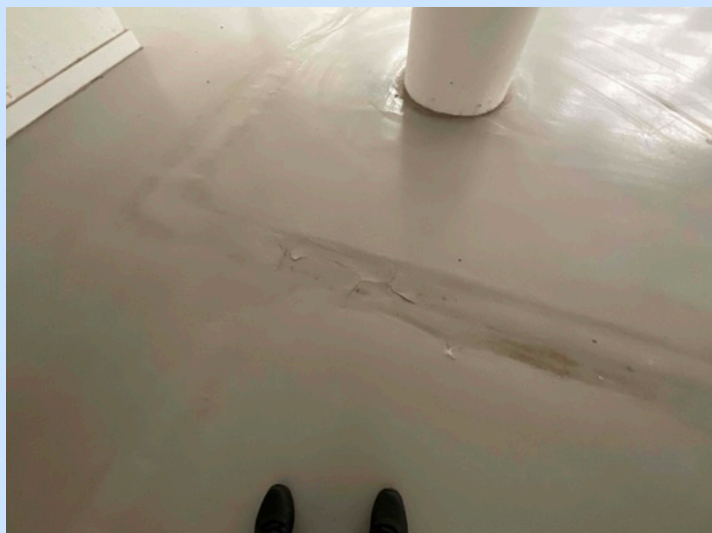
<b>Location</b> A1  <b>Element</b> Floor coverings
<b>Item description</b> Floor paint over surface.	<b>Item condition</b> Cracking and detachment to coatings in one localised area.
<b>Work required</b> Make good and renew paint coatings.	<b>Notes</b>

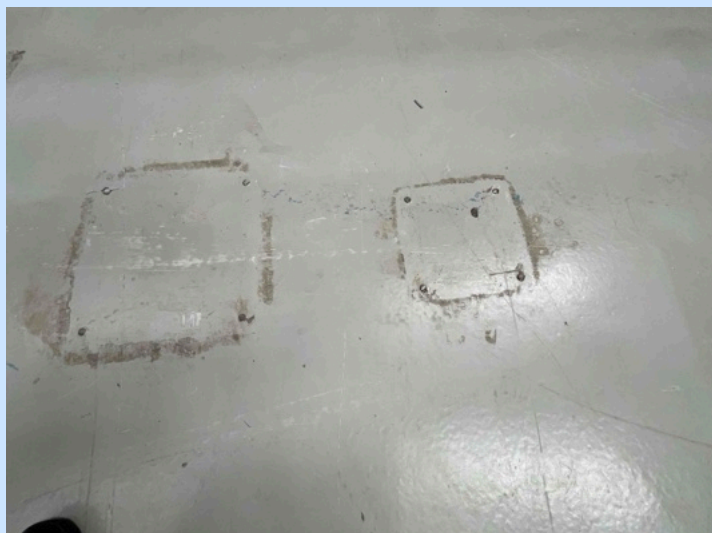
<b>Location</b> A2  <b>Element</b> Floor structure
<b>Item description</b> Solid concrete floor structure with smooth screed	<b>Item condition</b> Floor bolts ground off rather than removed in around 20 locations. Bolts protrude from floor surface.
<b>Work required</b> Remove bolts and make good.	<b>Notes</b>

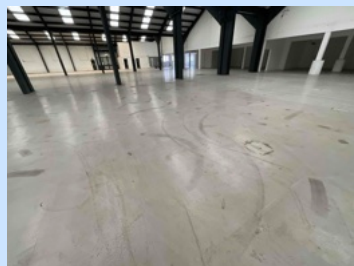
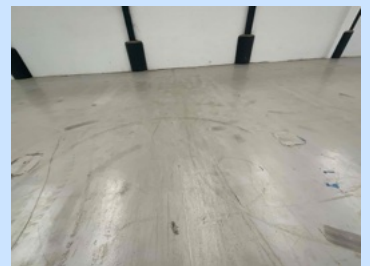
<b>Location</b> A3 <b>Element</b> Floor structure
<b>Item description</b> Solid concrete floor structure with smooth screed	<b>Item condition</b> Floor bolts ground off rather than removed in around 4 locations. Bolts protrude from floor surface.
<b>Work required</b> Remove floor bolts and make good.	<b>Notes</b>

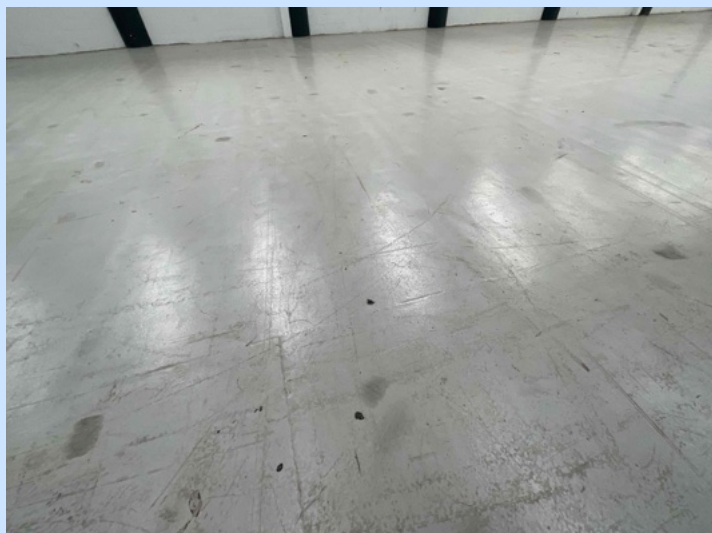
<b>Location</b> A4 <b>Element</b> Floor structure
<b>Item description</b> Solid concrete floor structure with smooth screed	<b>Item condition</b> Floor bolts ground off rather than removed in around 2 locations. Bolts protrude from floor surface.
<b>Work required</b> Remove bolts and make good.	<b>Notes</b>

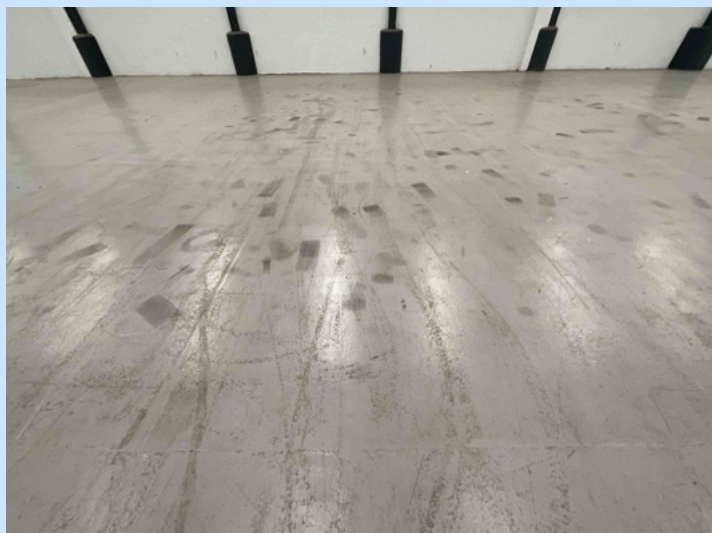
<b>Location</b> A5 <b>Element</b> Floor structure
<b>Item description</b> Solid concrete floor structure with smooth screed	<b>Item condition</b> Floor bolts ground off rather than removed in around 1 location. Bolts protrude from floor surface.
<b>Work required</b> Remove bolts and make good surface.	<b>Notes</b>

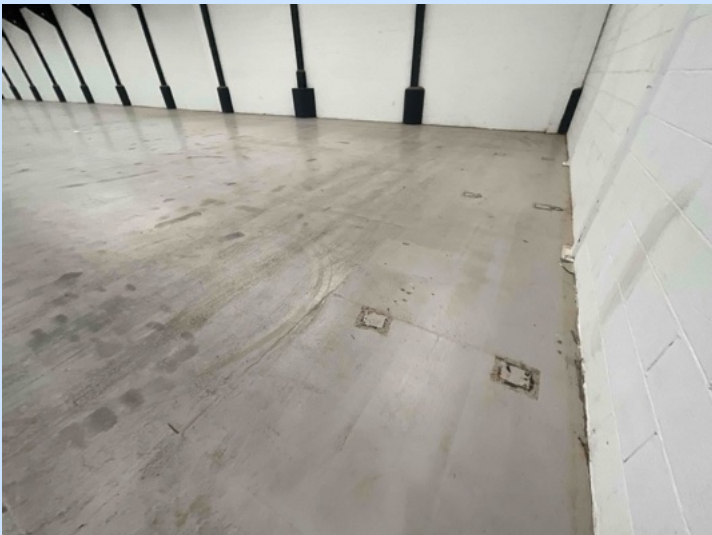
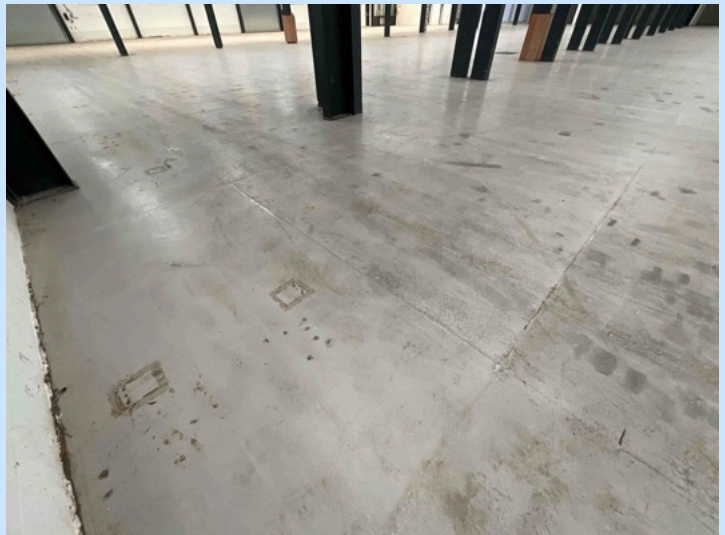
<b>Location</b> A6 <b>Element</b> Floor structure
<b>Item description</b> Solid concrete floor structure with smooth screed	<b>Item condition</b> Floor bolts ground off rather than removed in around 8 location. Bolts protrude from floor surface.
<b>Work required</b> Remove bolts and make good.	<b>Notes</b>

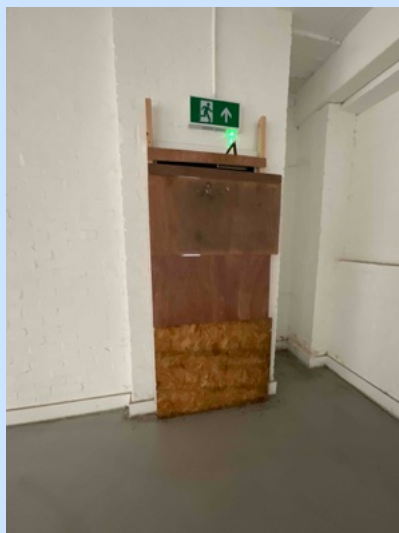
<b>Location</b> B1 <b>Element</b> Doors
<b>Item description</b> The door is boarded up and could not be inspected.	<b>Item condition</b> The door is boarded up and could not be inspected.
<b>Work required</b> Expose door and validate.	<b>Notes</b>

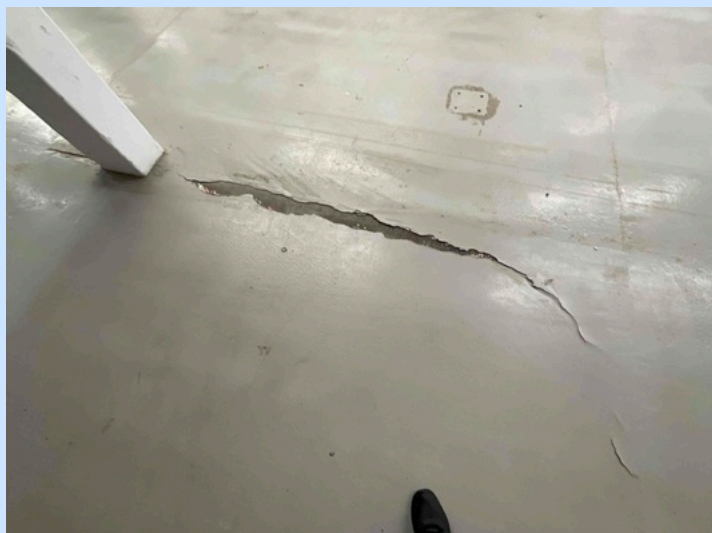
<b>Location</b> B1
<b>Item description</b> Floor paint over surface.	<b>Element</b> Floor coverings
<b>Work required</b> Repair damaged areas of paint and make good.	<b>Item condition</b> In an aged condition and cracking in a number of areas
	<b>Notes</b>

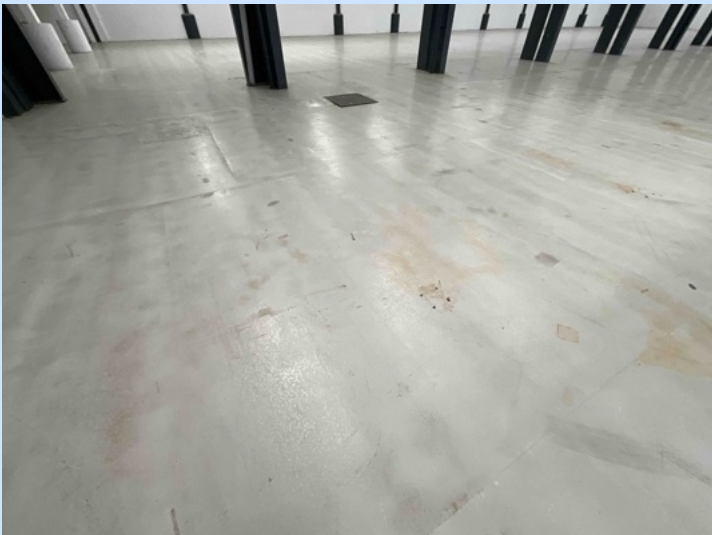
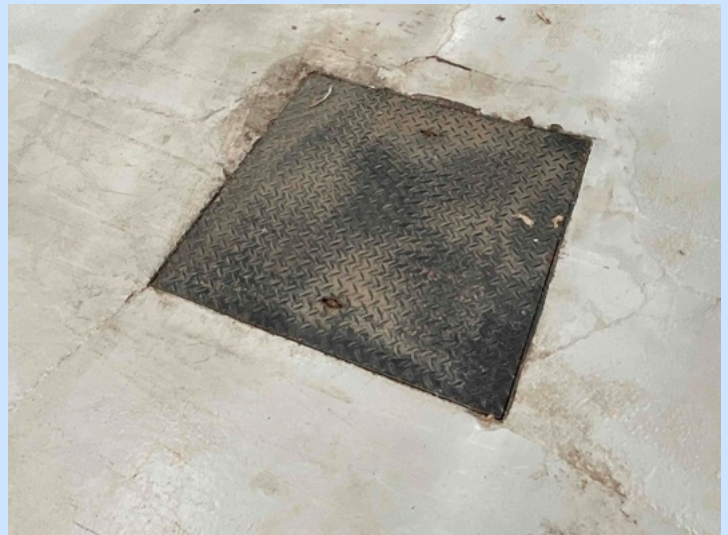
<b>Location</b> <p>B2</p>
<b>Item description</b> <p>Solid concrete floor structure with smooth screed.</p> <p>IC covers.</p>	<b>Element</b> <p>Floor structure</p>
<b>Work required</b> <p>Remove bolts and make.</p> <p>Reseat the IC covers.</p>	<b>Item condition</b> <p>Floor bolts ground off rather than removed in around 3 locations. Bolts protrude from floor surface.</p> <p>IC covers sitting proud/not level with floor.</p>
<b>Notes</b>

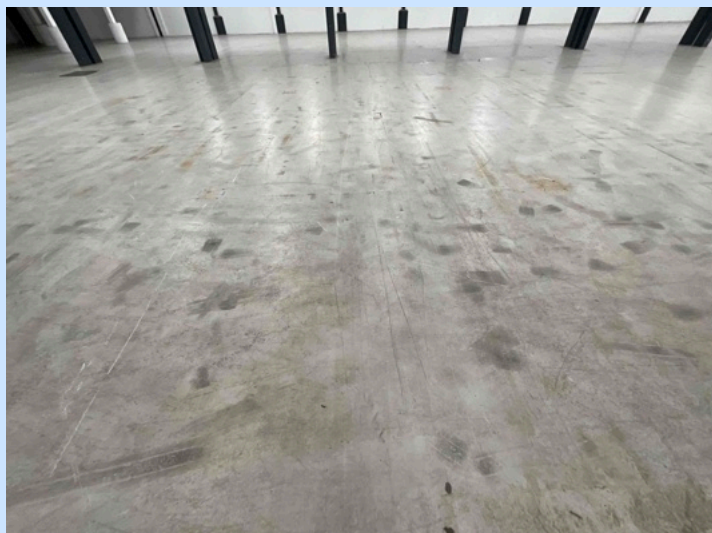
<b>Location</b> B3 <b>Element</b> Floor structure
<b>Item description</b> Solid concrete floor structure with smooth screed.	<b>Item condition</b> Floor bolts ground off rather than removed in around 8 locations. Bolts protrude from floor surface.
<b>Work required</b> Remove bolts, make good, and redecorate.	<b>Notes</b>

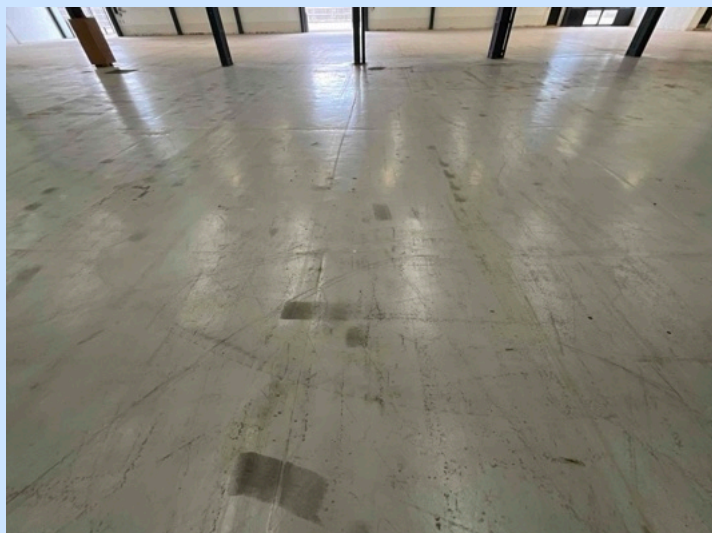
<b>Location</b> B4 <b>Element</b> Floor structure
<b>Item description</b> Solid concrete floor structure with smooth screed.	<b>Item condition</b> Floor bolts ground off rather than removed in around 8 locations. Bolts protrude from floor surface.
<b>Work required</b> Remove bolts, make good and redecorate.	<b>Notes</b>

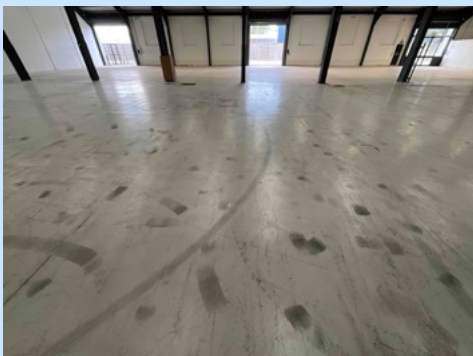
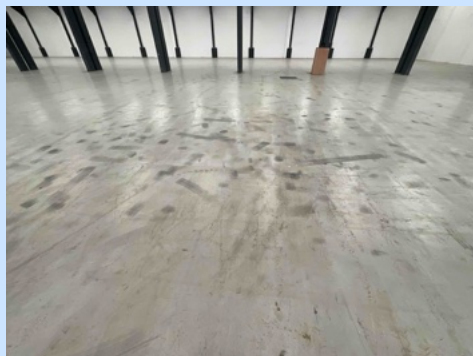
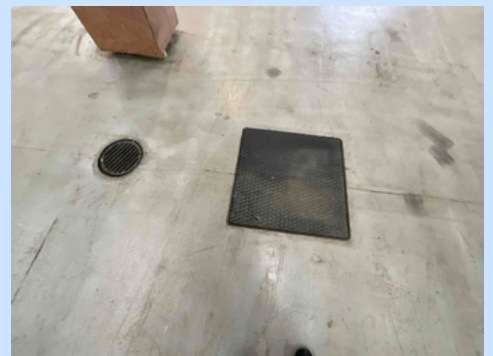
<b>Location</b> B5 <b>Element</b> Floor structure
<b>Item description</b> Solid concrete floor structure with smooth screed. IC covers.	<b>Item condition</b> Floor bolts ground off rather than removed in around 3 locations. Bolts protrude from floor surface.
<b>Work required</b> Remove bolt, make good, and redecorate.	<b>Notes</b>

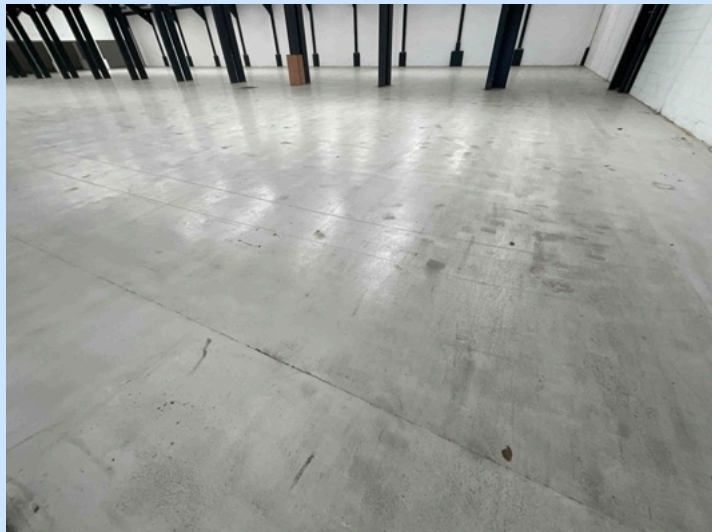
<b>Location</b> B6 <b>Element</b> Floor structure
<b>Item description</b> Solid concrete floor structure with screed.	<b>Item condition</b> Floor bolts ground off rather than removed in around 12 locations. Bolts protrude from floor surface.
<b>Work required</b> Remove bolts, make good, redecorate.	<b>Notes</b>

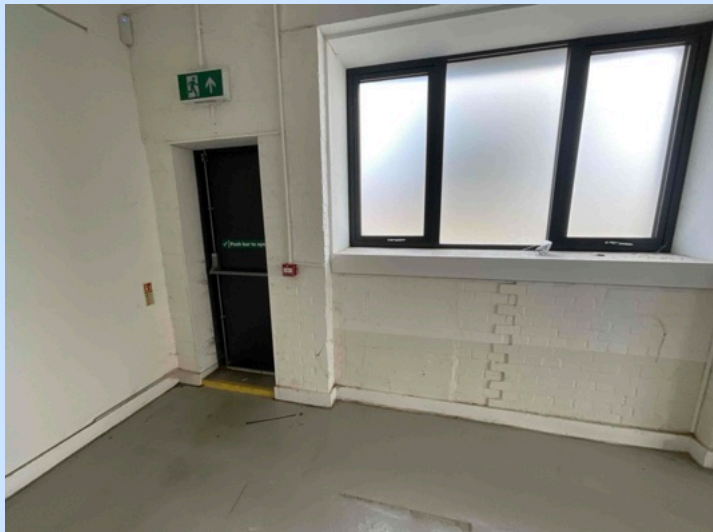
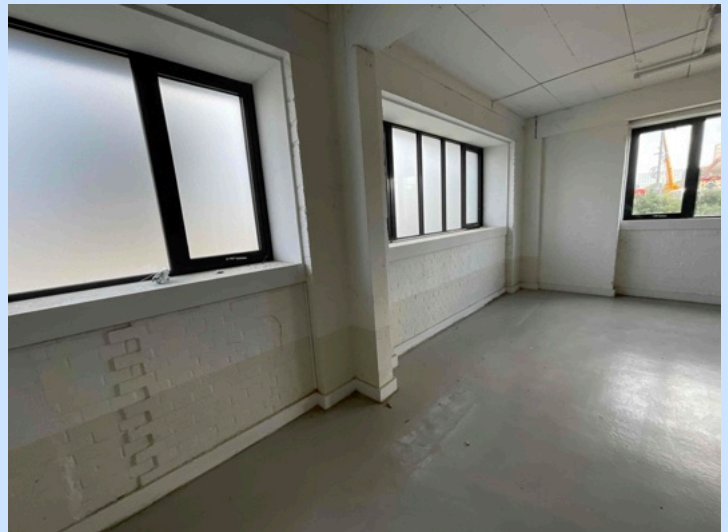
<b>Location</b> C1 <b>Element</b> Walls
<b>Item description</b> Blockwork walls coated in white paint	<b>Item condition</b> Very dirty surfaces to windowsills.
<b>Work required</b> Arrange deep clean.	<b>Notes</b>

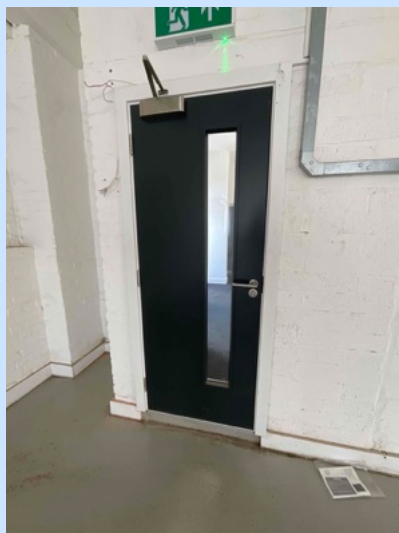
<b>Location</b> C1 <b>Element</b> Doors
<b>Item description</b> <p>Factory finished door with brushed stainless ironmongery, kicker plates and closer.</p>	<b>Item condition</b> <p>Generally in a good condition, but with some marks and dents over the surface no that this is a factory finished door and may not be suitable for redecoration</p>
<b>Work required</b> <p>Make good damage to door, consider replacing door if necessary.</p>	<b>Notes</b>

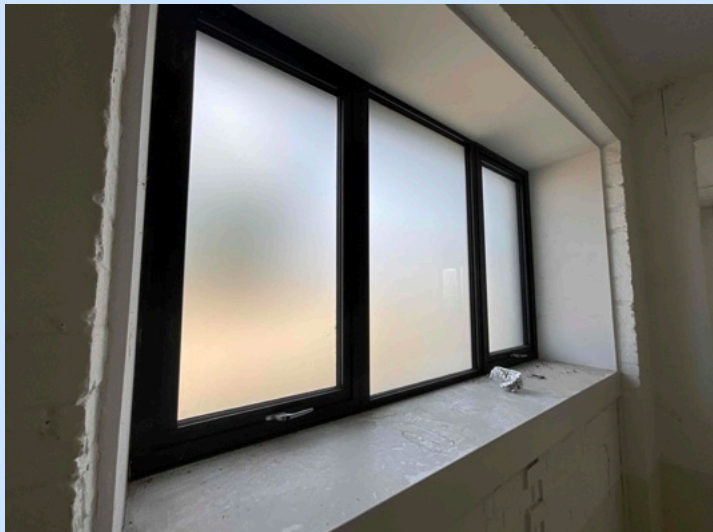
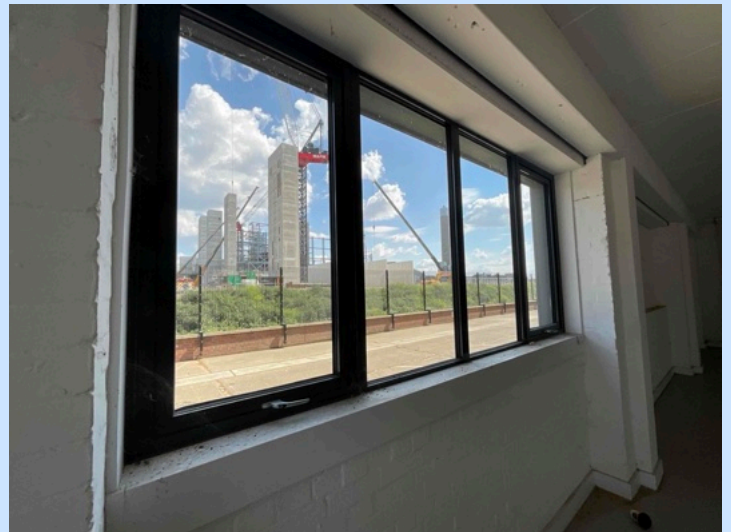
<b>Location</b> C1  <b>Element</b> Windows
<b>Item description</b> <p>Polymer coated double glazed aluminium casement windows</p>	<b>Item condition</b> <p>Locked at the time of the inspection, the windows could not be tested.</p>
<b>Work required</b> <p>Arrange testing and validation of windows.</p>	<b>Notes</b>

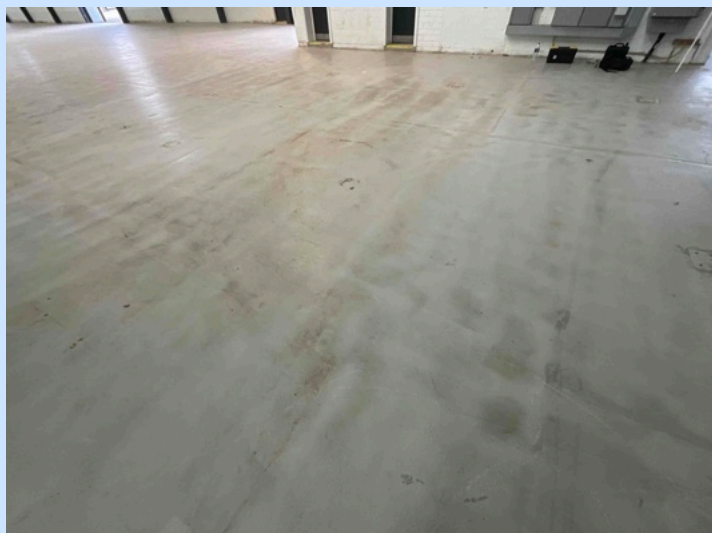
<b>Location</b> C2 <b>Element</b> Floor structure
<b>Item description</b> Solid concrete floor structure with smooth screed	<b>Item condition</b> Floor bolts ground off rather than removed in around 8 locations. Bolts protrude from floor surface.
<b>Work required</b> Remove bolts, make good, and redecorate.	<b>Notes</b>

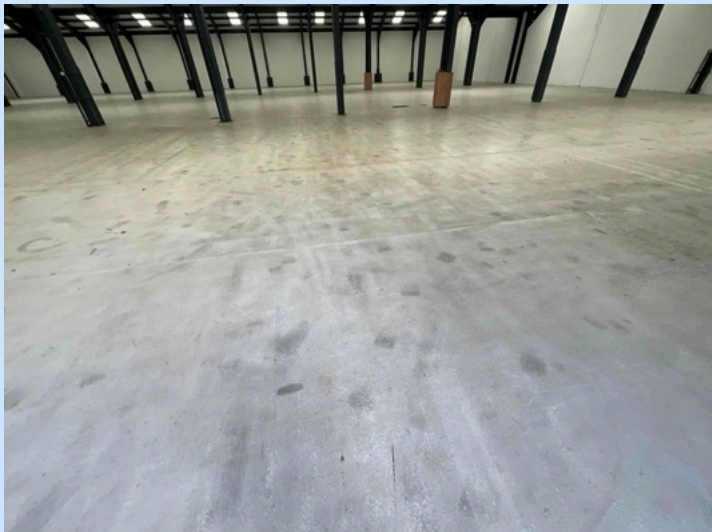
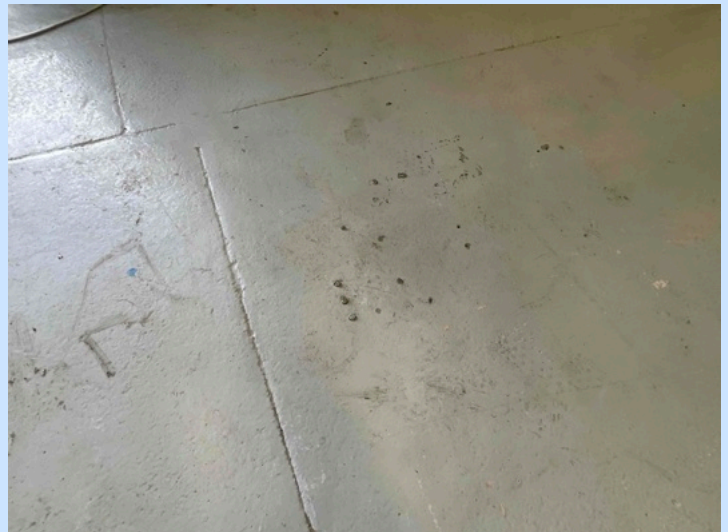
<b>Location</b> C5 <b>Element</b> Floor structure
<b>Item description</b> Solid concrete floor structure with smooth screed	<b>Item condition</b> Studs protruding in 3 locations.
<b>Work required</b> Remove bolts, make good, redecorate.	<b>Notes</b>

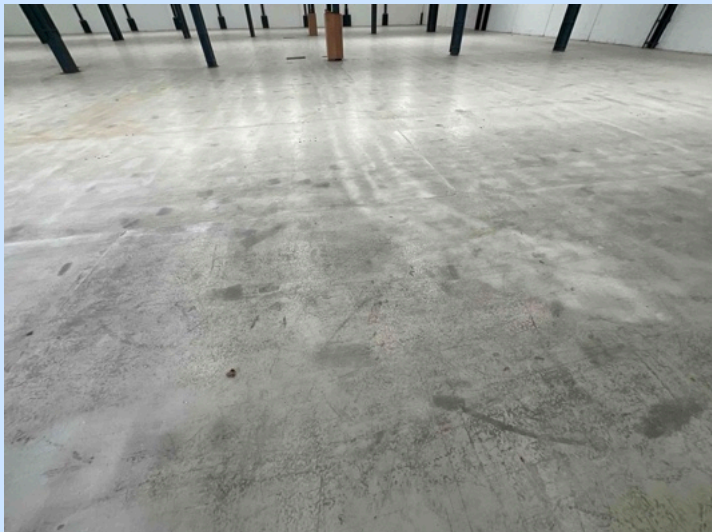
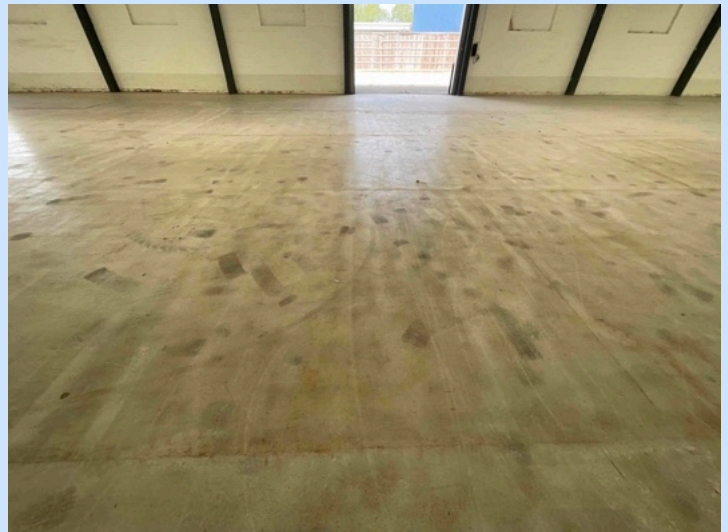
<b>Location</b> C5  <b>Element</b> Floor coverings
<b>Item description</b> Floor paint over surface	<b>Item condition</b> In an aged condition, soiled. Cracking to finishes in localised areas.
<b>Work required</b> Make good cracked finishes.	<b>Notes</b>

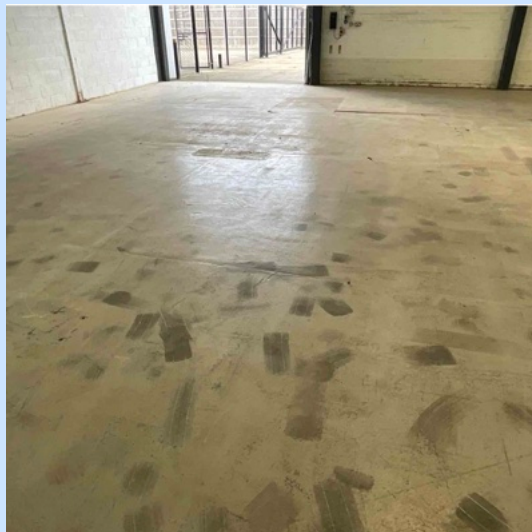
<b>Location</b> C6  <b>Element</b> Floor structure
<b>Item description</b> Solid concrete floor structure with smooth screed	<b>Item condition</b> Studs protruding in 3 locations. Multiple areas with cracked surface finishes.
<b>Work required</b> Remove bolts, make good, redecorate. Make good disturbed surface.	<b>Notes</b>

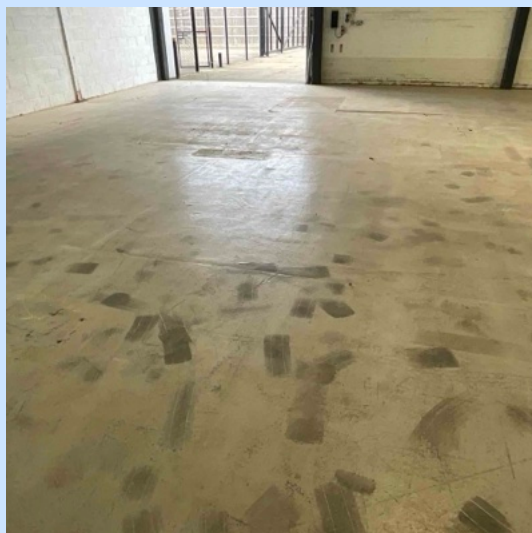
<b>Location</b> C6 <b>Element</b> Floor coverings
<b>Item description</b> Floor paint over surface	<b>Item condition</b> In an aged condition, soiled. Cracking to finishes in localised areas.
<b>Work required</b> Make good surfaces and redecorate.	<b>Notes</b>

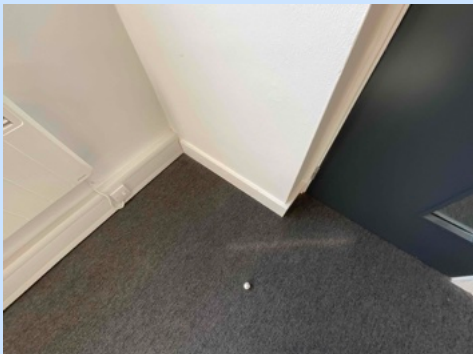
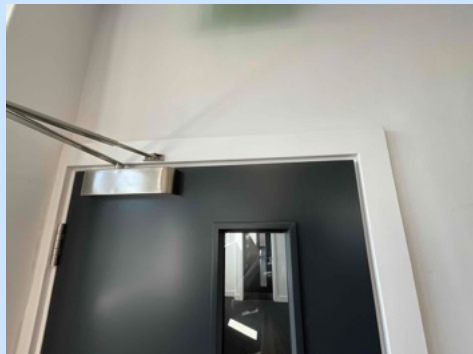
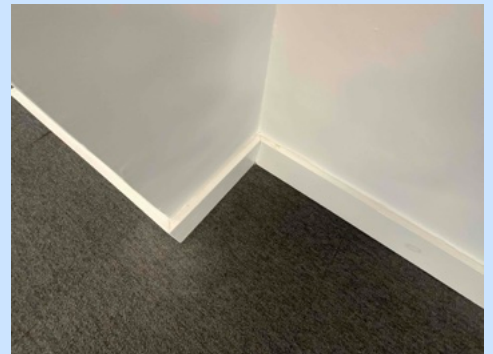
<b>Location</b> 1st Floor Office North  <b>Element</b> Joinery
<b>Item description</b> MDF/timber joinery coated in flat paint	<b>Item condition</b> Generally in good condition, but with some cracking at door perimeter and abutment with walls
<b>Work required</b> Fill and redecorate.	<b>Notes</b>

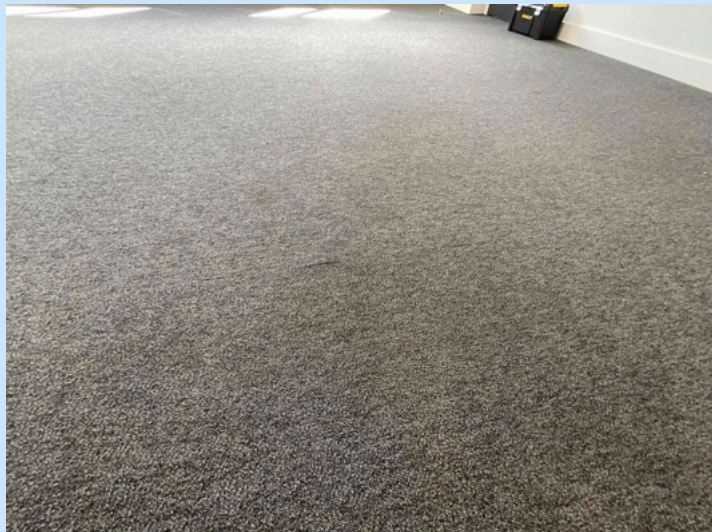
<b>Location</b> 1st Floor Office North  <b>Element</b> Floor coverings
<b>Item description</b> Carpet tiles	<b>Item condition</b> Generally in a good condition as new, but with some lifting at seams.
<b>Work required</b> Refix carpet tiles locally.	<b>Notes</b>

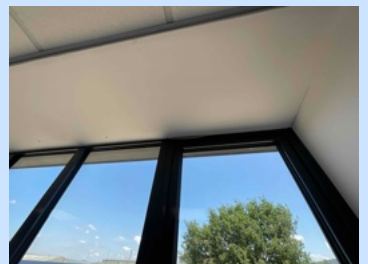
<b>Location</b> 1st Floor Office North  <b>Element</b> Windows
<b>Item description</b>  Powder coated aluminium windows with double glazing	<b>Item condition</b>  Generally, windows are soiled and cobwebs surrounds the windows and opening mechanisms  Water ingress was noted back to the north west window at the corner.  Tape noted to Sentral window paint to North West window group  Sealant joint has become dislodged to North West window group right most window.
<b>Work required</b>  Investigate water ingress to window frame, undertake remedial works (photo 40)  Clean down windows.  Remove tape and clean any residue (photo 45)  Refix sealant joint (photo 46)	<b>Notes</b>

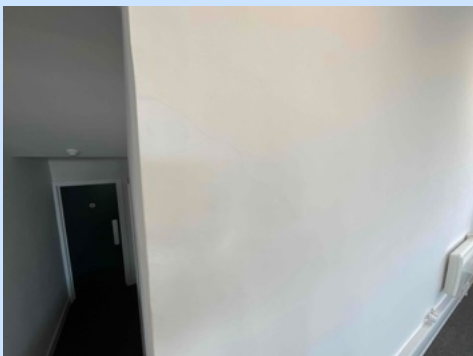
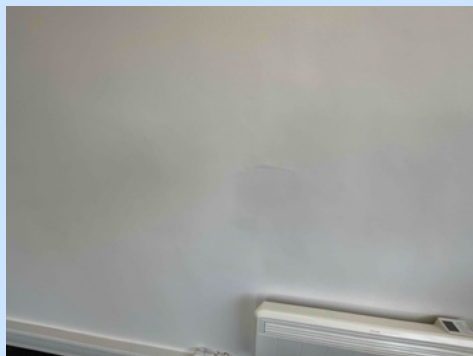
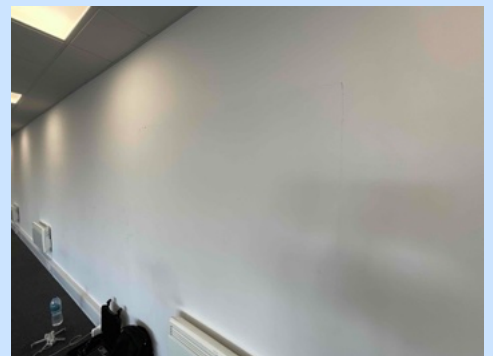
<b>Location</b> 1st Floor Office North  <b>Element</b> Walls
<b>Item description</b> Emulsion coated plaster	<b>Item condition</b> Hairline Cracking forming square panel to west wall. Fine crack adjacent to GWC door. Find cracking around windowsills to north wall.
<b>Work required</b>	<b>Notes</b>

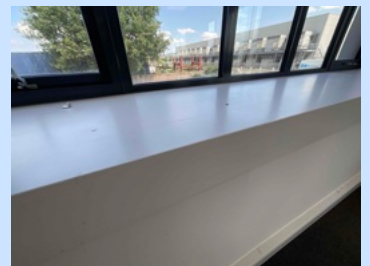
<b>Location</b> 1st Floor Office North  <b>Element</b> Windowsill
<b>Item description</b> Mdf coated in paint.	<b>Item condition</b> Cracking at perimeter abutments with walls.  Permanent marker to top surface to left most window group.  Popped screw caps generally over surface, breaking surface filler.
<b>Work required</b> Fill cracks and make good.  Remove markings and redecorate.  Remove broken filler and install new to appropriate specification.	<b>Notes</b>

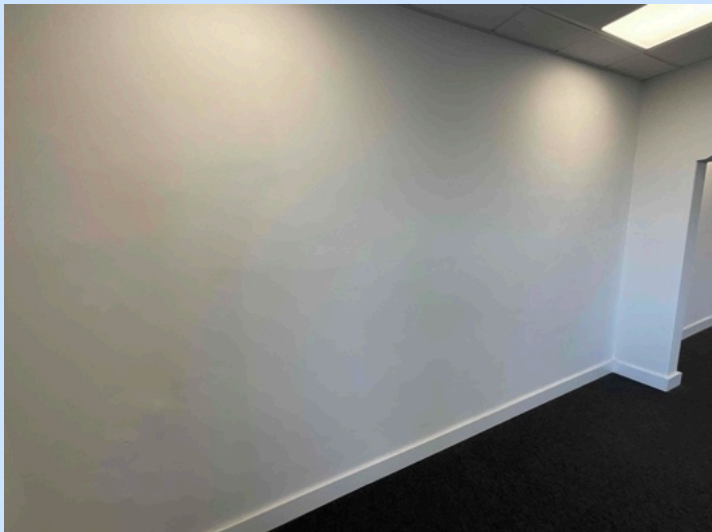
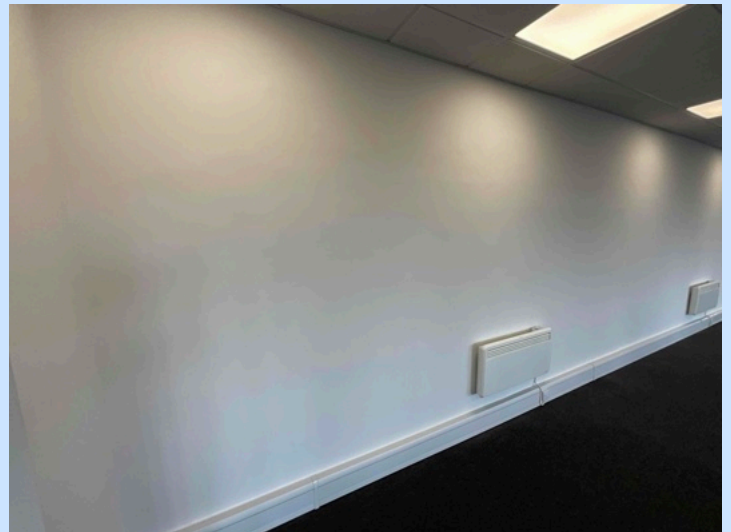
<b>Location</b> 1st Floor Office Central  <b>Element</b> Walls
<b>Item description</b> Emulsion coated plaster	<b>Item condition</b> In good condition generally but with poor decorative finish requiring redecoration.  Find crack above radiator to south of East facing wall.
<b>Work required</b> Fill cracks and redecorate.	<b>Notes</b>

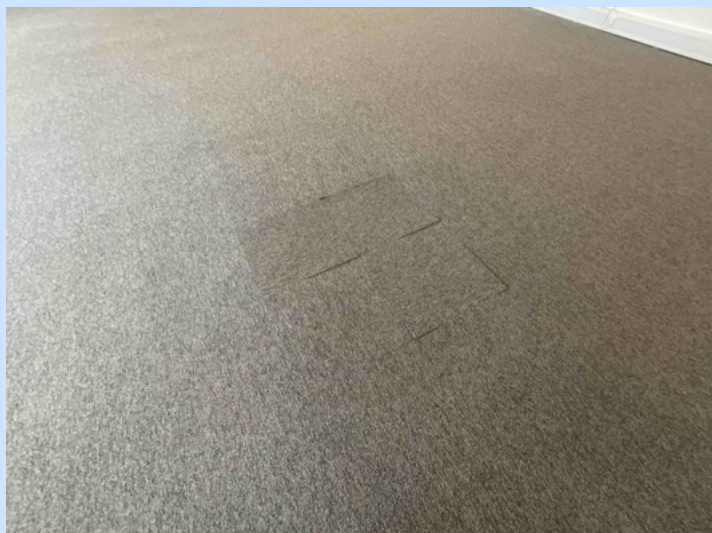
<b>Location</b> 1st Floor Office Central  <b>Element</b> Floor coverings
<b>Item description</b> Carpet tiles.	<b>Item condition</b> Generally in a good condition, four tiles lifted towards centre of Office.
<b>Work required</b> Refix lifted carpet tiles.	<b>Notes</b>

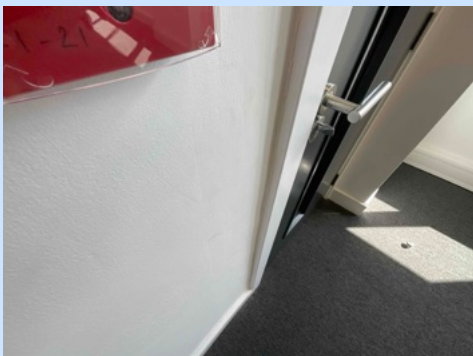
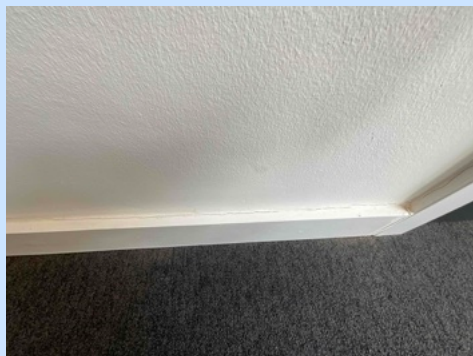
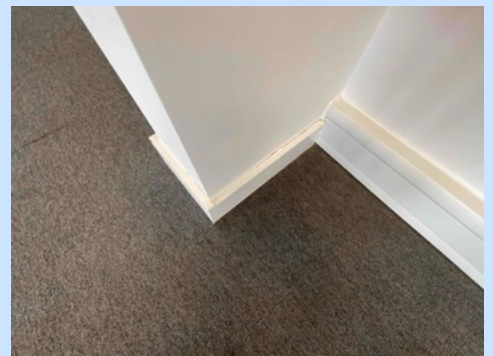
<b>Location</b> 1st Floor Office Central  <b>Element</b> Joinery
<b>Item description</b> MDF/timber joinery coated in flat paint	<b>Item condition</b> Cracking at door perimeter and abutment with walls
<b>Work required</b> Fill cracks, make good, and redecorate.	<b>Notes</b>

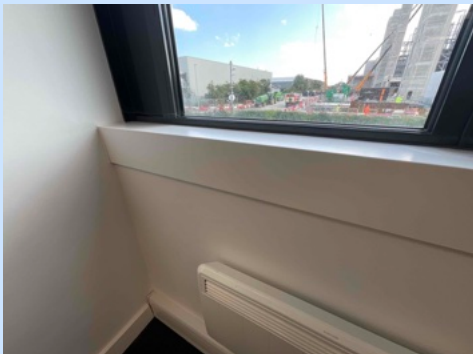
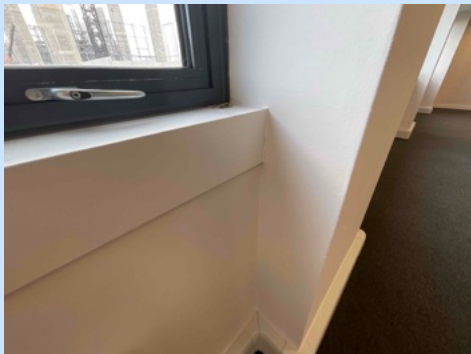
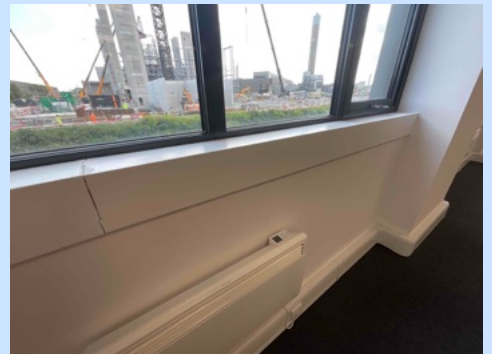
<b>Location</b> 1st Floor Office Central  <b>Element</b> Windowsills
<b>Item description</b> Mdf coated in paint.	<b>Item condition</b> Perimeter cracking to each sill.  Central crack to centre window group section.
<b>Work required</b> Fill and redecorate.	<b>Notes</b>

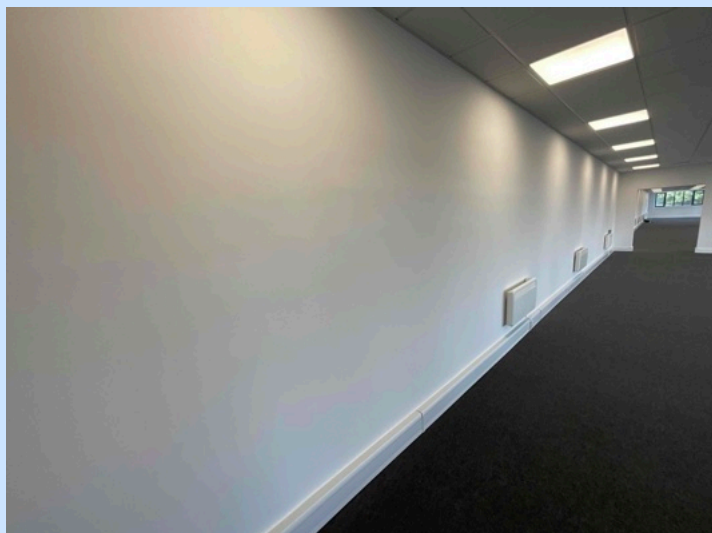
<b>Location</b> 1st Floor Office South  <b>Element</b> Walls
<b>Item description</b> Emulsion coated plaster	<b>Item condition</b> Fine crack above radiator to south of East facing wall
<b>Work required</b> Fill cracks, make good, redecorate.	<b>Notes</b>

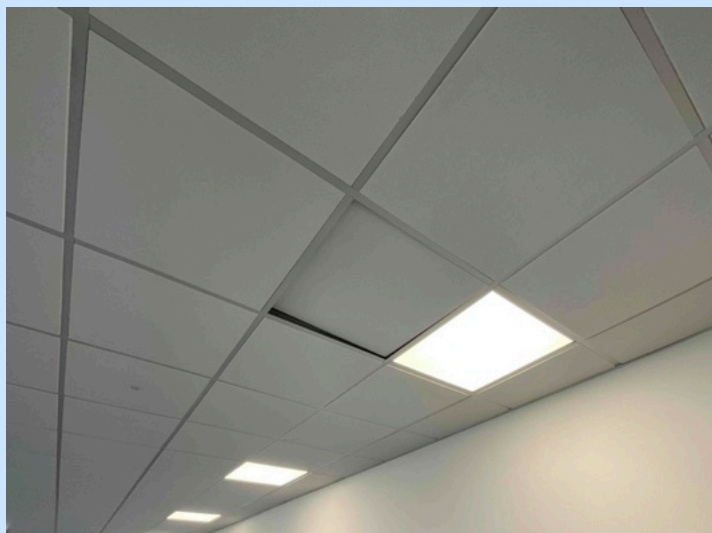
<b>Location</b> 1st Floor Office South  <b>Element</b> Ceiling
<b>Item description</b> Mineral tile suspended ceiling grid.  With inset panel lights and fire detection sounders and sensor.	<b>Item condition</b> One dislodged tile at entrance to adjoining room
<b>Work required</b> Refix tile.	<b>Notes</b>

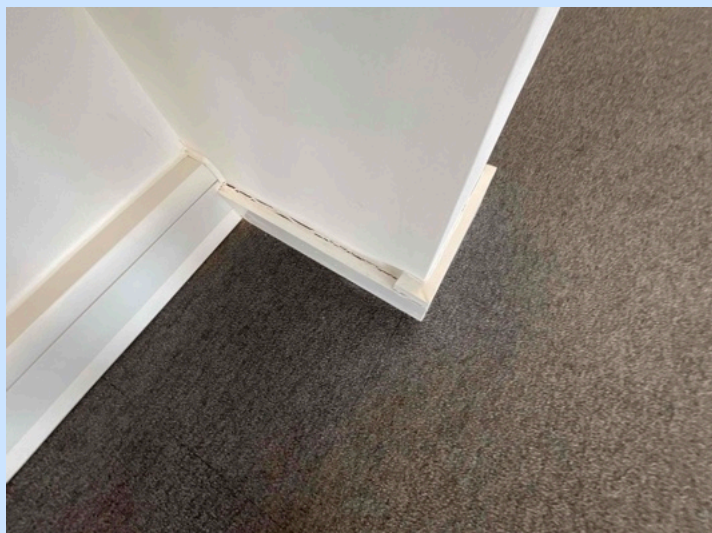
<b>Location</b> 1st Floor Office South  <b>Element</b> Joinery
<b>Item description</b> MDF/timber joinery coated in flat paint.	<b>Item condition</b> Generally in good condition, but with some cracking at door perimeter and abutment with walls
<b>Work required</b> Fill and redecorate.	<b>Notes</b>

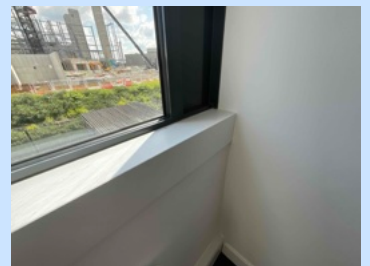
<b>Location</b> 1st Floor Office South  <b>Element</b> Windowsills
<b>Item description</b> Mdf with flat paint	<b>Item condition</b> Satisfactory with opening at sealant joint.
<b>Work required</b> Renew sealant joints where necessary.	<b>Notes</b>

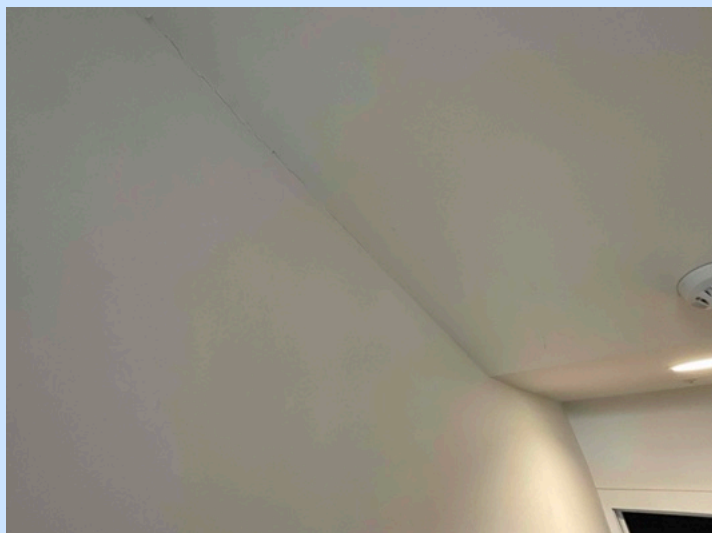
<b>Location</b> Lobby to WC
<b>Item description</b> Emulsion coated plaster	<b>Element</b> Walls
<b>Work required</b> Fill and redecorate.	<b>Item condition</b> General cracking between ceiling and wall junction.
	<b>Notes</b>

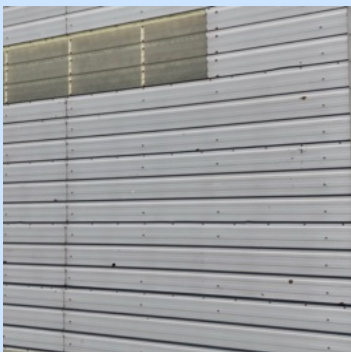
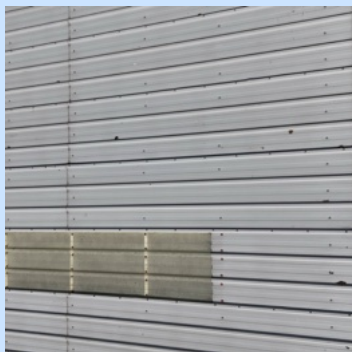
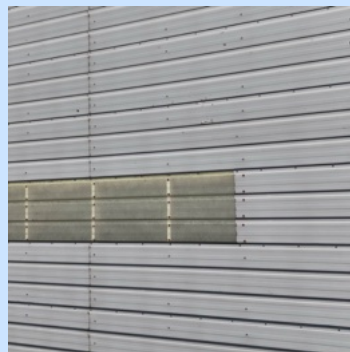
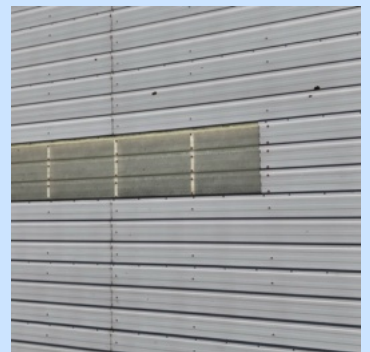
<b>Location</b> Roof 1  <b>Element</b> Roof covering and Rooflights
<b>Item description</b> <p>Profiled metal sheet roof covering with metal ridge flashings fixed with rivets.</p> <p>The roof sheets have a single lap at half length.</p> <p>Tek screw fixings into purlins.</p>	<b>Item condition</b> <p>Dark spots were observed to the surface of the roof sheets in localised areas, most likely either rust spots or bird droppings.</p> <p>Tek screws appear to have deteriorated and screws gaskets are generally cracked.</p>
<b>Work required</b> <p>Arrange walk over inspection to investigate dark spots.</p> <p>Undertake torque test and vacuum seal test for Tek screws to understand potential for roof leaks.</p>	<b>Notes</b>

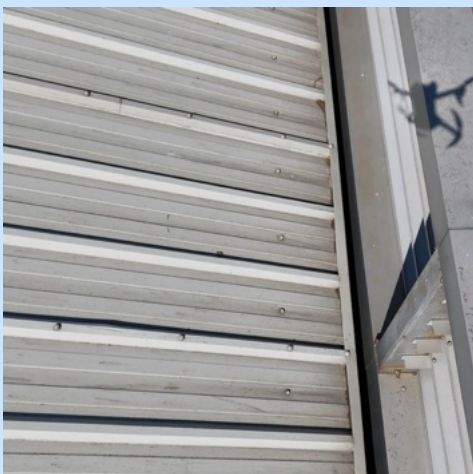
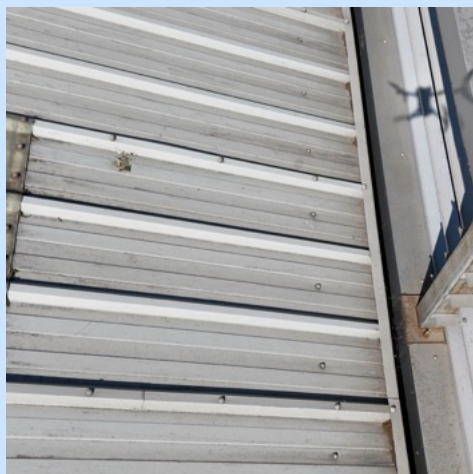
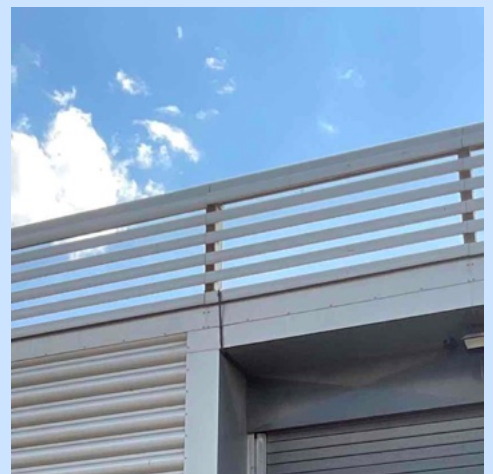
<b>Location</b> Roof 1  <b>Element</b> Parapet walls
<b>Item description</b> Metal edge balustrade.	<b>Item condition</b> Corrosion noted at bases and stanchions.
<b>Work required</b> Provide anti-corrosion treatment to stanchions and bases.	<b>Notes</b>

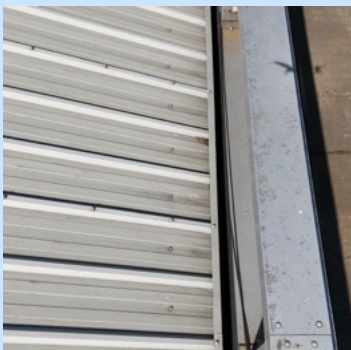
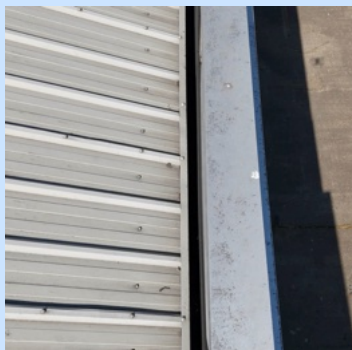
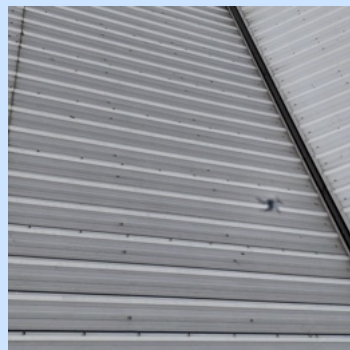
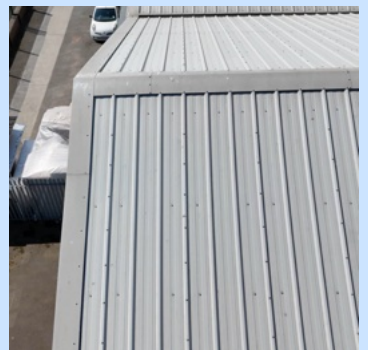
<p><b>Location</b></p> <p>Roof 2</p> <p><b>Element</b></p> <p>Roof covering.</p>
<p><b>Item description</b></p> <p>Profiled metal sheet roof covering with metal ridge flashings fixed with rivets.</p> <p>The roof sheets have a single lap at half length.</p> <p>Tek screw fixings into purlins.</p>	<p><b>Item condition</b></p> <p>Tek screws appear to have deteriorated and screws gaskets are generally cracked.</p>
<p><b>Work required</b></p> <p>Undertake torque test and vacuum seal test for Tek screws to understand potential for roof leaks.</p>	<p><b>Notes</b></p>

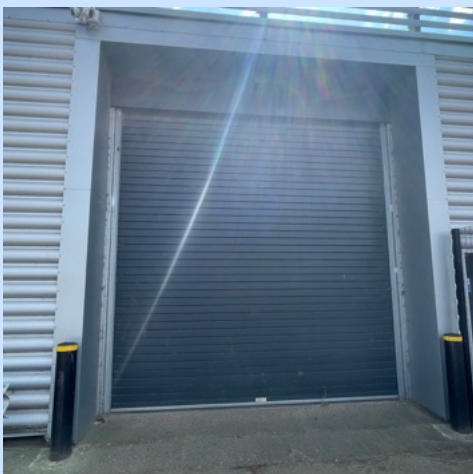
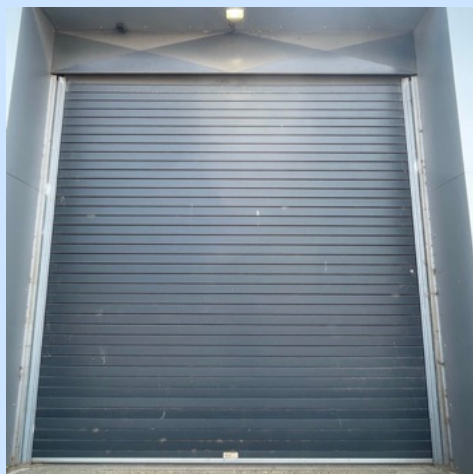
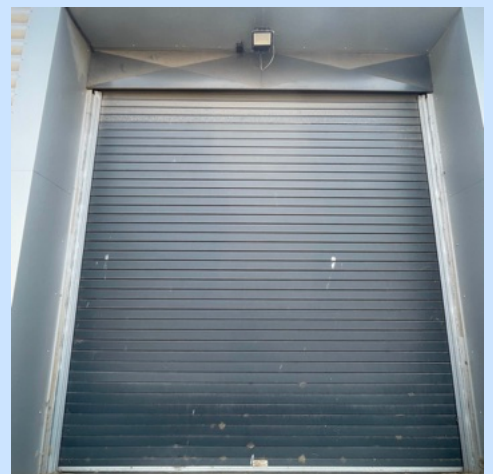
<b>Location</b> External roller doors  <b>Element</b> Door leaf
<b>Item description</b> Metal segmental roller door.	<b>Item condition</b> Soiling may conceal surface defects.
<b>Work required</b> Clean down and reevaluate condition.	<b>Notes</b>

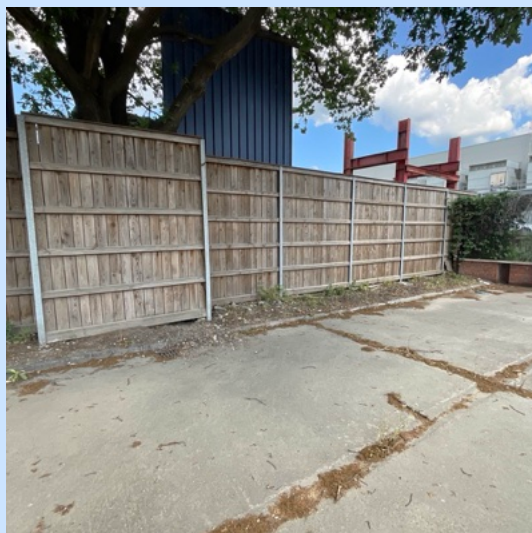
<b>Location</b> Grounds  <b>Element</b> Edging
<b>Item description</b> Soft landscaped edging with soil and plant growth.	<b>Item condition</b> Generally untidy
<b>Work required</b> Consider planting or paving over.	<b>Notes</b>
