### \_\_\_\_\_ ^ 쓰 \_\_\_\_\_ Ayling Associates Ltd.

Chartered Building Surveyors

### A Introduction to the report

This RICS Home Survey – Level 3 has been produced by a surveyor, who has written this report for you to use. If you decide not to act on the advice in this report, you do so at your own risk.

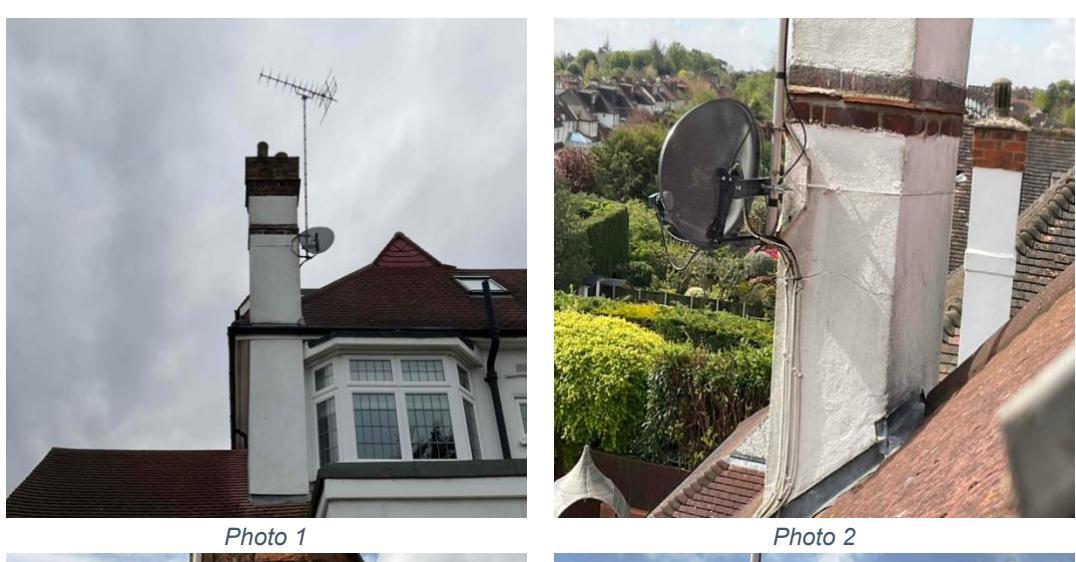
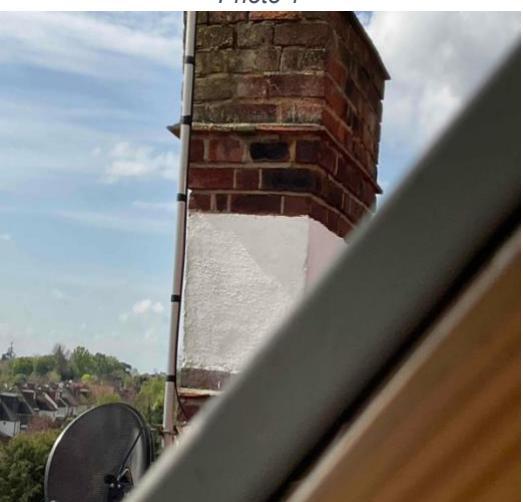
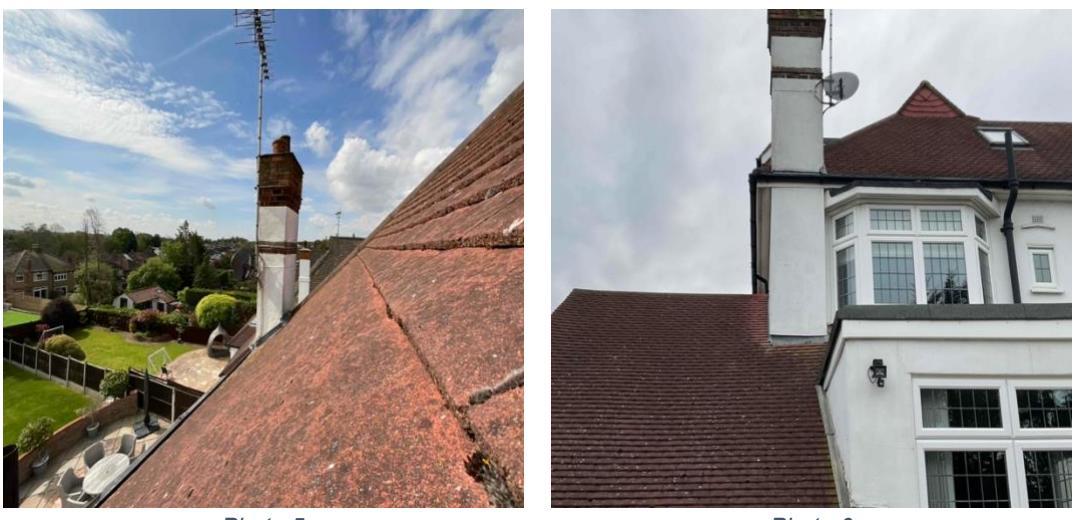
The pointing to the chimney appears in a poor condition. Chimney pointing maintenance is crucial for preserving the integrity of brick units of the chimney. Properly maintained pointing also mitigates against the onset or progression of leaning in the chimney structure. Moreover, it plays a significant role in inhibiting water ingress, thereby protecting the internal components of the building structure from moisture-related damage. Failure to properly maintain the chimney pointing can lead to an escalation in repair costs (condition rating 2).

The brick units appear generally in satisfactory condition, this is an indication that historic maintenance has been generally sufficient. Pointing should always be maintained in good condition to prevent the accelerated deterioration of the masonry units.

Render to the chimney is cracked and an allowance should be made for hacking of and replacing locally.

The term "flaunching" refers to a sloping fillet of cement or mortar embedding the base of a chimney pot to hold it in place. Aged flaunchings can be susceptible to water ingress and erosion and should be maintained to hold the pots in place and to prevent the brickwork from deteriorating. The flaunching is in a poor condition and will require repairs or replacement. (Condition rating 2).

We noted that none of the pots are covered with cowls or caps. Generally, chimney stacks and pots should be capped and vented. The caps prevent the ingress of rainwater and nesting birds and insects. Where flues are sealed below and/or fireplaces are not used, there is a risk of a build-up of condensation internally within the flue, which can create dampness issues. Where flues are to be used for solid fuel fires or gas appliances, a specialist should be appointed in order to determine that the gases are sufficiently vented with the caps or cowls in place.

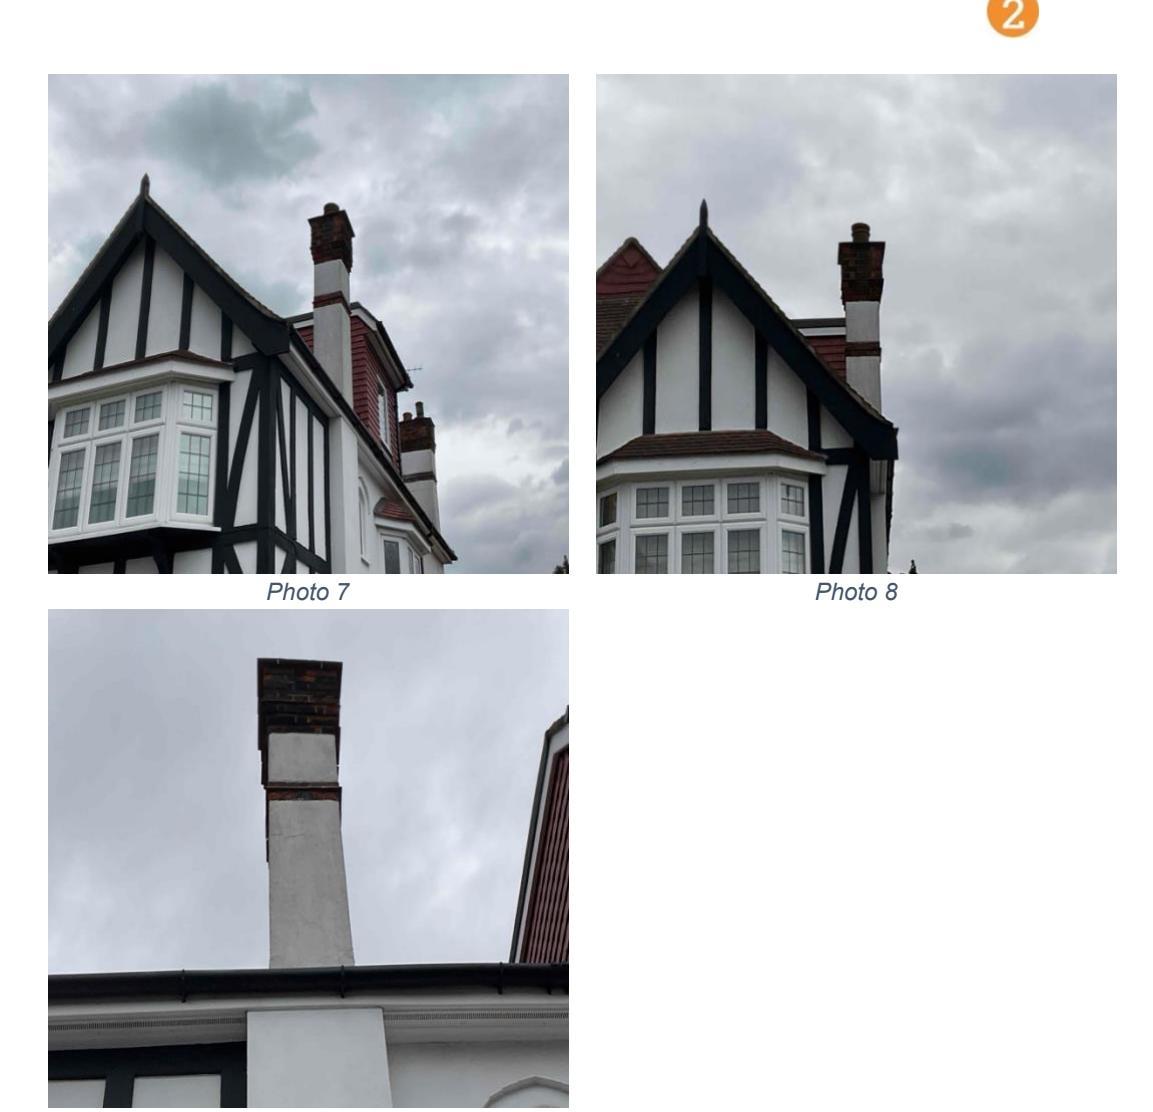
Photo 9

The pointing to the chimney appears in a poor condition. Failure to properly maintain the chimney pointing can lead to an escalation in repair costs (condition rating 2).

The brick units to the chimney appear to have undergone some deterioration. The cause of

the deterioration of the bricks may be the poor condition of the pointing which can inhibit their ability to shed water and lead to freeze/thaw action. It may be necessary to replace damaged bricks locally and an allowance should be made for this. Pointing should always be maintained in good condition to prevent the accelerated deterioration of the masonry units (condition rating 2).

Render to the chimney is cracked and an allowance should be made for hacking off and replacing locally.

The term "flaunching" refers to a sloping fillet of cement or mortar embedding the base of a chimney pot to hold it in place. Aged flaunchings can be susceptible to water ingress and erosion and should be maintained to hold the pots in place and to prevent the brickwork from deteriorating. The flaunching is in a poor condition and will require repairs or replacement (condition rating 2).

We noted that none of the pots are covered with cowls or caps. Generally, chimney stacks and pots should be capped and vented. The caps prevent the ingress of rainwater and nesting birds and insects. Where flues are sealed below and/or fireplaces are not used, there is a risk of a build-up of condensation internally within the flue, which can create dampness issues. Where flues are to be used for solid fuel fires or gas appliances, a specialist should be appointed in order to determine that the gases are sufficiently vented with the caps or cowls in place.

The chimney appears to lean slightly. We recommend that the degree of leaning is monitored. It may be necessary to stabilise or rebuild the chimney over the coming years, and an allowance should be set aside for this.

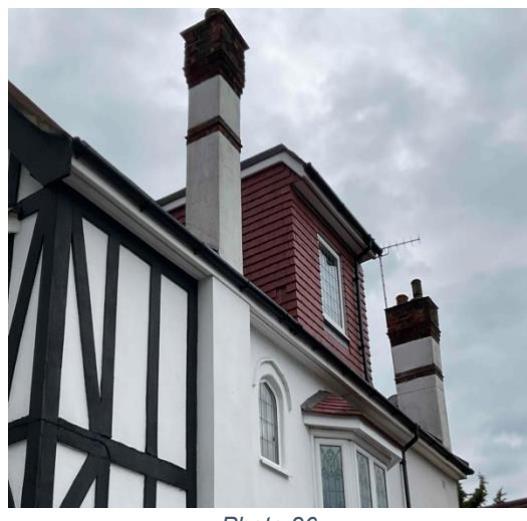
Photo 26

The roof was not inspected during our assessment. Further investigation or another survey may be necessary to understand the roof's condition. Alternatively, the roof may carry an existing guarantee, and your legal advisor should be asked to request this.

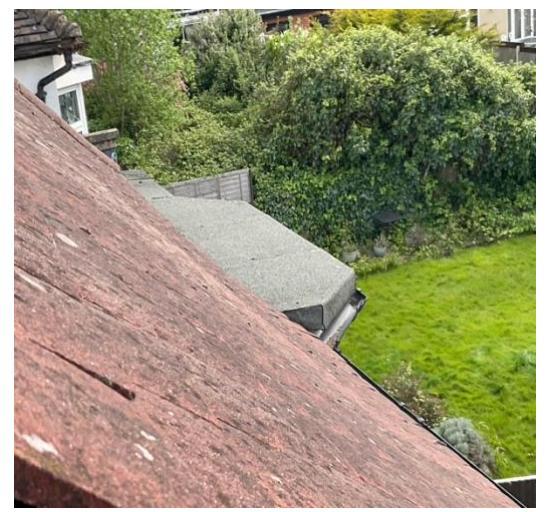
Photo 27

There are two roofs to bay windows to the rear of the property, one of which could be seen from the upper window and the other was obscured by the aspect of the building. In this section we have allowed for replacement of the roof that we could not inspect on the assumption that it was installed at the same time and is therefore in a similar condition.

The roof covering is a reinforced bitumen membrane (RBM). These roof coverings most likely date from the original loft conversion understood to have taken place in 2005. We estimate the age of the roof age is approaching (20 years) and as such we consider that it is close to or has exceeded the typical life expectancy. The condition should be monitored and an allowance should be made for replacement over the next 5-10 years to ensure that water does not begin to enter the building fabric (condition rating 2).

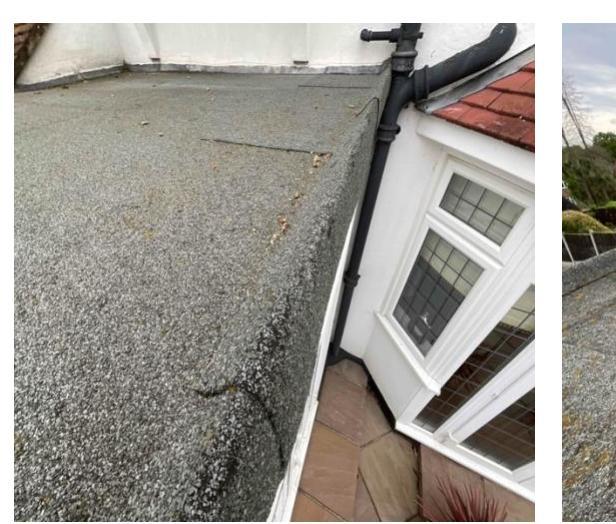
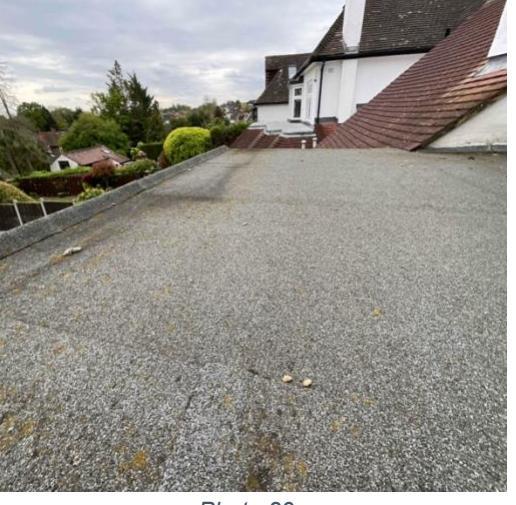
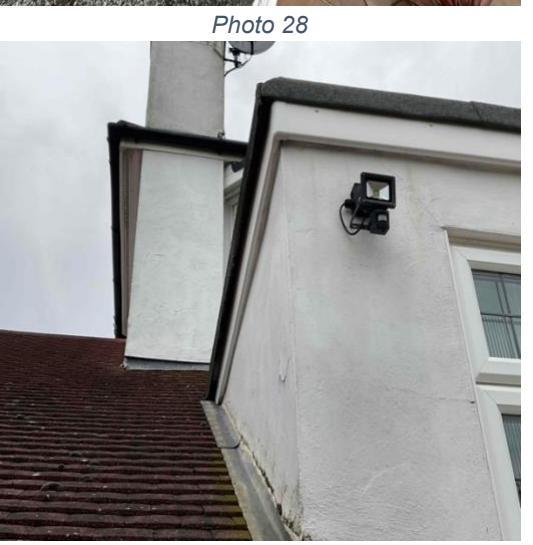
The roof covering is a reinforced bitumen membrane (RBM). The condition of the roof appears commensurate with the other flat roofs to the property. The condition should be monitored, and an allowance should be made for replacement over the next 5-10 years to ensure that water does not begin to enter the building fabric (condition rating 2).

The flat roof is constructed using a cold deck unventilated design. In this setup, the insulation is placed below the structural deck, and there is no dedicated ventilation. This absence of ventilation can be problematic, as the roof might be prone to condensation issues. Condensation, if not managed, can cause timber rot, compromise the structural integrity of the roof, and lead to an escalation in repair costs.

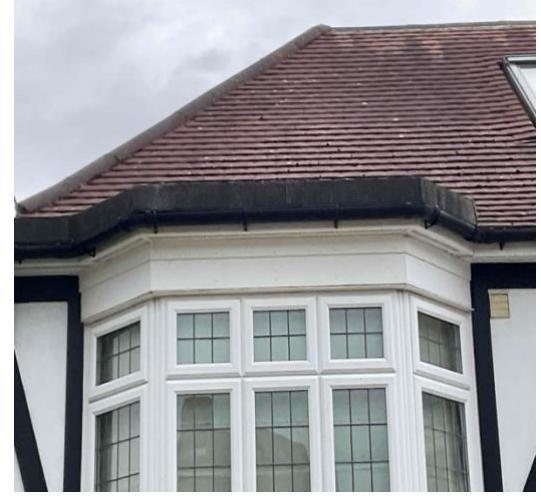
Photo 34

The inspection was conducted from the ground level due to the pitched nature of the roof. While this method offers a broader view of the roof, some details might not be as apparent as with a closer inspection.

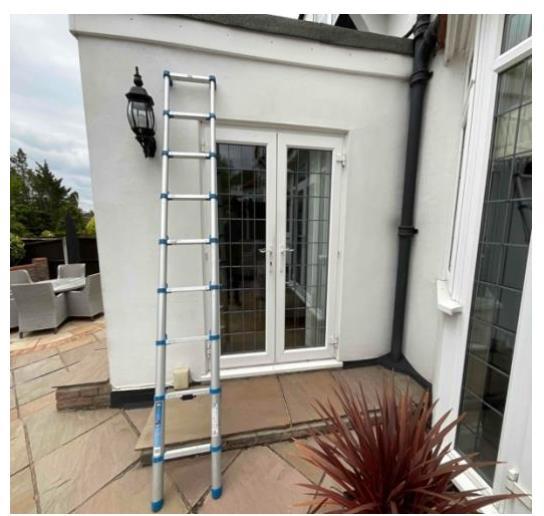
Photo 72

PVCu double glazed door is in a satisfactory condition.

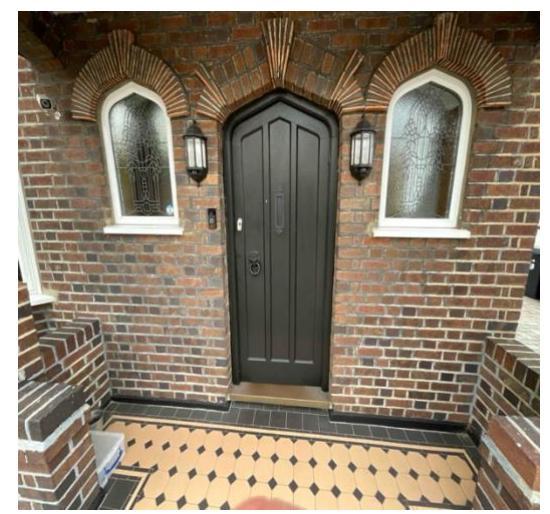
Photo 73

Timber door is in a satisfactory condition.

The door has typical ironmongery and has a mortice deadlock.

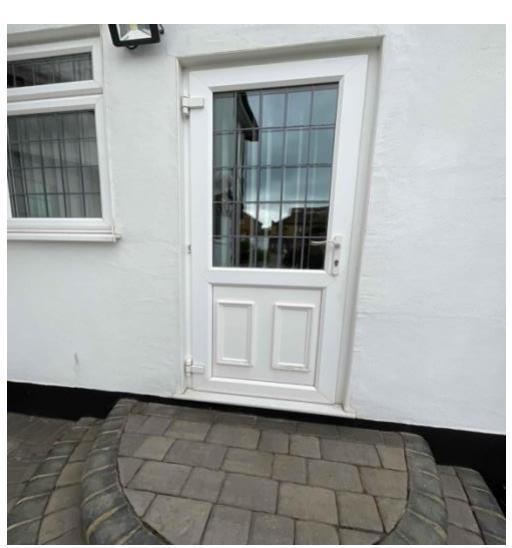
Photo 74

PVCu double glazed door is in a satisfactory condition.

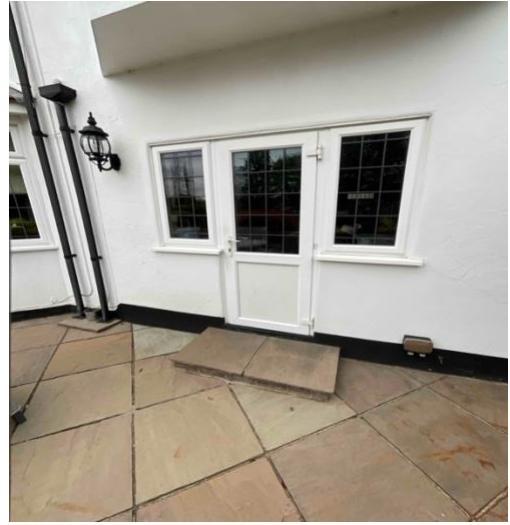
Photo 75

PVCu double glazed door is in a satisfactory condition.

The door has typical ironmongery and has a key operated multi-point locking system.

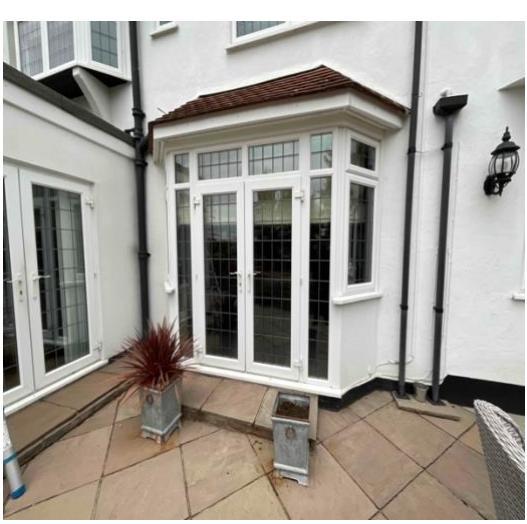
Photo 76

PVCu double glazed door is in a satisfactory condition.

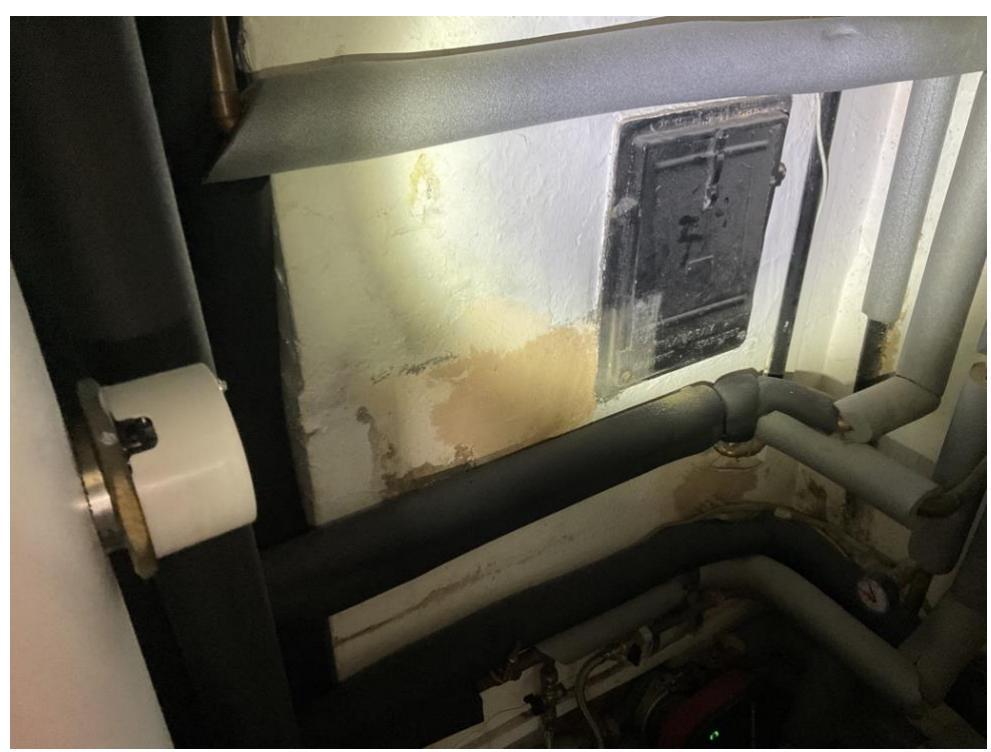
Photo 91

The flue associated with this chimney is not visible in the rooms below until reaching the utility area at ground floor level. It is possible that the chimney has been discontinued at a higher level within the building.

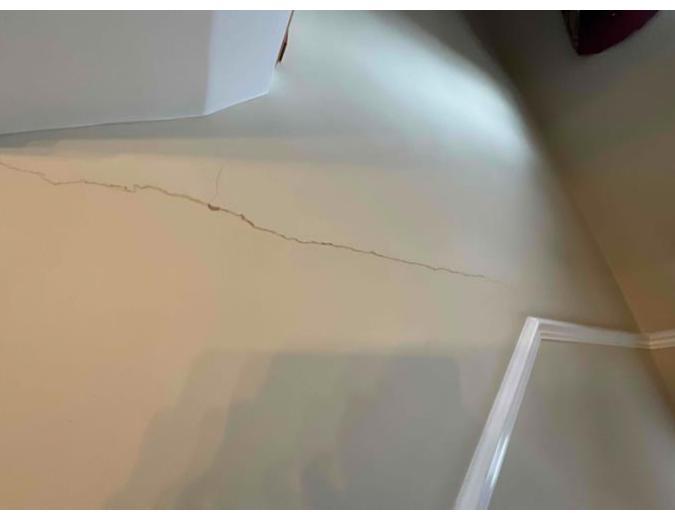
Photo 92

We noted a significant cracking at the walls to the stair at the 2<sup>nd</sup> floor level in the hallway. The crack has formed at the junction between the masonry walls, and the timber stud partition walls that are built on top as part of the loft conversion. Differential movement between these two materials may persist due to seasonal moisture movement in the timber. An attempt can be made to mitigate the cracking by installing a scrim or other reinforcement and repairing the plaster over.

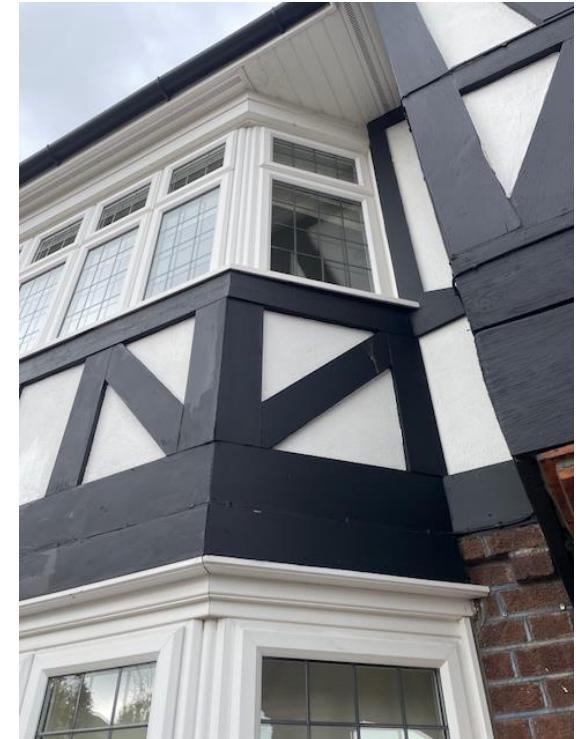
We noted cracking to the inner face of the front bay window at first floor level (Bedroom 2) which we consider may be either caused by replacement of load bearing bay windows, or movement of the bay window in relation to the main building. You are advised to request building regulation completion certificates for the window replacement works and note that approved installer schemes do not apply to windows which are load bearing or structural, and therefore if these elements are load bearing, a building regulation application would have been necessary. In any event referral to a structural engineer is recommended.

Photo 208 Front bay with cracking to the interior but not the exterior
