## Snagging List

Date: **13<sup>th</sup> May 2025**

## B Snagging List Shop Floor

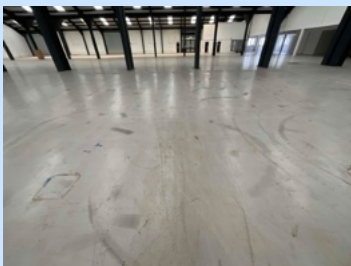
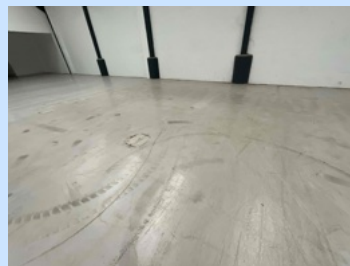
<b>Location</b> A3 <b>Element</b> Floor structure
<b>Item description</b> Solid concrete floor structure with smooth screed	<b>Item condition</b> Floor bolts ground off rather than removed in around 4 locations. Bolts protrude from floor surface.
<b>Work required</b> Remove floor bolts and make good.	<b>Notes</b>

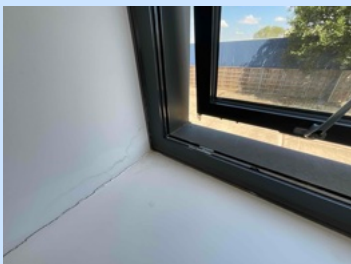
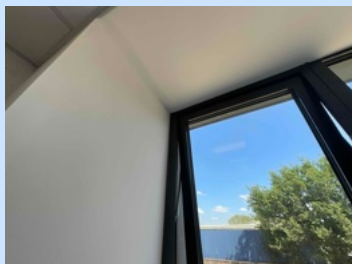
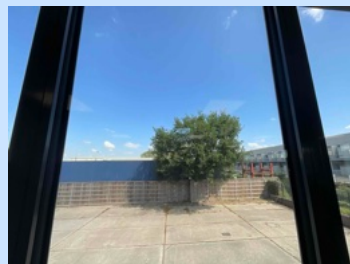
<b>Location</b> 1st Floor Office North  <b>Element</b> Windows
<b>Item description</b>  Powder coated aluminium windows with double glazing	<b>Item condition</b>  Generally, windows are soiled and cobwebs surrounds the windows and opening mechanisms  Water ingress was noted back to the north west window at the corner.  Tape noted to Sentral window paint to North West window group  Sealant joint has become dislodged to North West window group right most window.
<b>Work required</b>  Investigate water ingress to window frame, undertake remedial works (photo 40)  Clean down windows.  Remove tape and clean any residue (photo 45)  Refix sealant joint (photo 46)	<b>Notes</b>

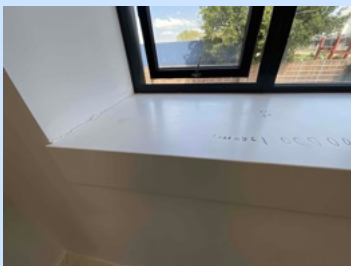
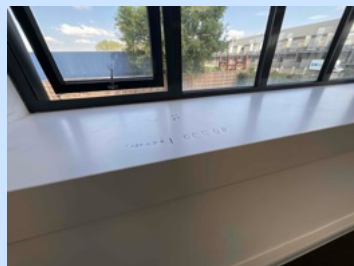
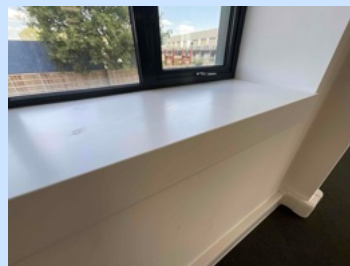
<b>Location</b> 1st Floor Office North  <b>Element</b> Windowsill
<b>Item description</b> Mdf coated in paint.	<b>Item condition</b> Cracking at perimeter abutments with walls.  Permanent marker to top surface to left most window group.  Popped screw caps generally over surface, breaking surface filler.
<b>Work required</b> Fill cracks and make good.  Remove markings and redecorate.  Remove broken filler and install new to appropriate specification.	<b>Notes</b>

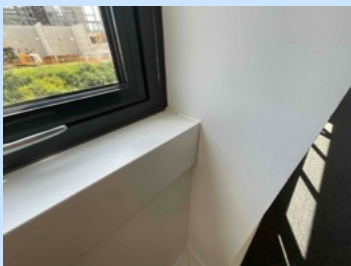
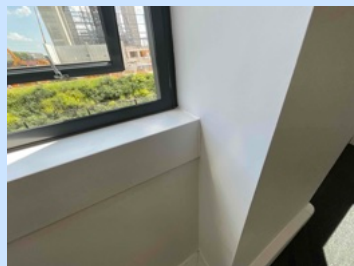
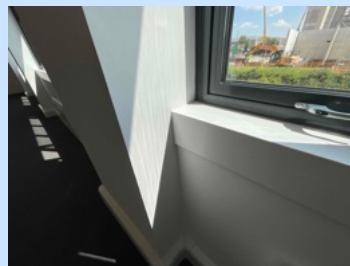
<b>Location</b> 1st Floor Office South  <b>Element</b> Windowsills
<b>Item description</b> Mdf with flat paint	<b>Item condition</b> Satisfactory with opening at sealant joint.
<b>Work required</b> Renew sealant joints where necessary.	<b>Notes</b>
