### \_\_\_\_\_ ^ 쓰 \_\_\_\_\_ Ayling Associates Ltd.

Chartered Building Surveyors

### A Introduction to the report

This RICS Home Survey – Level 3 has been produced by a surveyor, who has written this report for you to use. If you decide not to act on the advice in this report, you do so at your own risk.

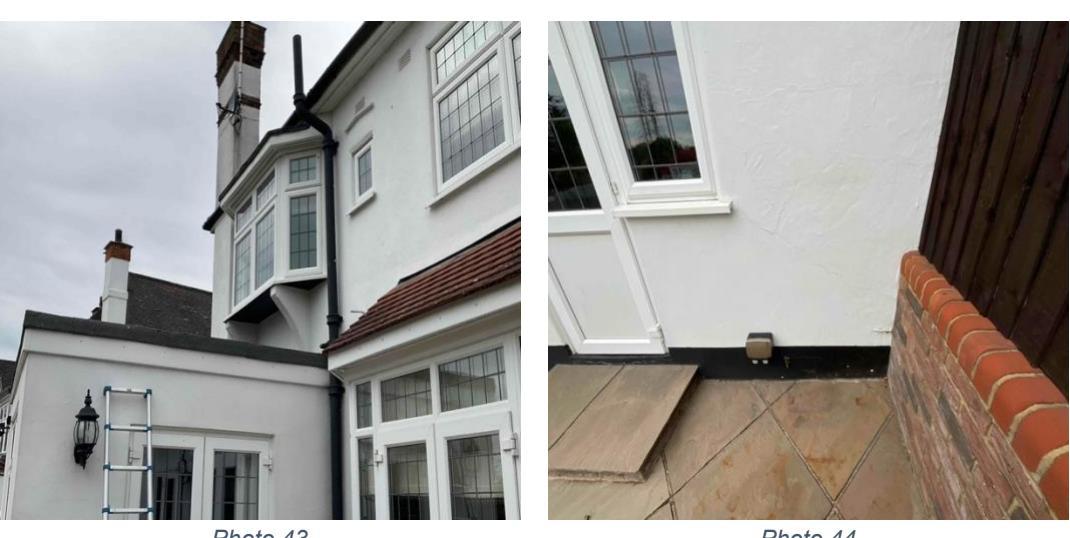
Photo 44

We noted potential structural movement to the rear elevation walls to the garage, which we do not consider is serious at this stage but nevertheless progressive movement cannot be ruled out.

Cracking, which might indicate potential subsidence or foundation issues, has been observed on the exterior wall at the rear of the garage (Photo 44). It is more probable that these cracks affect only the render and share a similar origin with the cracks observed in the adjacent render; nonetheless, the possibility of structural movement cannot be disregarded (condition rating 2).

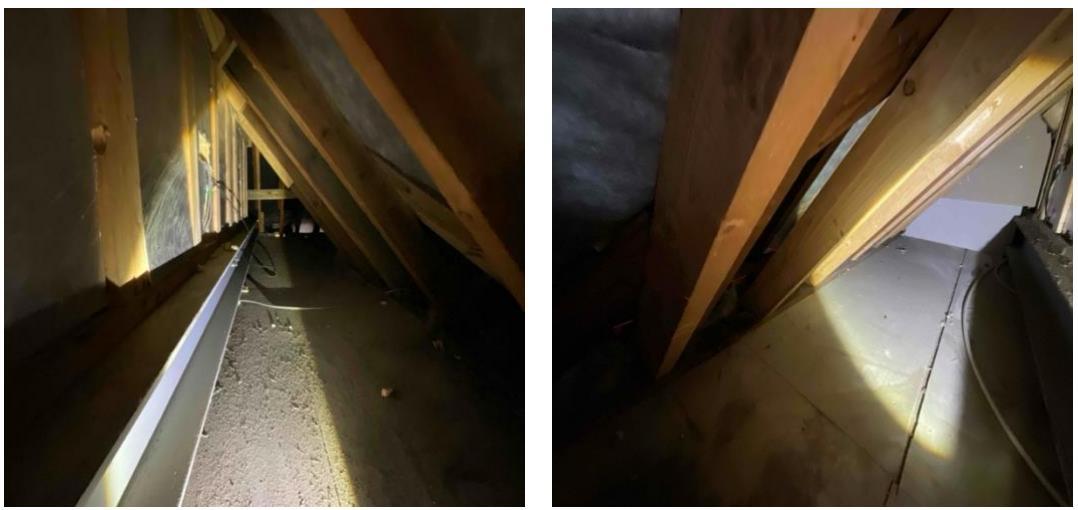
Photo 89 Steel beam as part of loft conversion

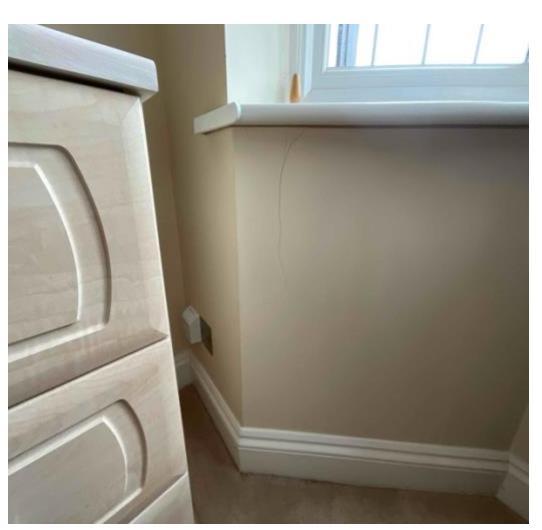
Photo 135

We noted cracking to the internal surfaces of the external walls to Bedroom 2 at the bay window (Photo 135) but noted no obvious associated cracking externally. We consider that the nature and severity of the cracking internally indicates that the cracks may be of a structural nature. Bay windows often move in relation to the main building as a consequence of differential settlement between the bay foundations and the foundations of the main building, and this could have caused this cracking pattern. Another possibility is that the load bearing mullions to the bay window below have either settled or moved during installation/replacement. Replacement of load bearing bay windows can require an additional building regulation application over and above what is normally covered under an approved installer scheme Building (Approved Inspectors etc.) Regulations 2010 e.g FENSA, which could mean a direct application to the local authority building control department is required, your legal advisor should be asked to request building control completion certificates for these works. Referral to a structural engineer is advised for a comprehensive assessment (condition rating 2).

We noted cracking to the internal surfaces of the external walls to Bedroom 2 at the bay window (Photo 135). We consider that the nature and severity of this crack indicates that it may be of a structural nature. Bay windows often move in relation to the main building as a consequence of differential settlement and this could have caused this cracking pattern. Another possibility is that the load bearing mullions to the bay window below have either settled or moved during installation/replacement. When encountering cracks of a significant nature, referral to a structural engineer is strongly advised for a comprehensive assessment. Such cracks could potentially indicate underlying structural issues that may require significant, highly

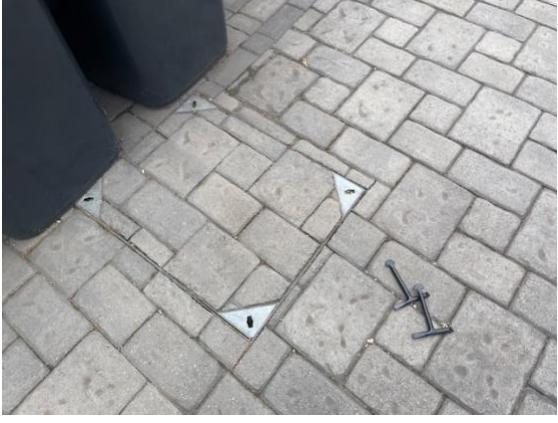
Photo 207 Access chamber could not be opened

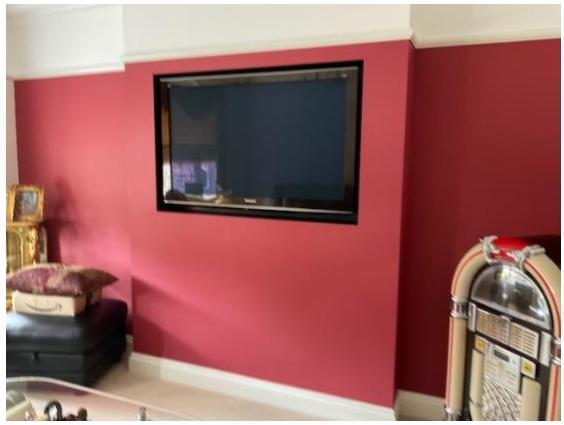
Photo 210 Faux chimney breast with TV

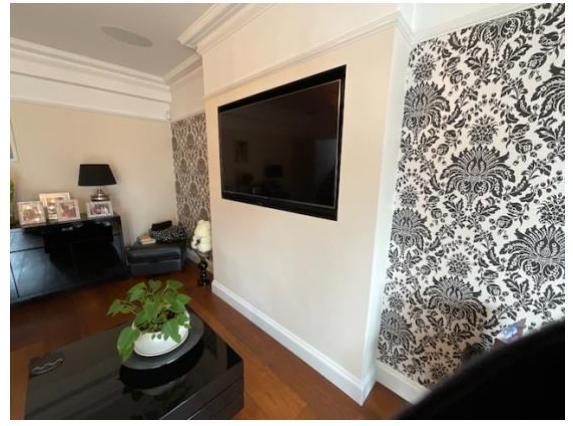
Photo 211 Faux chimney breast with TV

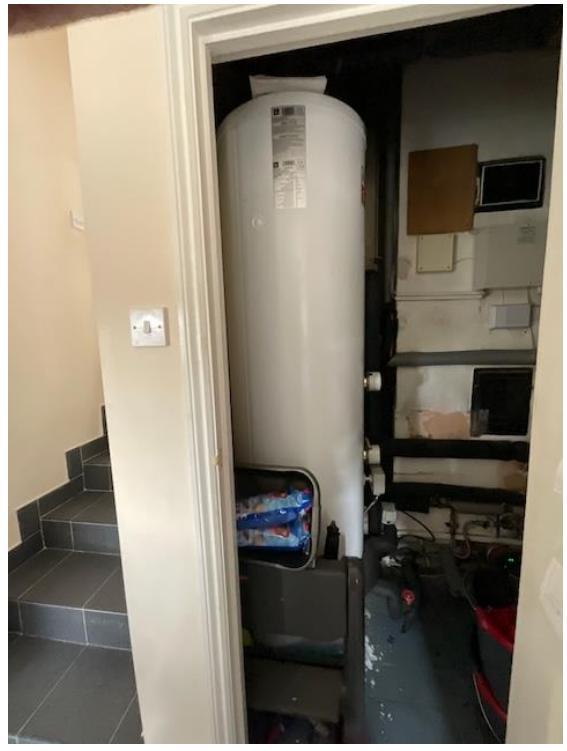
Photo 212 Hot water storage cistern

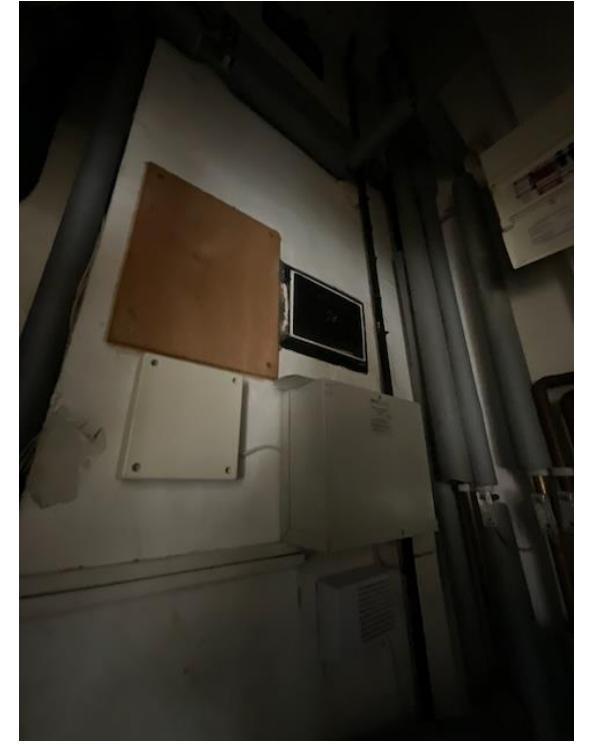
Photo 213 Chimney flue in store

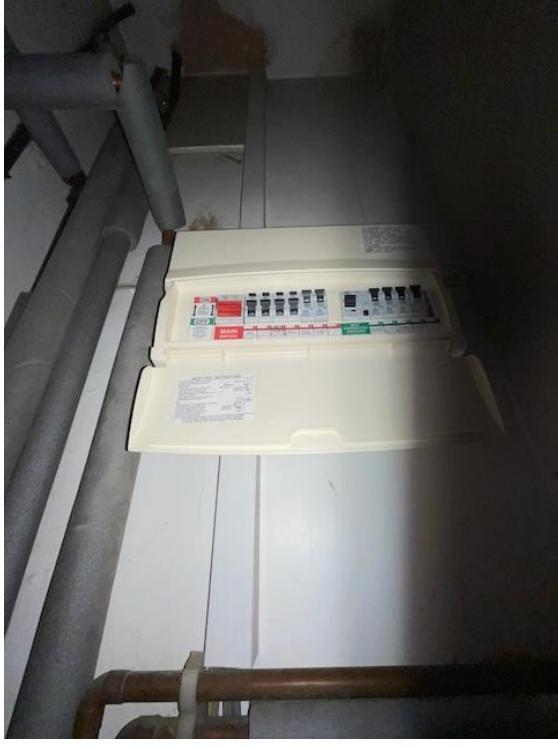
Photo 214 Consumer unit

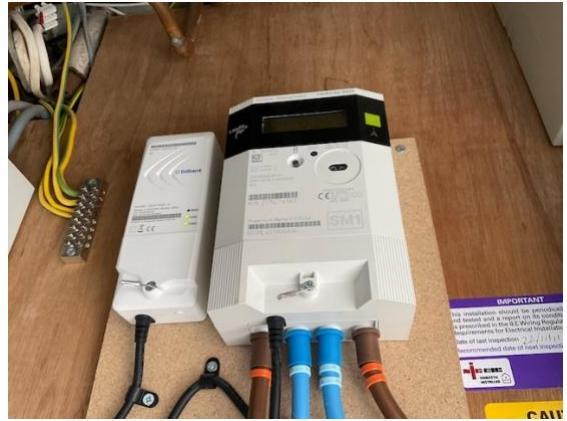
Photo 215 Electrical meter

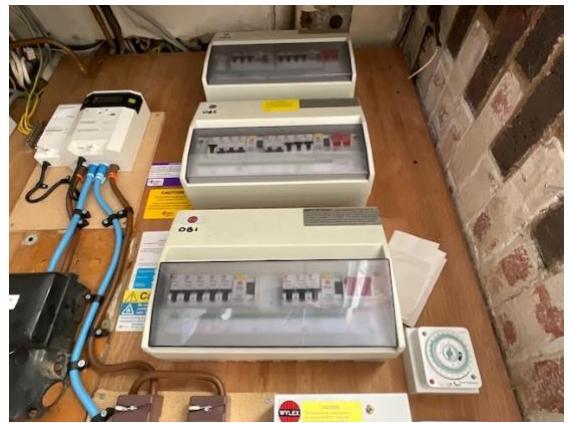
Photo 216 Consumer unit

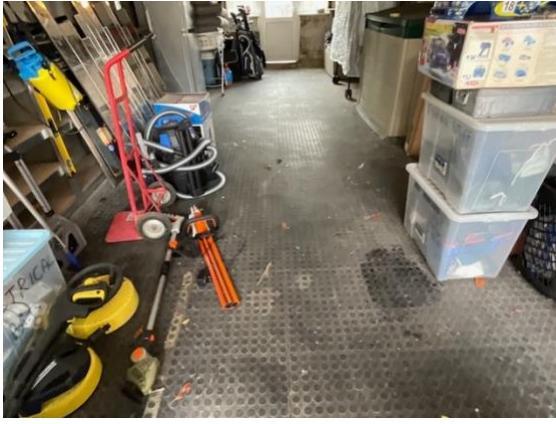
Photo 217 Garage floor

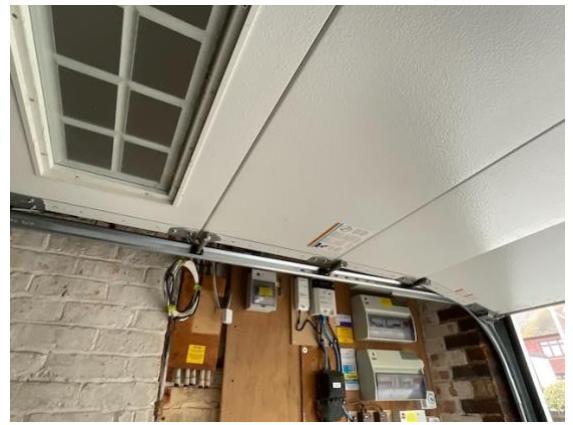
Photo 219 Garage door

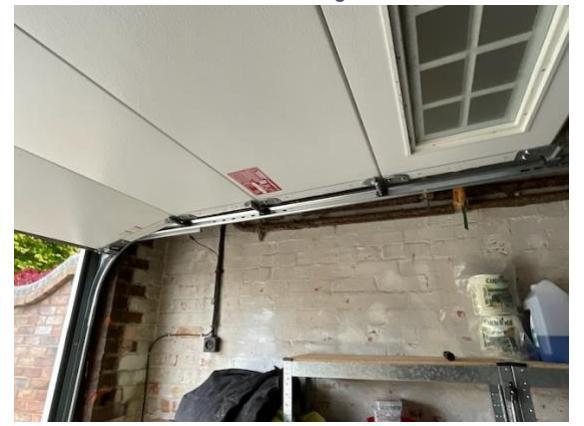
Photo 220 Garage door

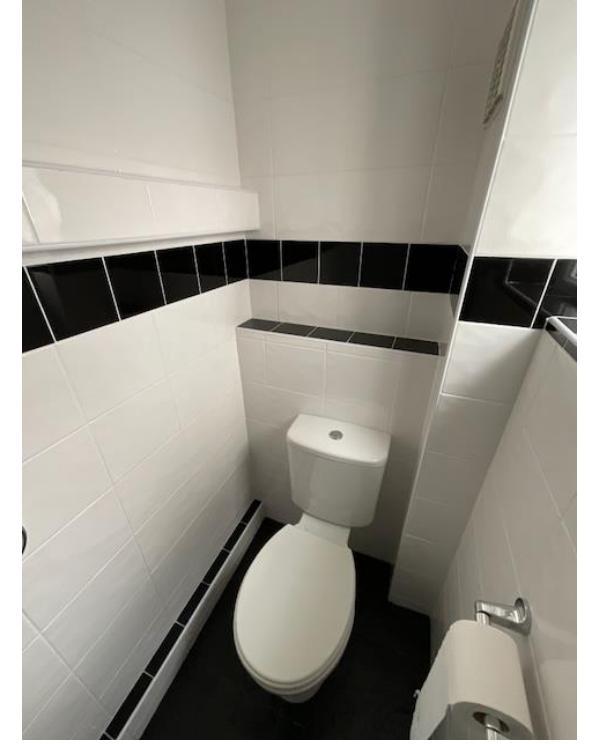
Photo 222 GF WC
