## Schedule of Condition

Date: 13<sup>th</sup> May 2025

## B Schedule of Condition Shop Floor

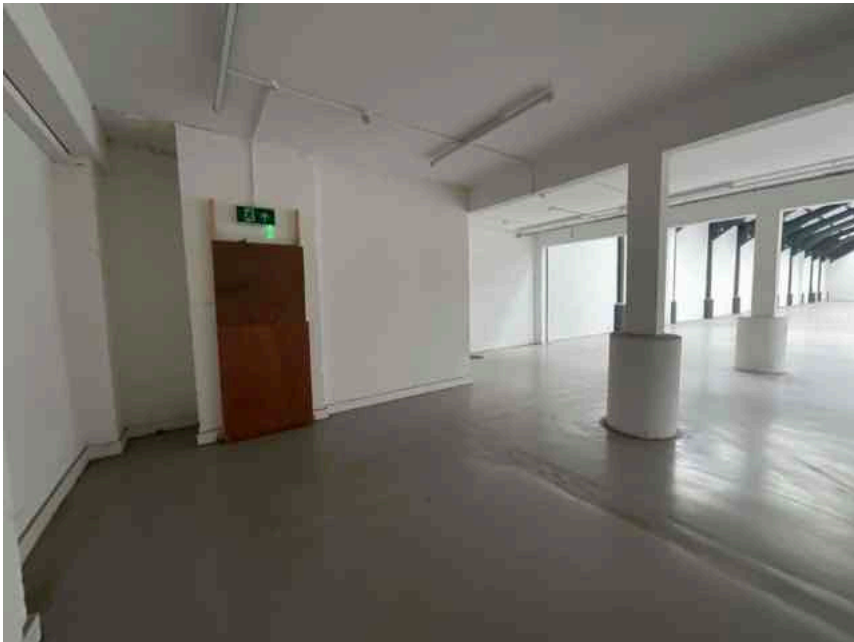
**Photo 2**

A1  
Walls

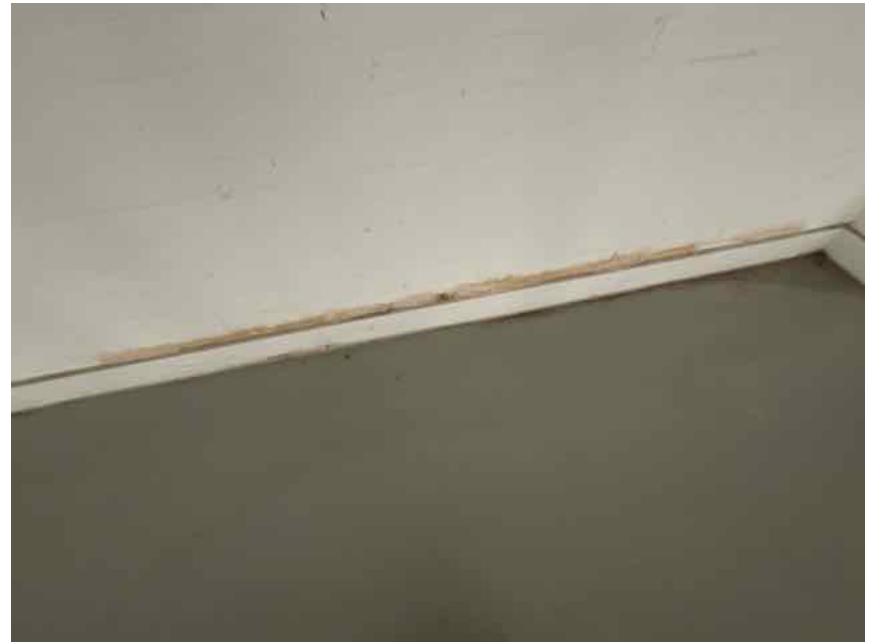
**Photo 3**

A1  
Walls

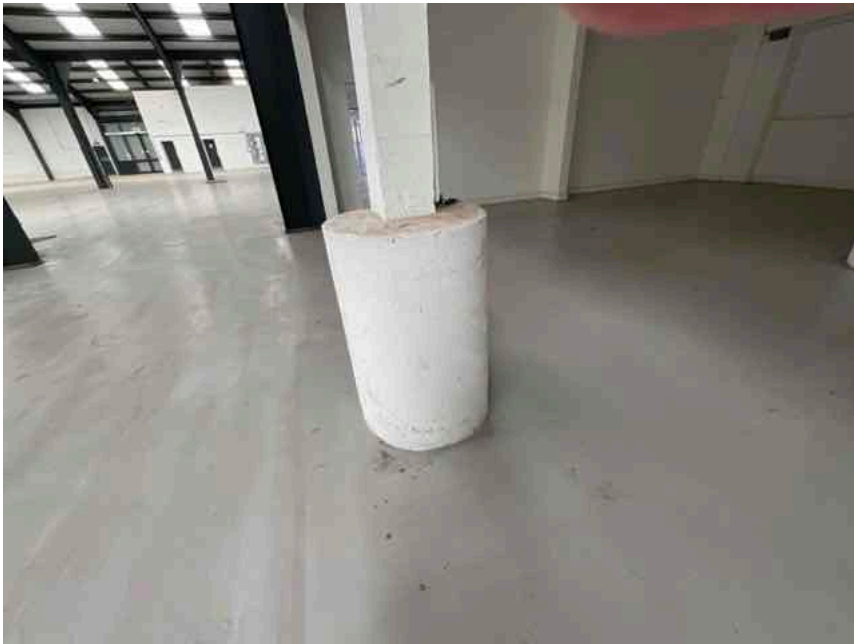
**Photo 4**

A1  
Walls

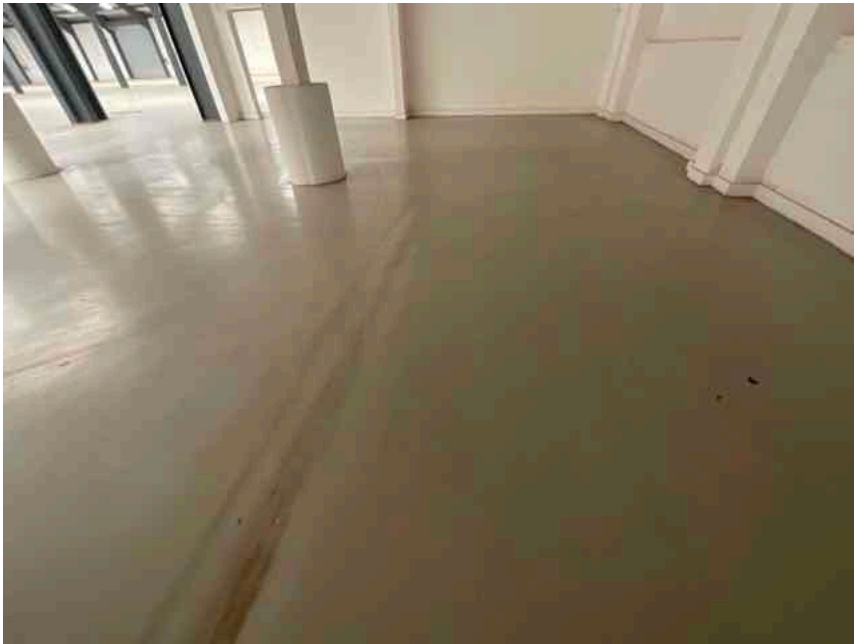
**Photo 12**

<b>Weather Conditions</b>	<b>Sunny and dry</b>
<b>Undertaken by:</b>	<b>Clayton Ayling of Ayling Associates Chartered Surveyors</b>	<b>Undertaken On:</b>	<b>12<sup>th</sup> May 2025</b>
<b>Location</b>	<b>Description</b>	<b>Condition</b>	<b>Photo No</b>
This Schedule of Condition is specific to the lease to which it is appended.			
<b>A1</b>			
Ceiling	Emulsion coated plaster with white paint.	Satisfaction condition.	1
Walls	Block work walls coated in white paint.	Generally, in good condition but in need of redecoration.  Water staining indicating rising damp above skirting to east wall.	2 - 4
Structure	Concrete encased columns with concrete round bases, top beam and stanchion.	Generally satisfactory but with rough finishes and detached paint.	5 - 8
Floor structure	Solid concrete floor structure with structural concrete surface.	Generally, in satisfactory condition.	9 - 11
Floor coverings	Floor paint over surface.	In an aged condition with cracking and detachment to coatings in one localised area.	12 - 13

A1  
Floor coverings

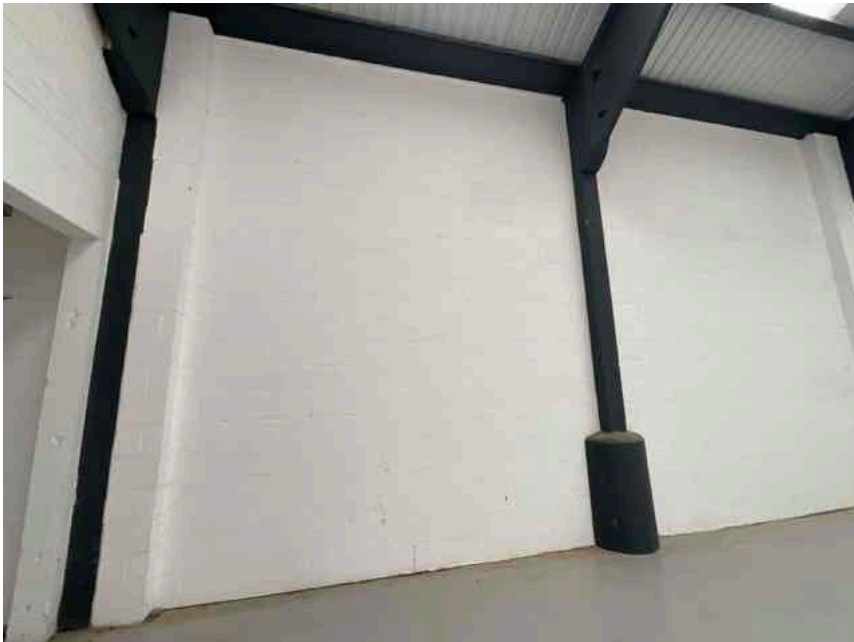
**Photo 14**

Doors	The door is boarded up and could not be inspected	The door is boarded up and could not be inspected	14
<b>A2</b>			
Walls	Block work walls coated in white paint	Generally, in good condition but in need of redecoration.	15 - 16

A1  
Doors

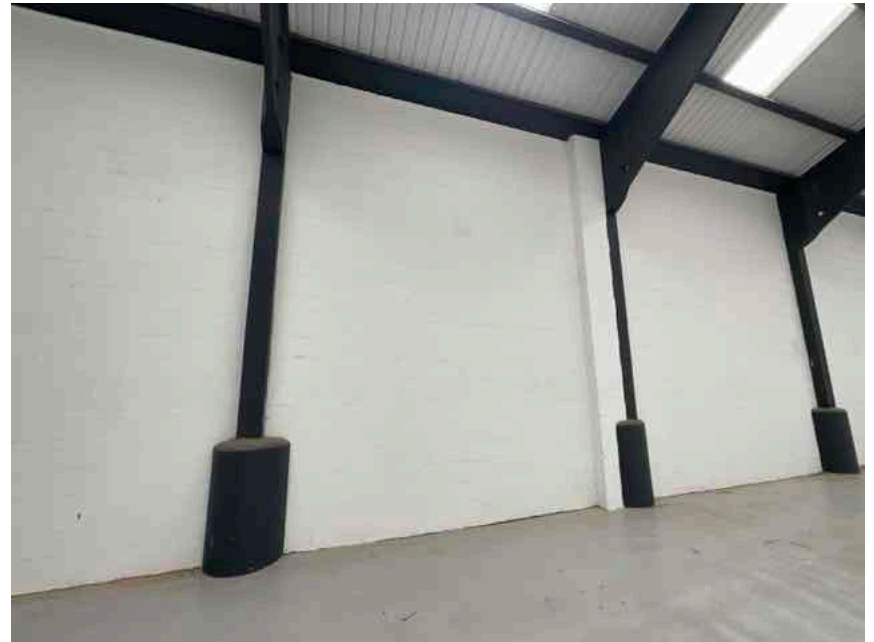
**Photo 15**

A2  
Walls

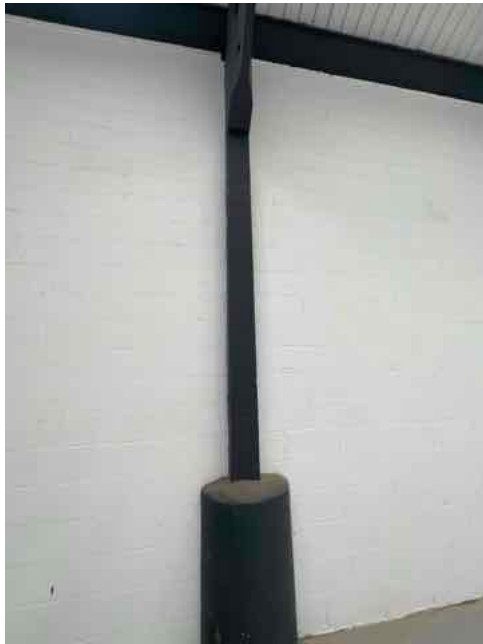
**Photo 16**

A2  
Walls

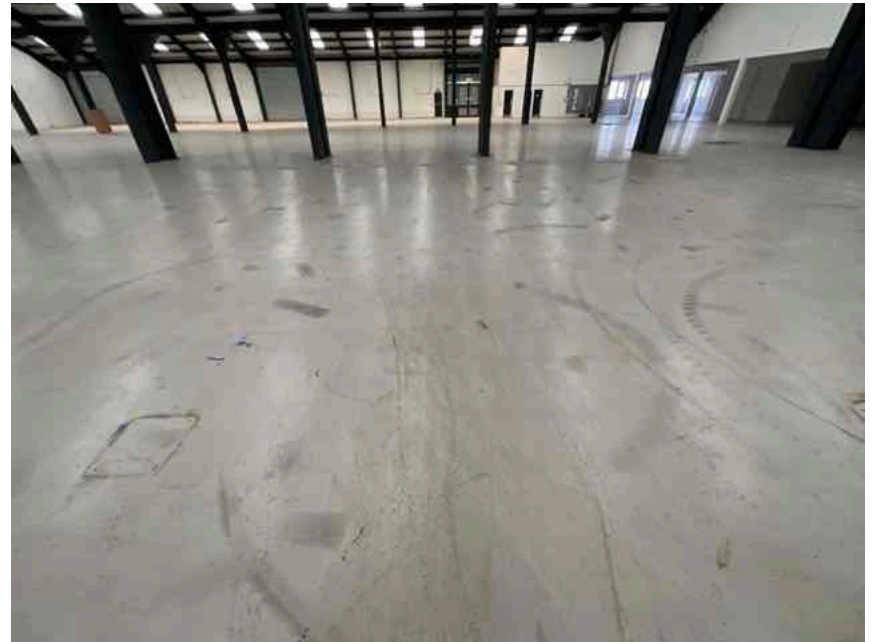
**Photo 27**

<b>Weather Conditions</b>	<b>Sunny and dry</b>
<b>Undertaken by:</b>	<b>Clayton Ayling of Ayling Associates Chartered Surveyors</b>	<b>Undertaken On:</b>	<b>12<sup>th</sup> May 2025</b>
<b>Location</b>	<b>Description</b>	<b>Condition</b>	<b>Photo No</b>
Structure	Concrete portal frame.	Generally satisfactory but with rough finishes and detached paint.	35 - 38
Floor coverings	Floor paint over surface	In an aged condition, soiled.	39 - 40
Roof lights	Clear GRP double skin.	Satisfactory and translucent, free from yellowing.	41
<b>A4</b>			
Floor coverings	Floor paint over surface	In an aged condition, soiled.	42
Floor structure	Solid concrete floor structure with smooth screed	Generally, in satisfactory condition  Floor bolts ground off rather than removed in around 2 locations. Bolts protrude from floor surface.	43
Roof lights	Clear GRP double skin.	Satisfactory and translucent, free from yellowing.	44

A2  
Roof lights

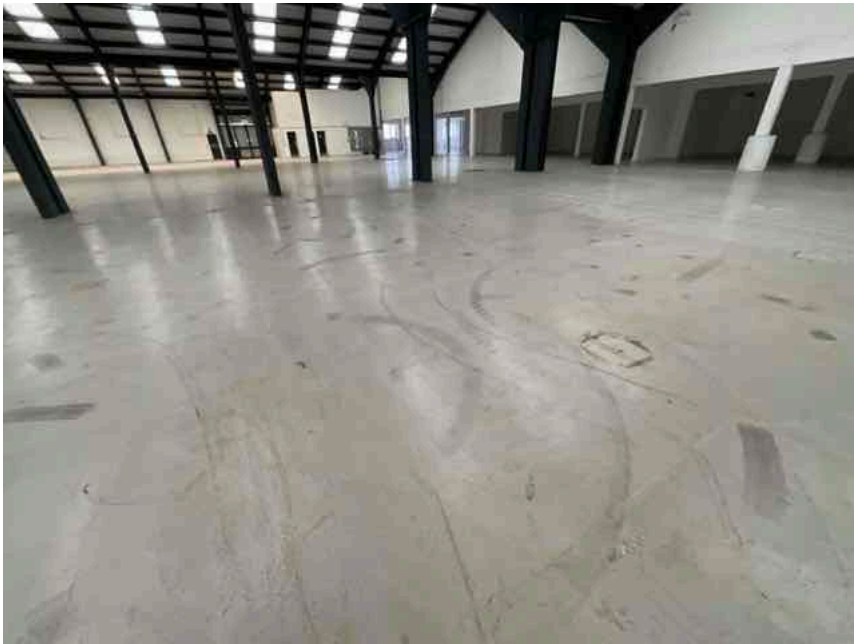
**Photo 28**

<b>Weather Conditions</b>	<b>Sunny and dry</b>
<b>Undertaken by:</b>	<b>Clayton Ayling of Ayling Associates Chartered Surveyors</b>	<b>Undertaken On:</b>	<b>12<sup>th</sup> May 2025</b>
<b>Location</b>	<b>Description</b>	<b>Condition</b>	<b>Photo No</b>
Structure	Concrete portal frame.	Generally satisfactory but with rough finishes and detached paint.	17 - 19
Ceiling	Soffit of roof covering supported off portal frame.	Satisfaction condition.	20 - 23
Floor structure	Solid concrete floor structure with smooth screed	Generally, in satisfactory condition  Floor bolts ground off rather than removed in around 20 locations. Bolts protrude from floor surface.	24 - 26
Floor coverings	Floor paint over surface.	In an aged condition and cracking in a number of areas.	
Roof lights	Clear GRP double skin.	Satisfactory and translucent, free from yellowing.	27
<b>A3</b>			
Floor structure	Solid concrete floor structure with smooth screed	Generally, in satisfactory condition  Floor bolts ground off rather than removed in around 4 locations. Bolts protrude from floor surface.	28 - 31

A3  
Floor structure

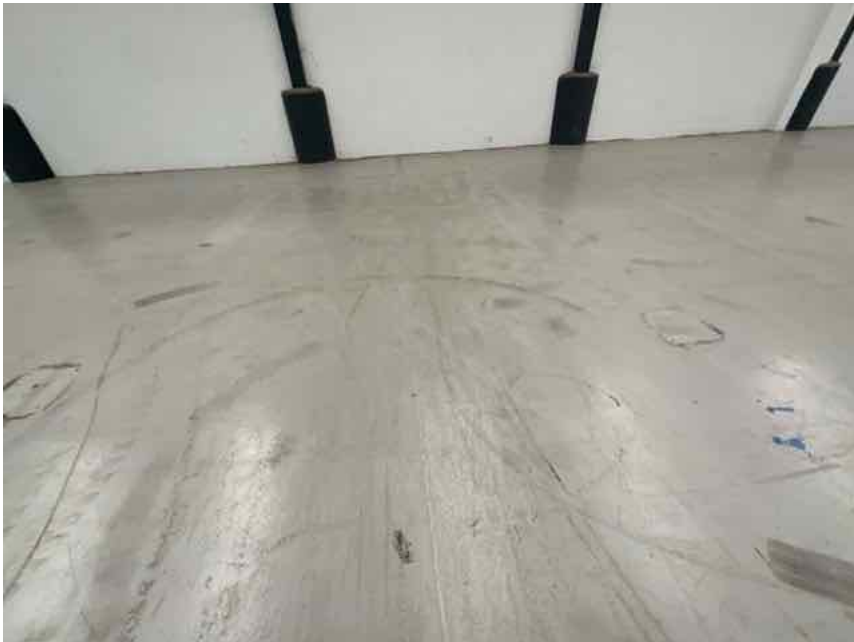
**Photo 30**

A3  
Floor structure

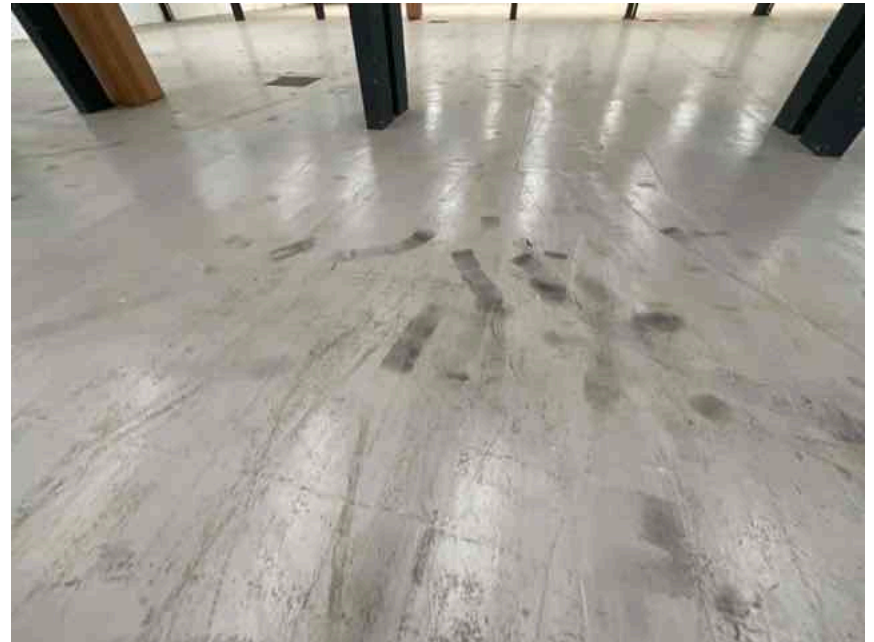
**Photo 51**

A5  
Floor coverings

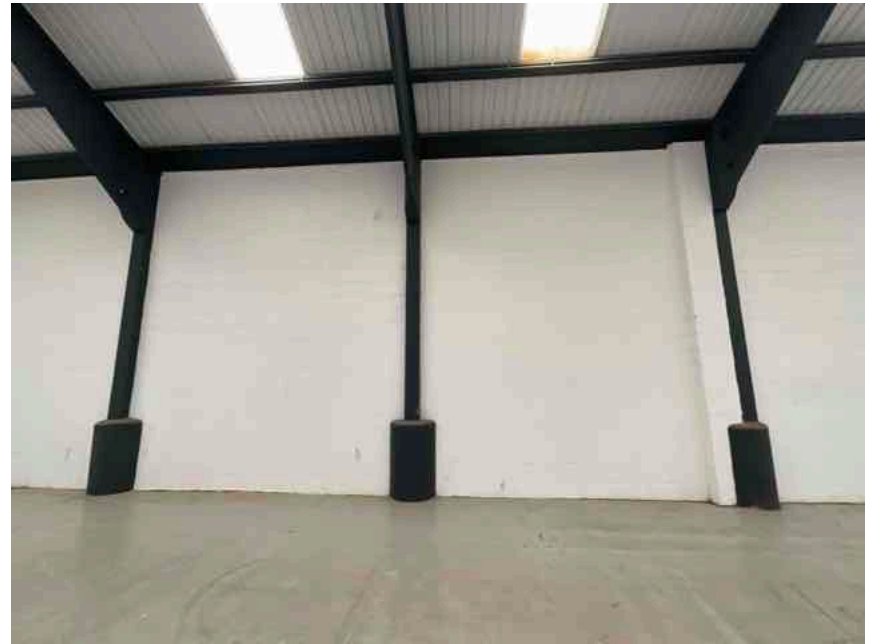
**Photo 53**

A5  
Structure.

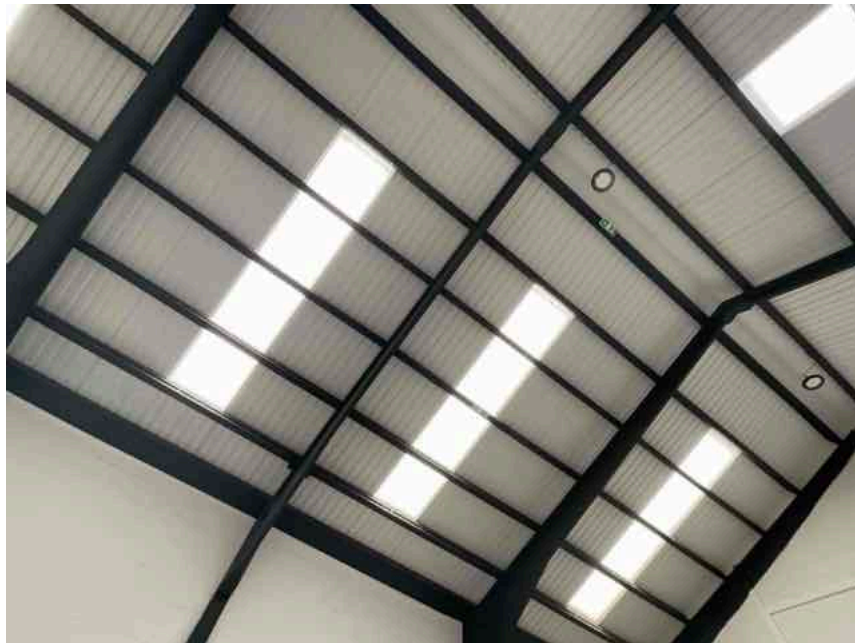
**Photo 54**

A5  
Walls

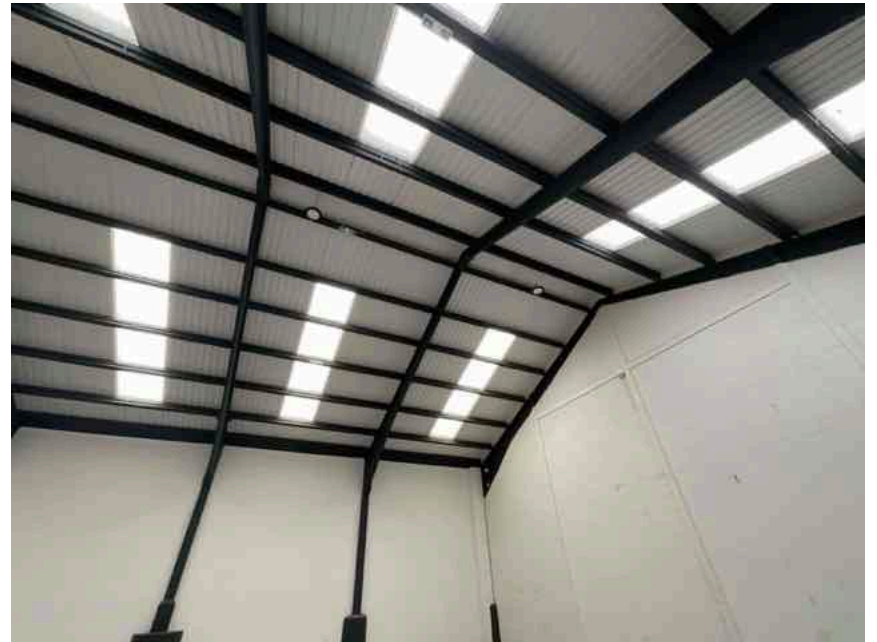
**Photo 59**

A6  
Structure

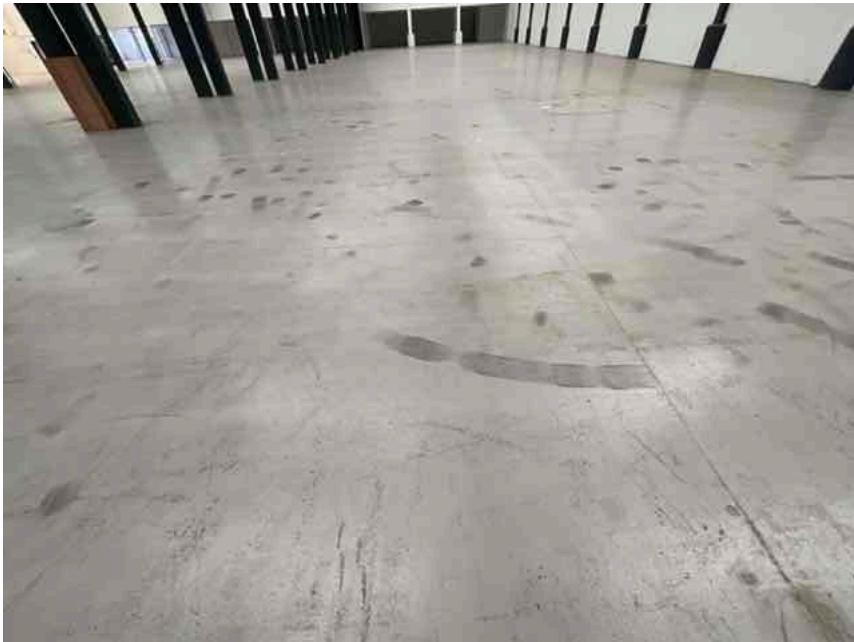
**Photo 62**

A6  
Floor coverings

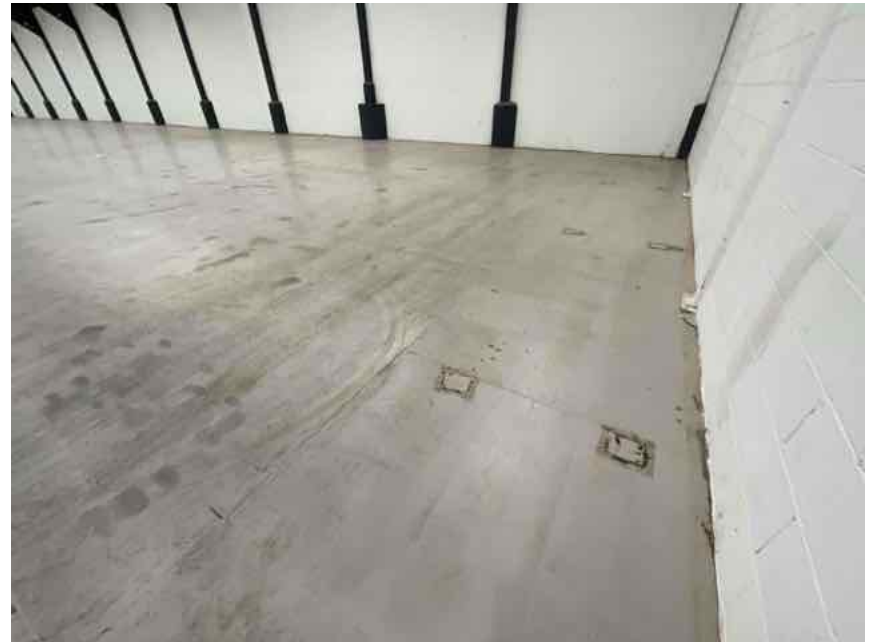
**Photo 63**

A6  
Floor coverings

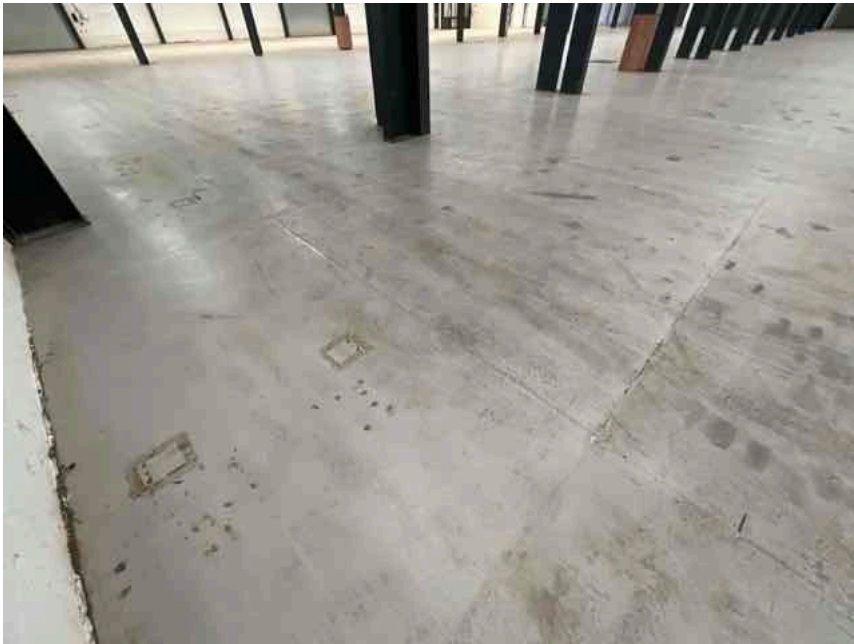
**Photo 64**

A6  
Floor structure

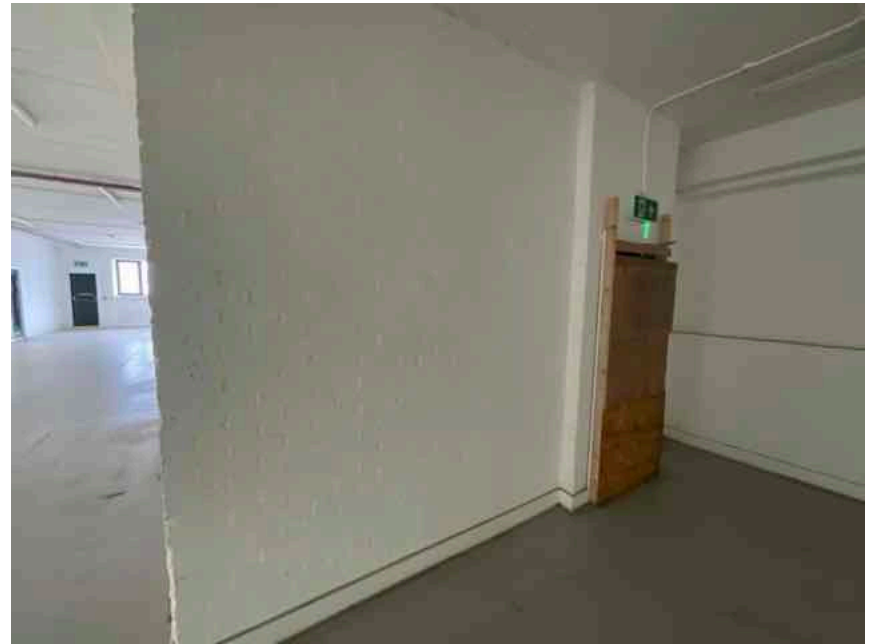
**Photo 65**

A6  
Floor structure

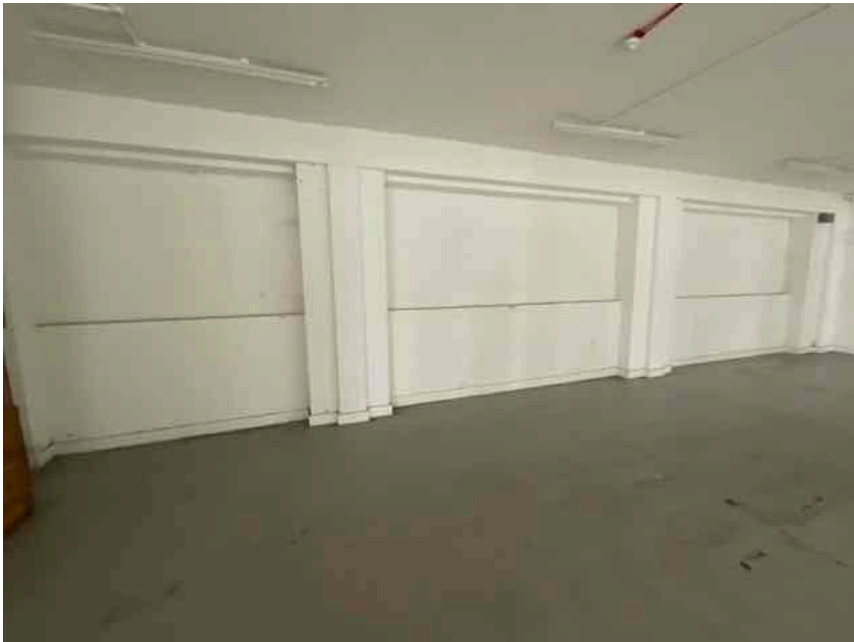
**Photo 66**

B1  
Walls

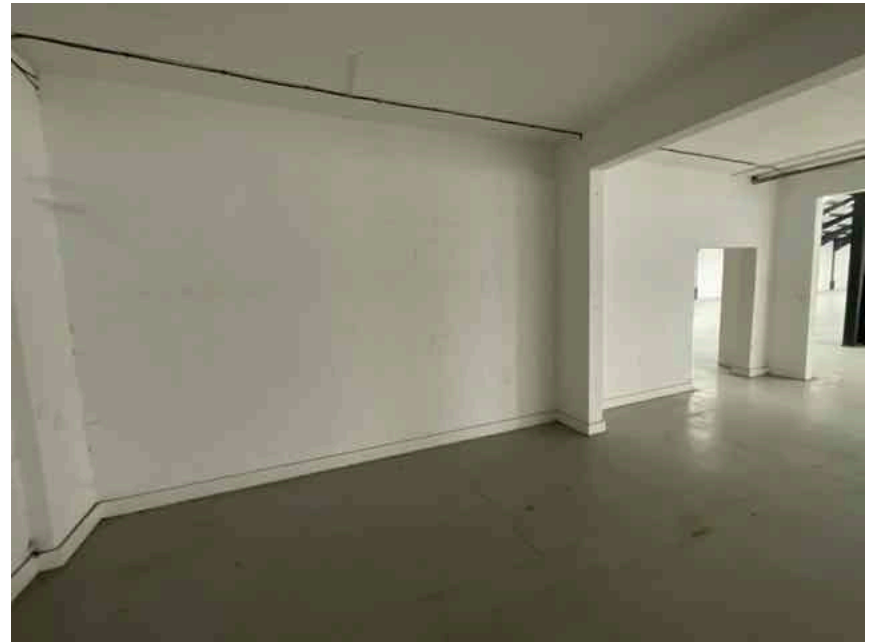
**Photo 67**

B1  
Walls

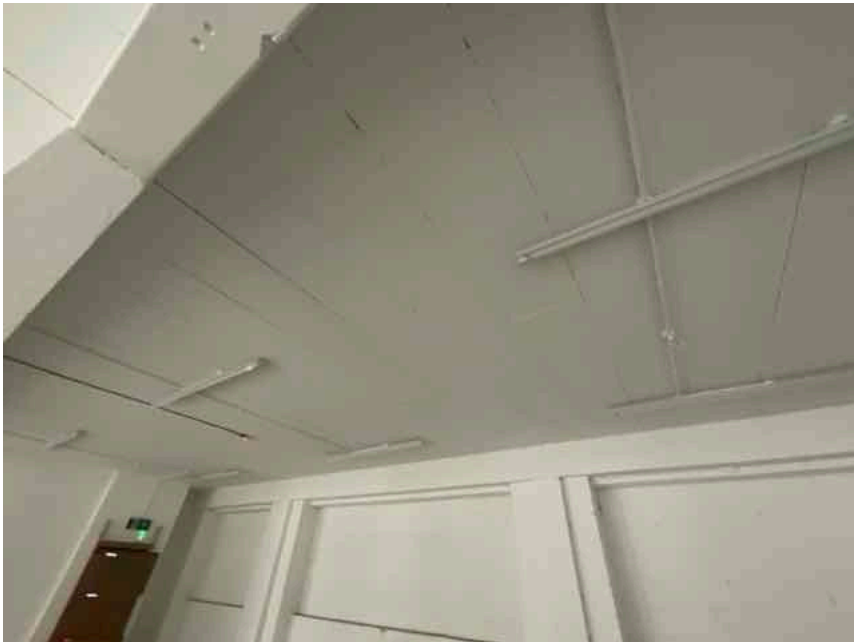
**Photo 70**

B1  
Ceiling

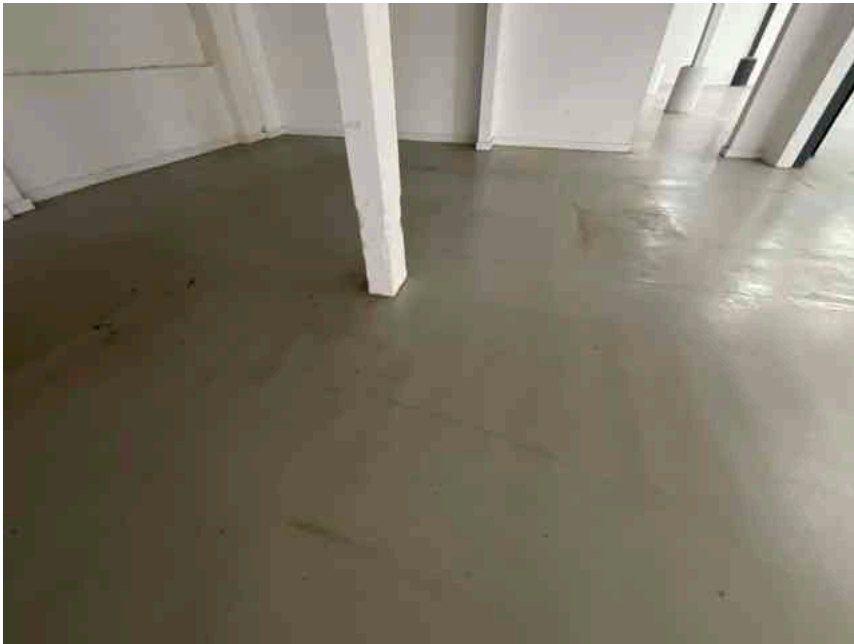
**Photo 76**

B1  
Floor coverings

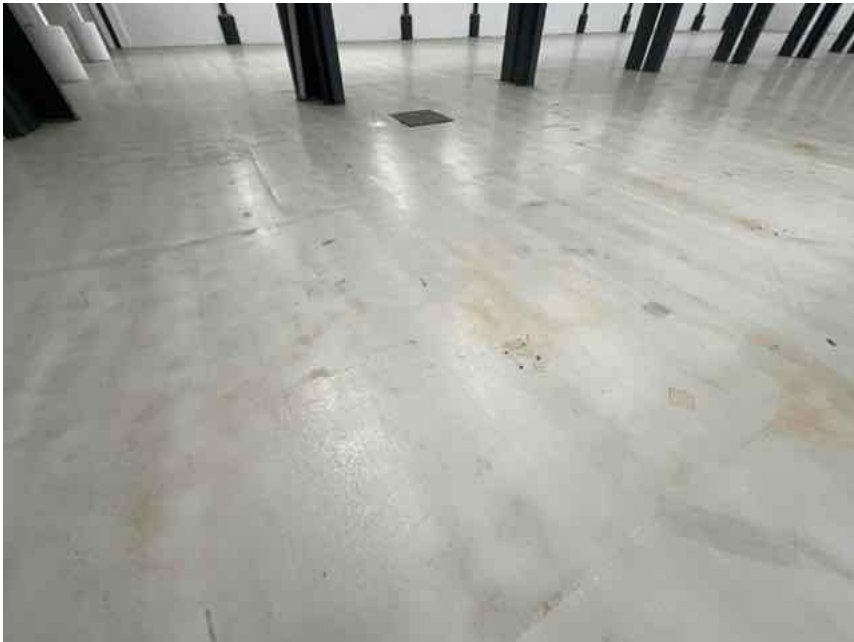
**Photo 78** B1  
Floor coverings

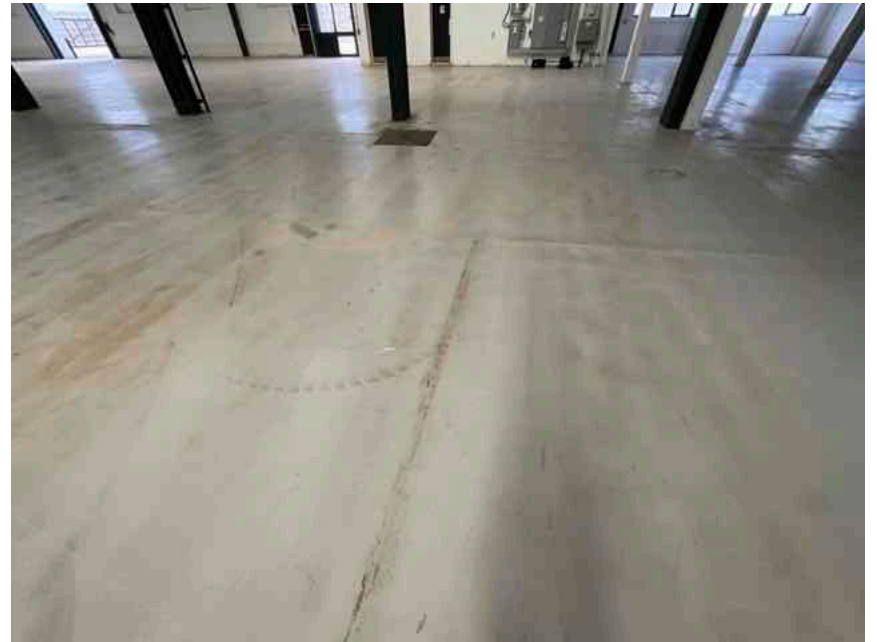
**Photo 79** B2  
Floor structure

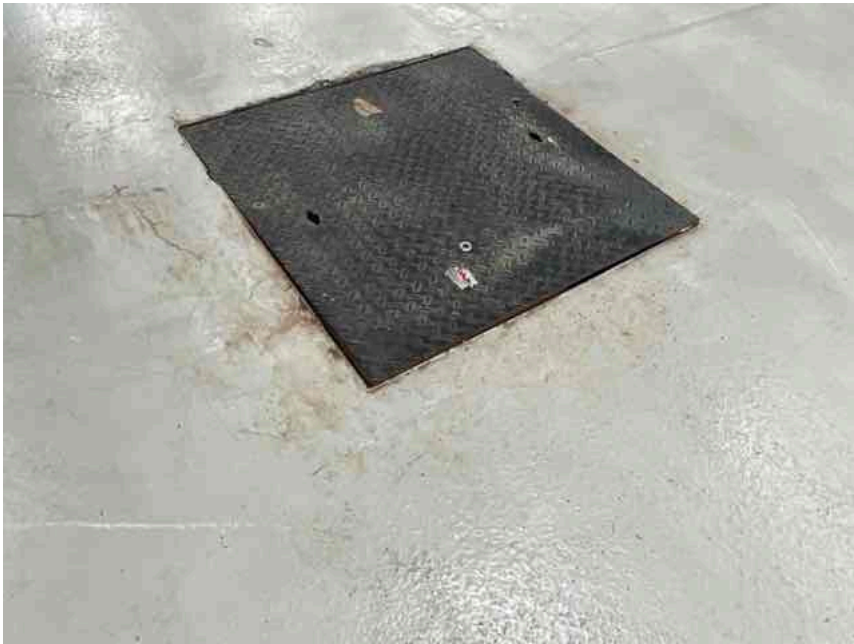
**Photo 80** B2  
Floor structure

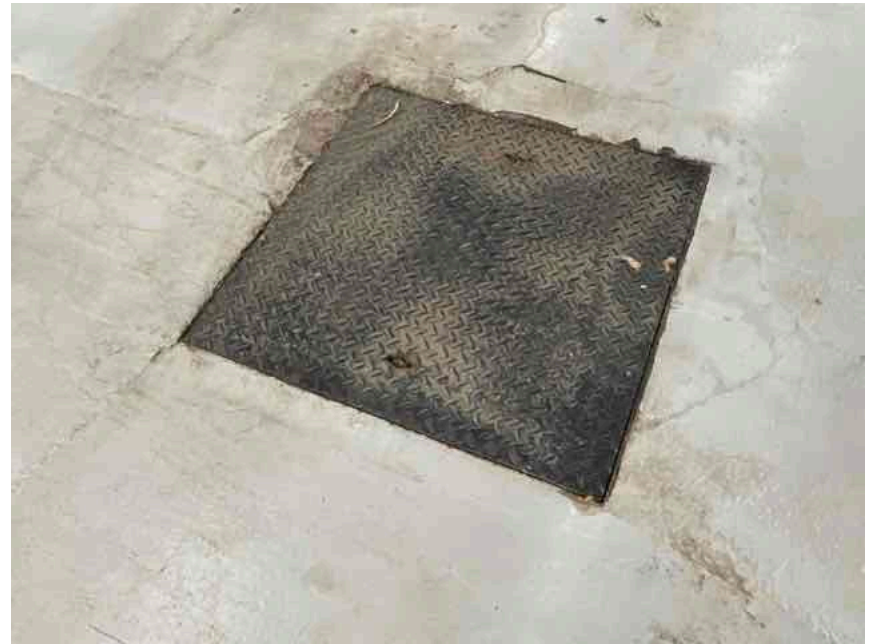
**Photo 81**

B2  
Floor structure

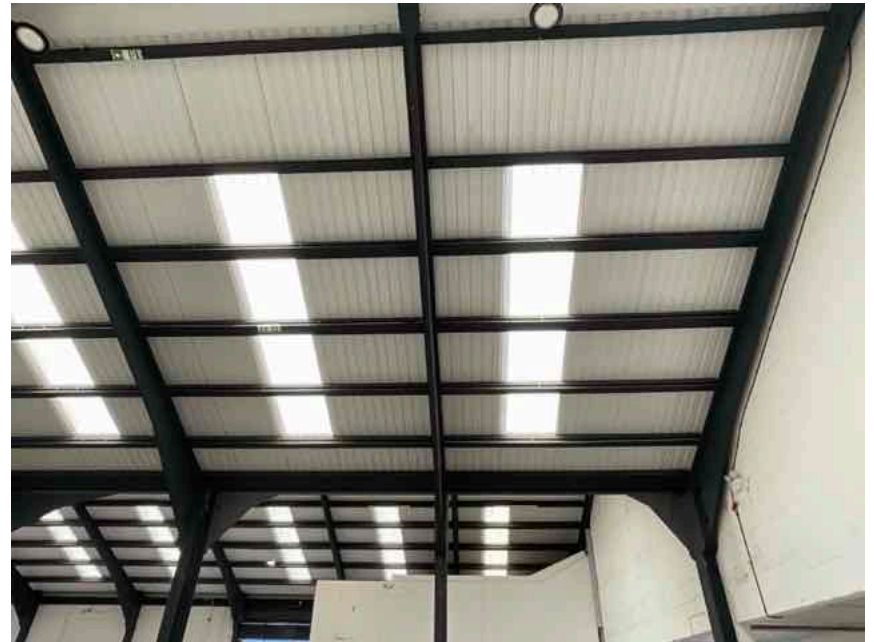
**Photo 83**

B2  
Ceiling

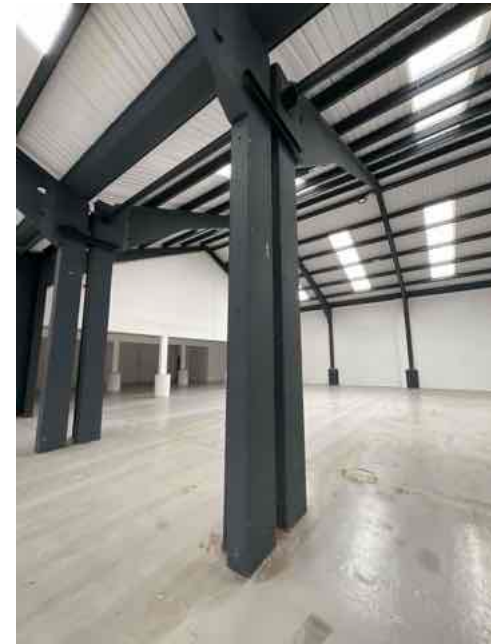
**Photo 85**

B2  
Structure

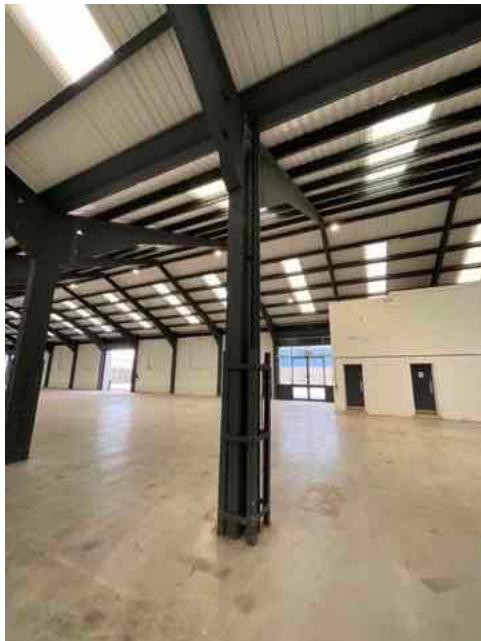
**Photo 86**

B2  
Structure

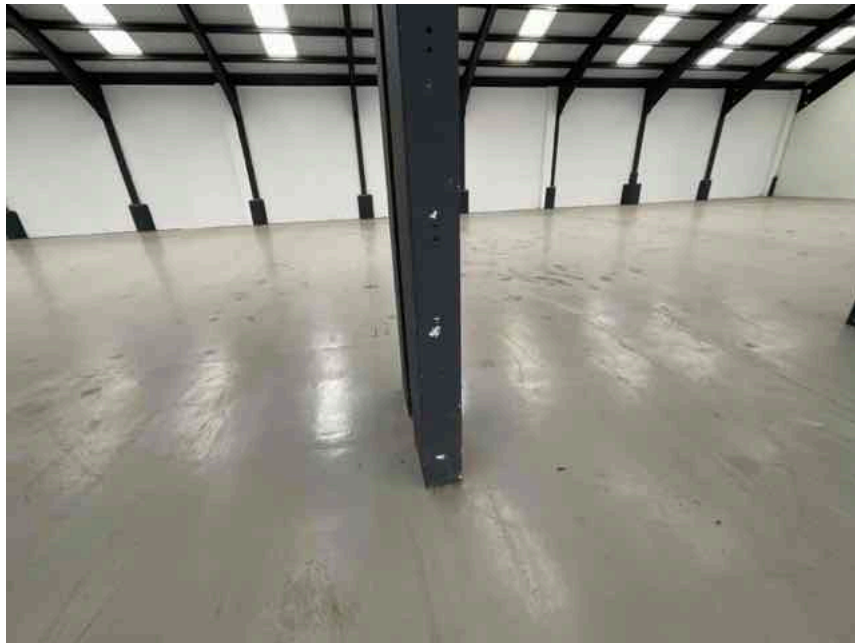
**Photo 98**

B4  
Structure

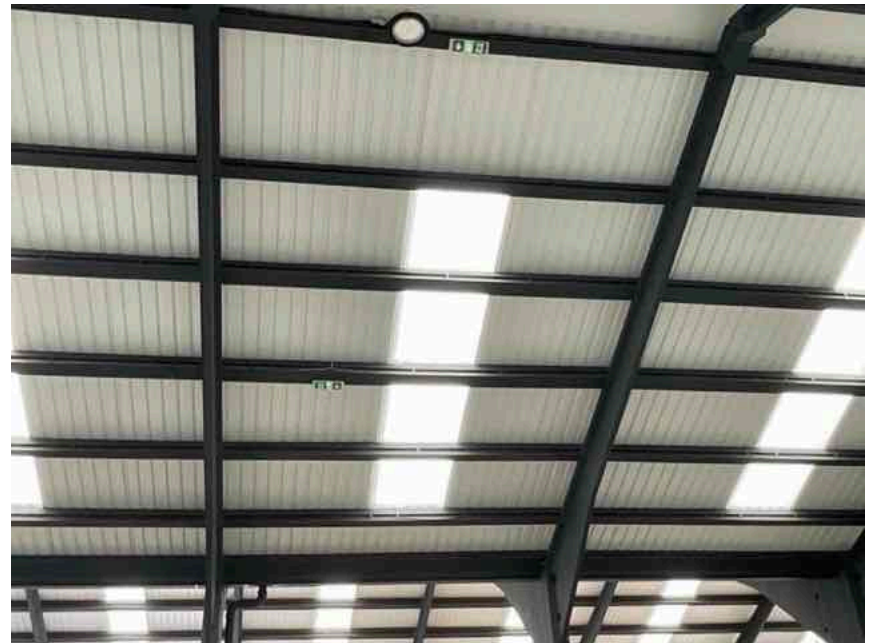
**Photo 99**

B4  
Structure

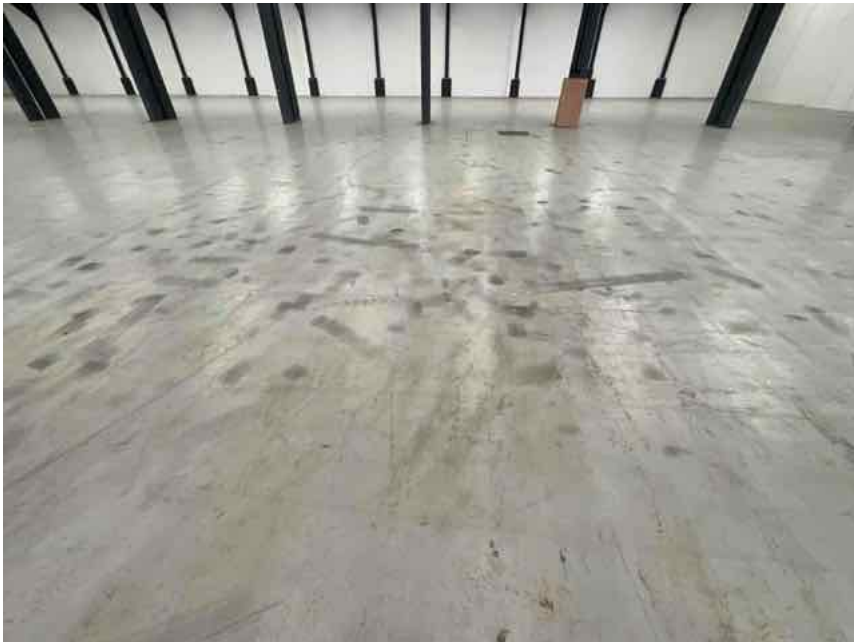
**Photo 102**

B5  
Floor structure

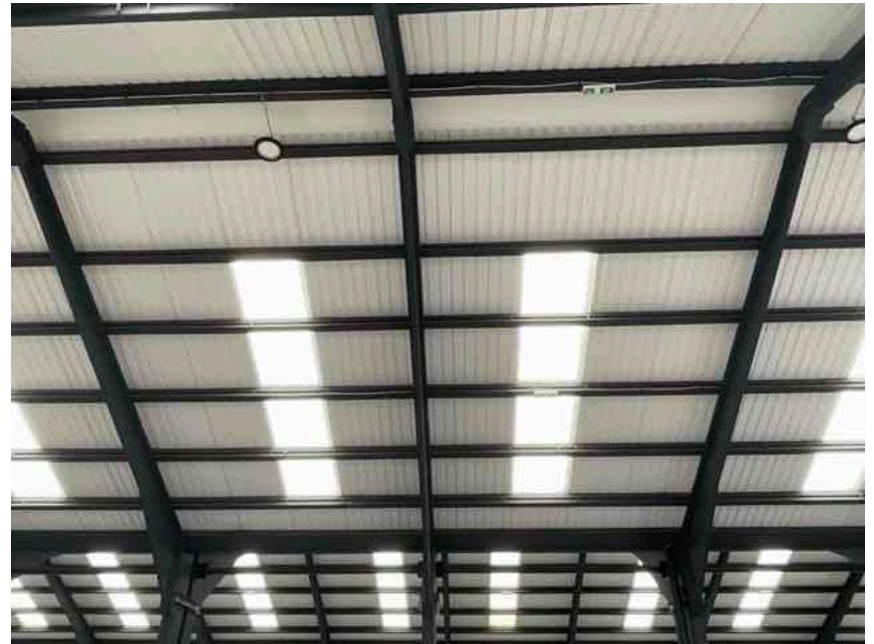
**Photo 105**

B5  
Roof lights

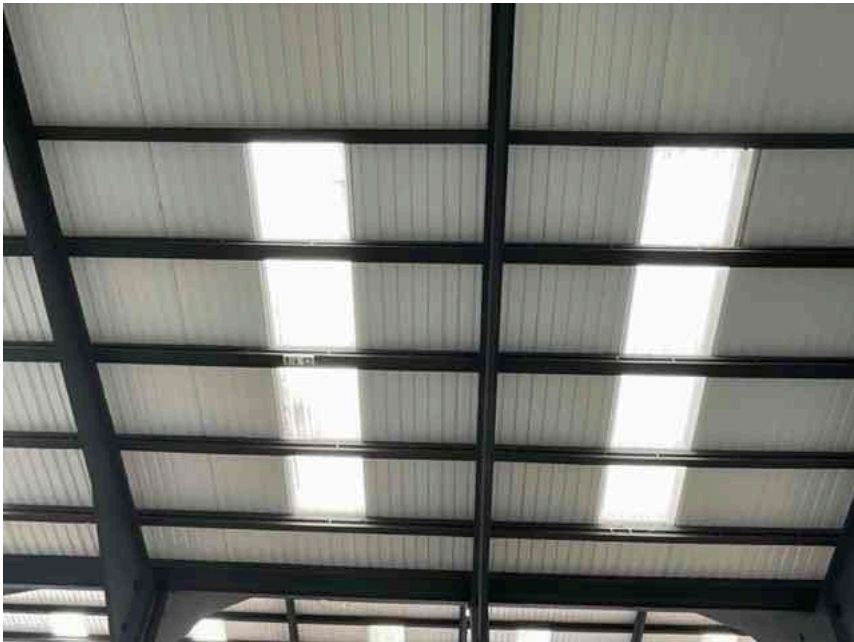
**Photo 106**

B5  
Ceiling

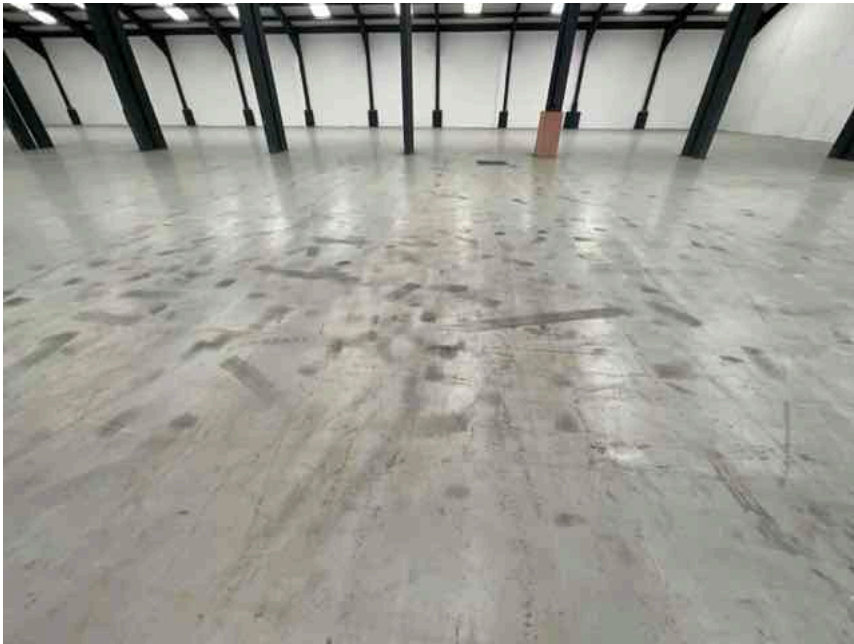
**Photo 108**

B5  
Floor coverings

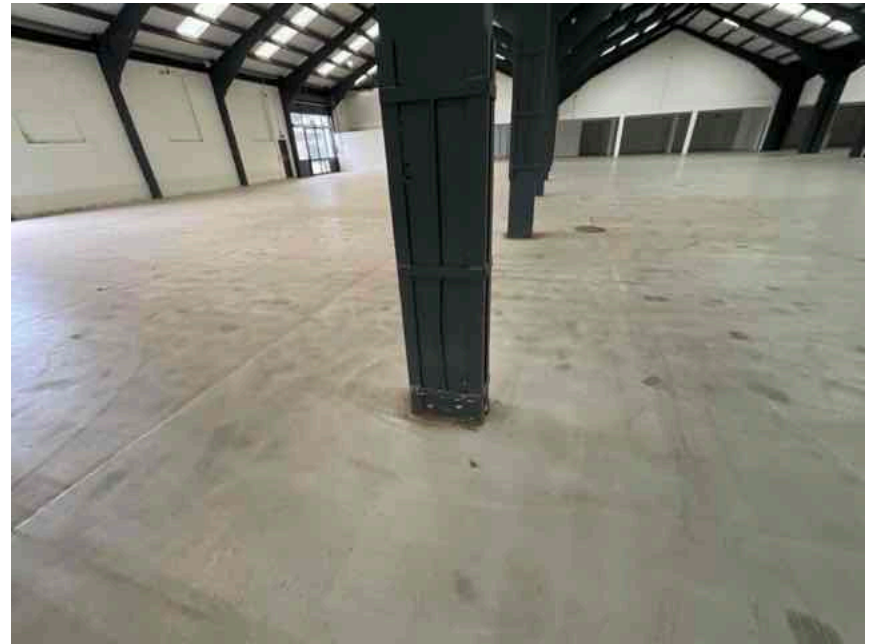
**Photo 109**

B5  
Floor coverings

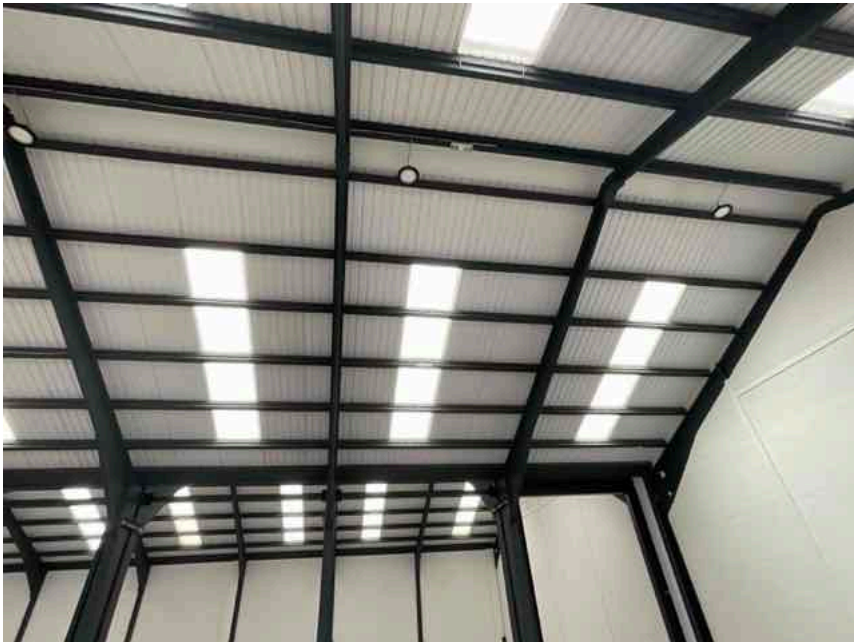
**Photo 110**

B5  
Structure

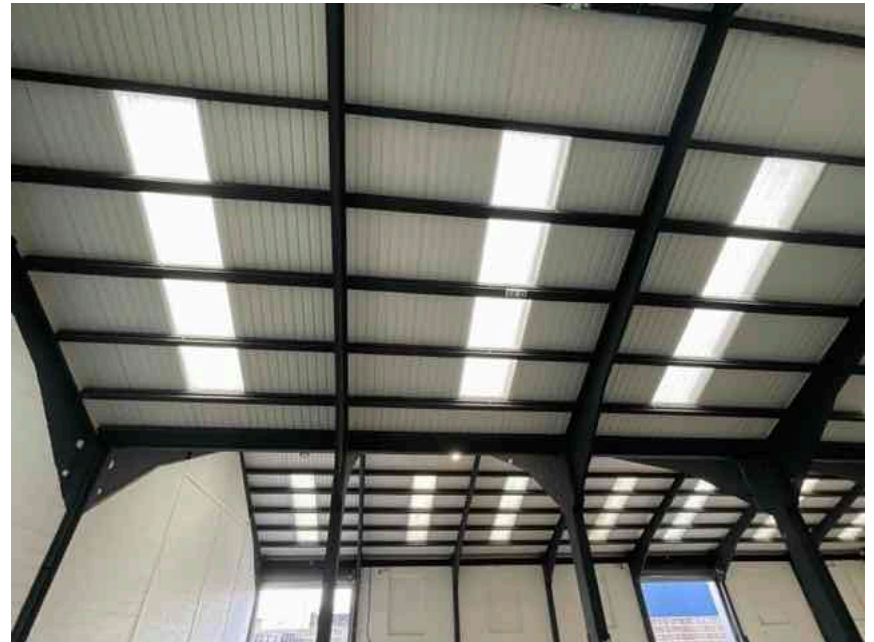
**Photo 111**

B6  
Ceiling

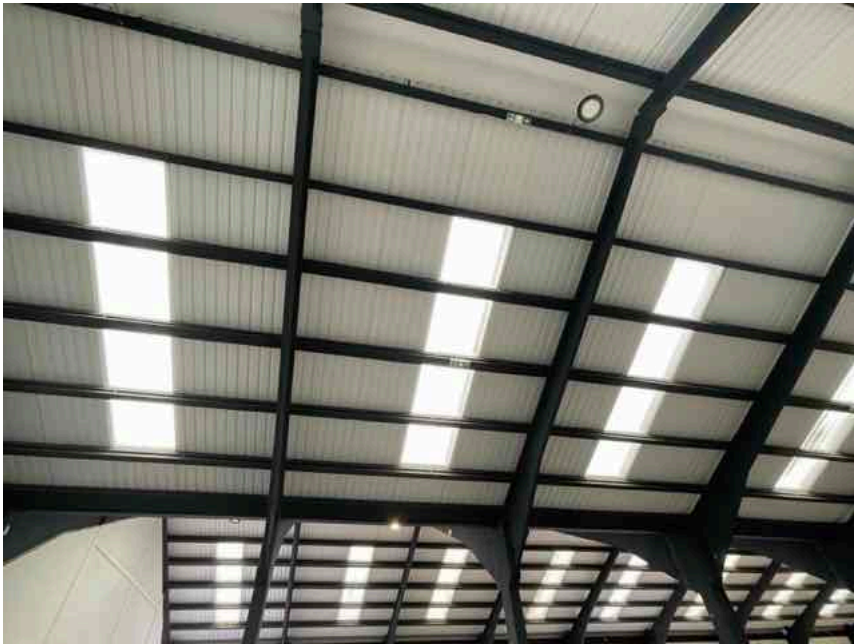
**Photo 112**

B6  
Ceiling

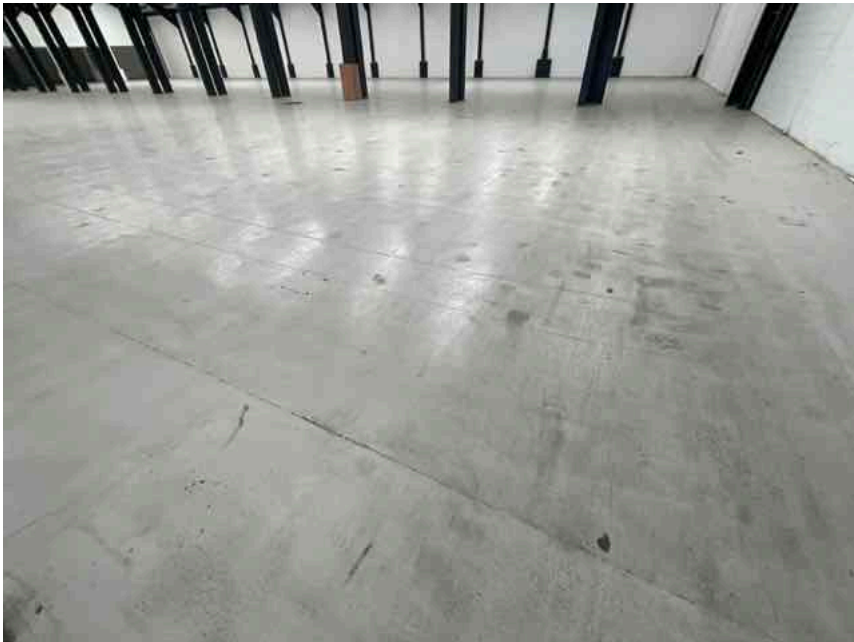
**Photo 114**

B6  
Structure

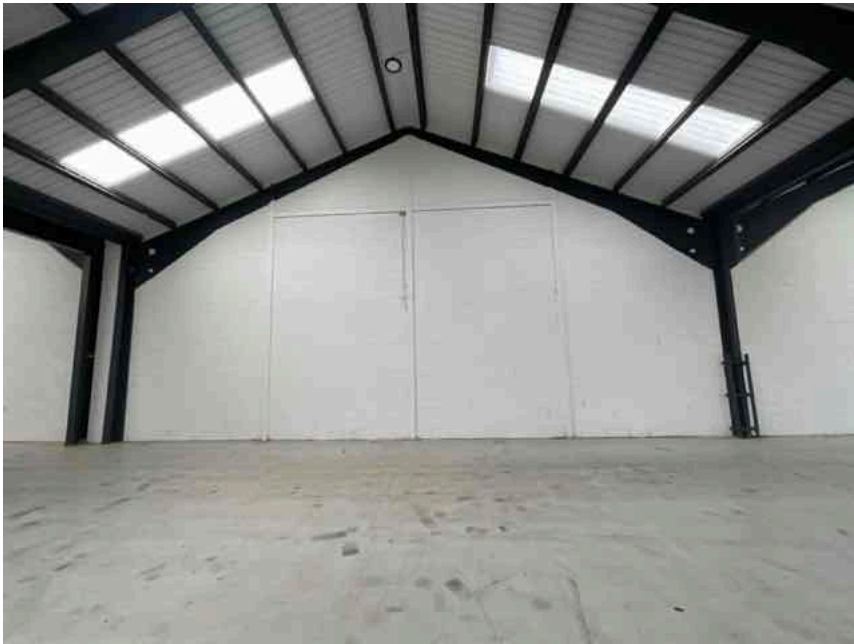
**Photo 116**

B6  
Floor coverings
