## Schedule of Condition

Date: 13<sup>th</sup> May 2025

## B Schedule of Condition Shop Floor

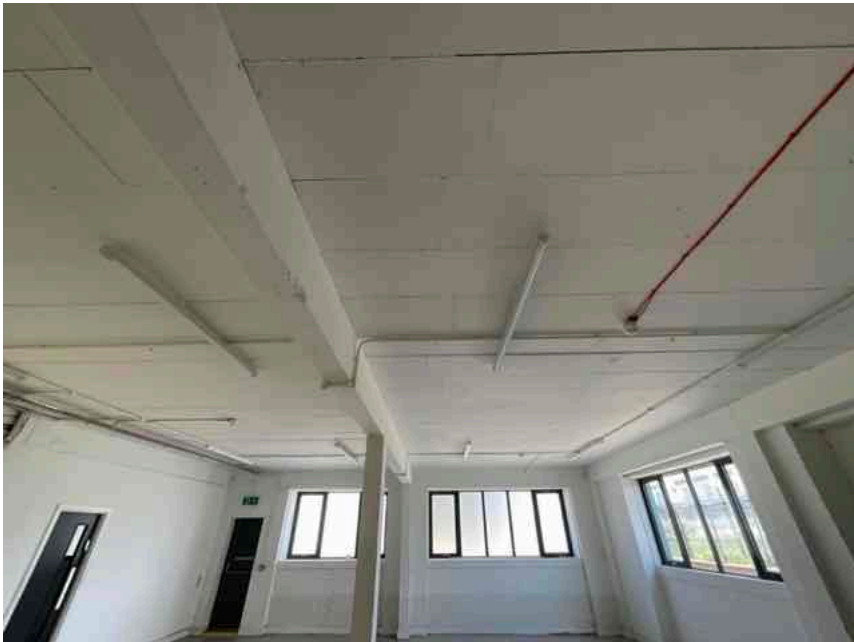
**Photo 118**

C1  
Ceiling

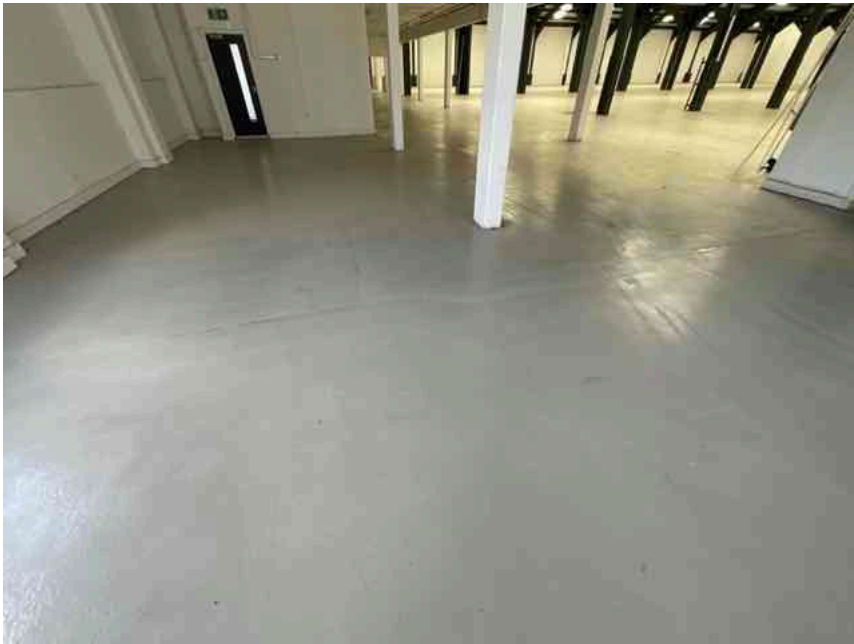
**Photo 120**

C1  
Floor structure

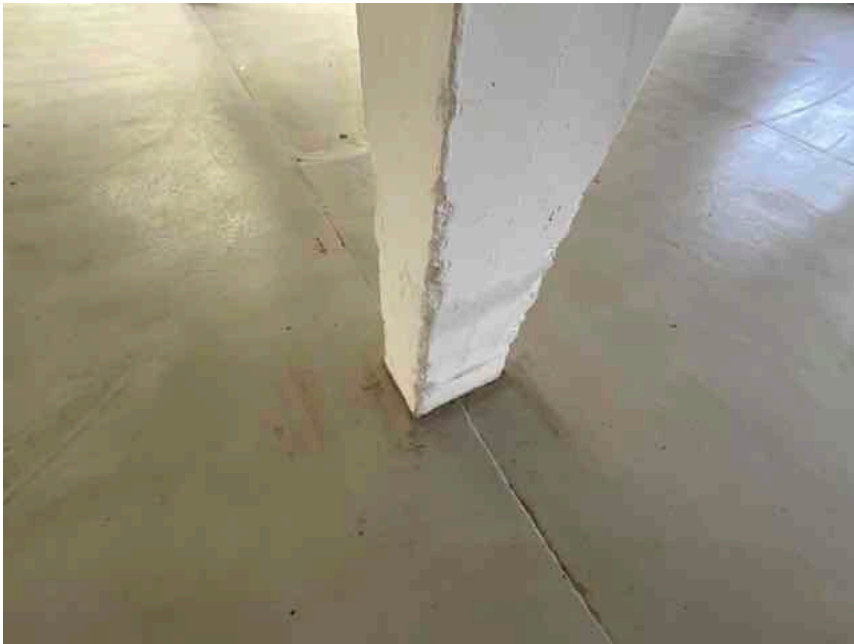
**Photo 124**

C1  
Structure

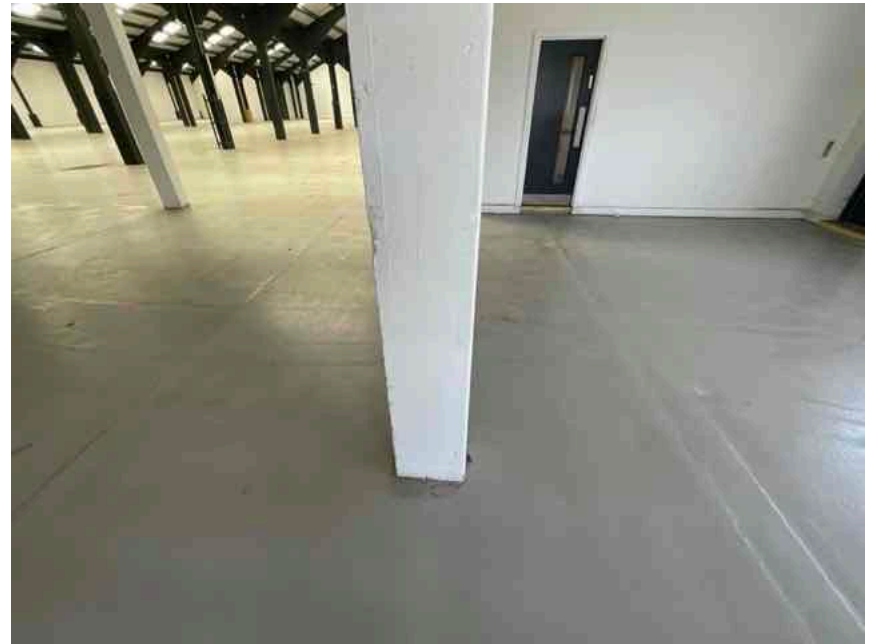
**Photo 125**

C1  
Structure

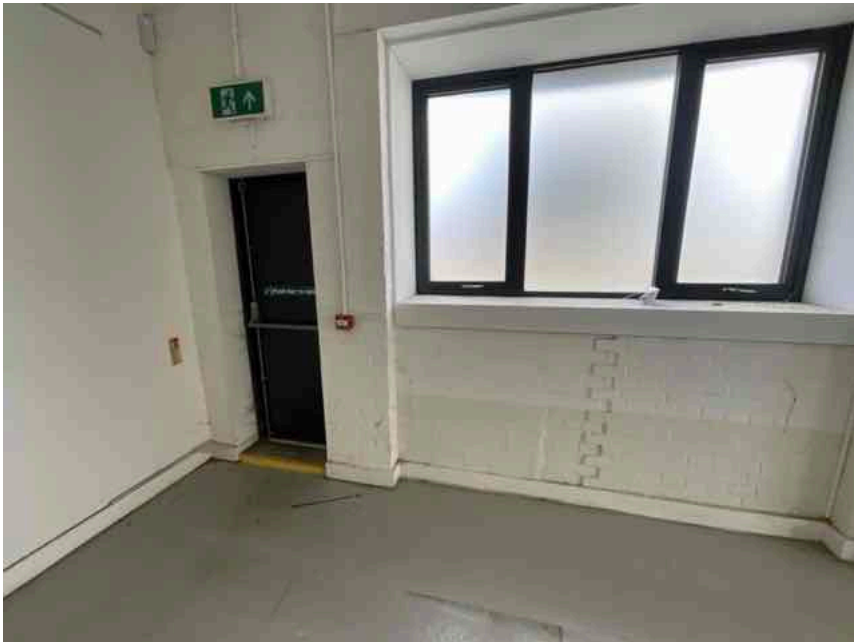
**Photo 126**

C1  
Structure

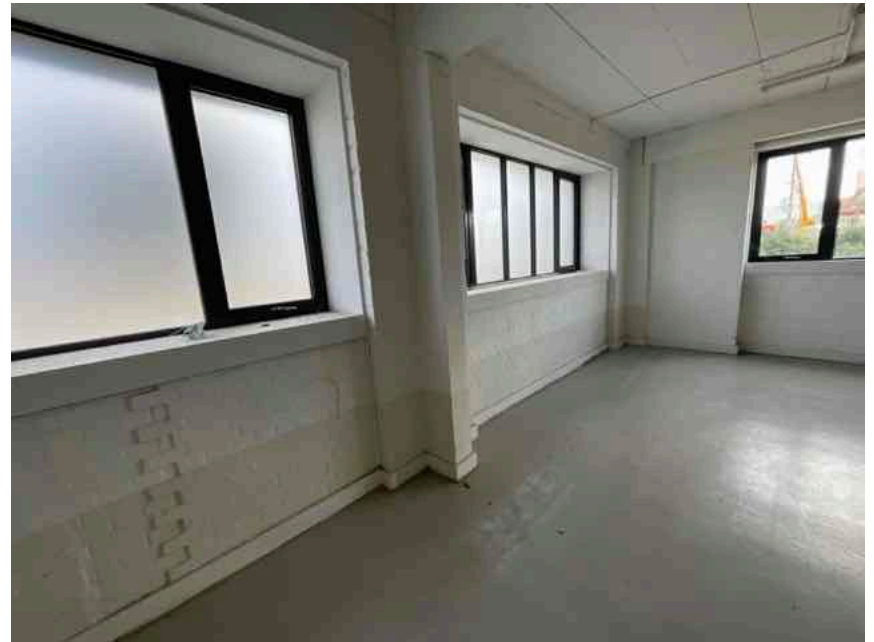
**Photo 127**

C1  
Walls

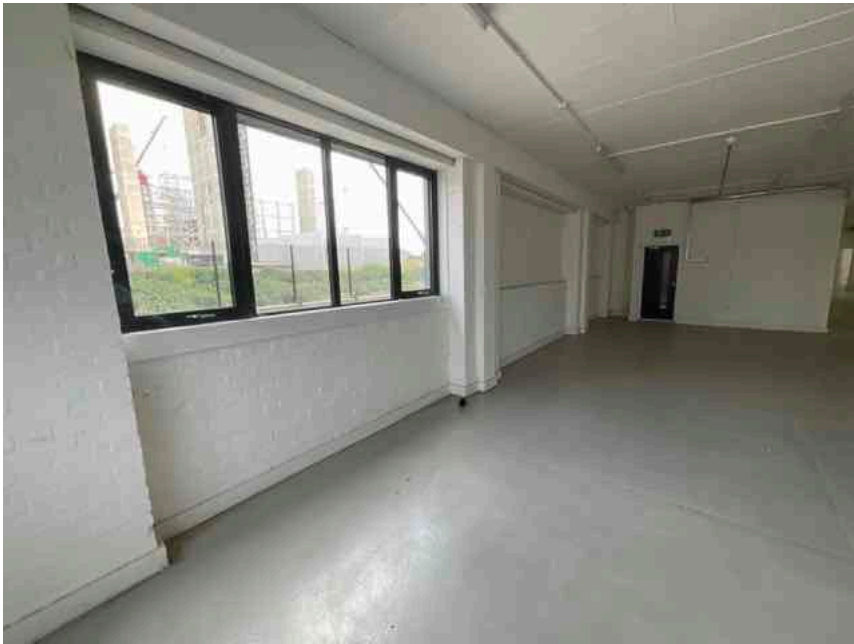
**Photo 128**

C1  
Walls

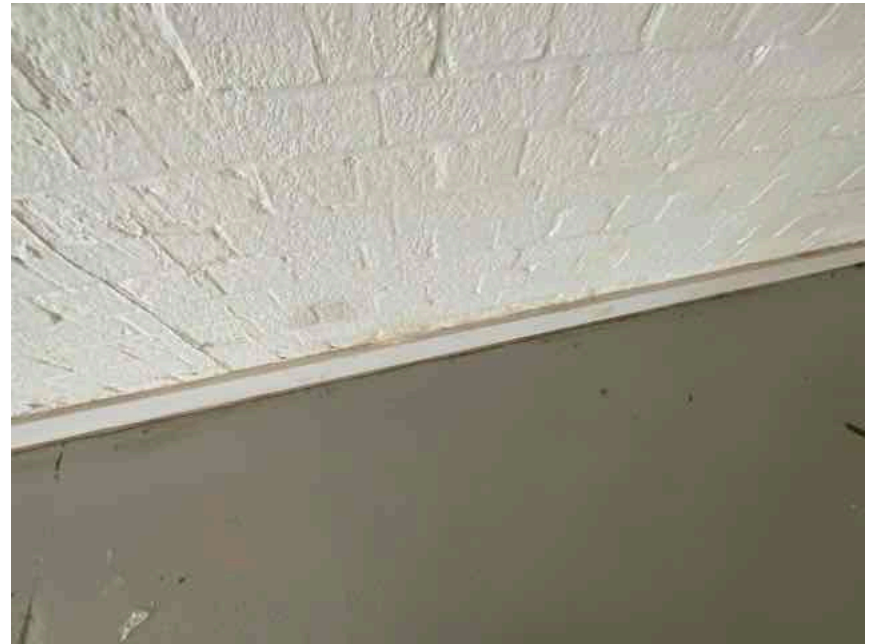
**Photo 129**  
C1  
Walls

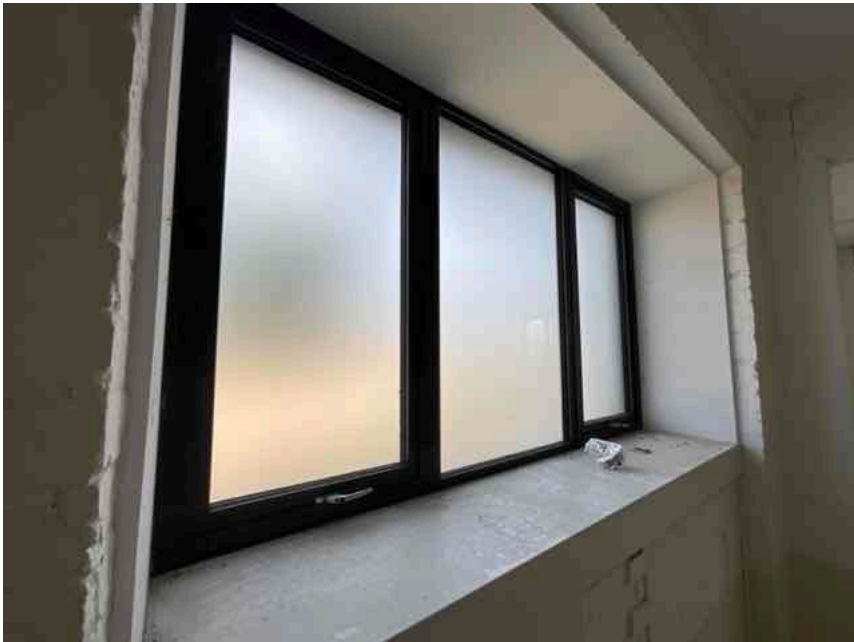
**Photo 130**  
C1  
Walls

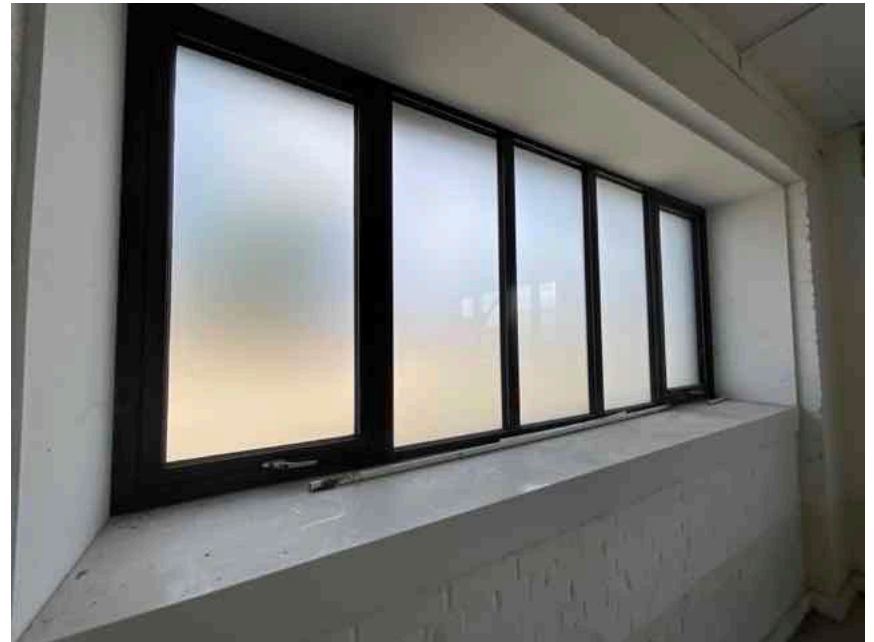
**Photo 131**  
C1  
Windows

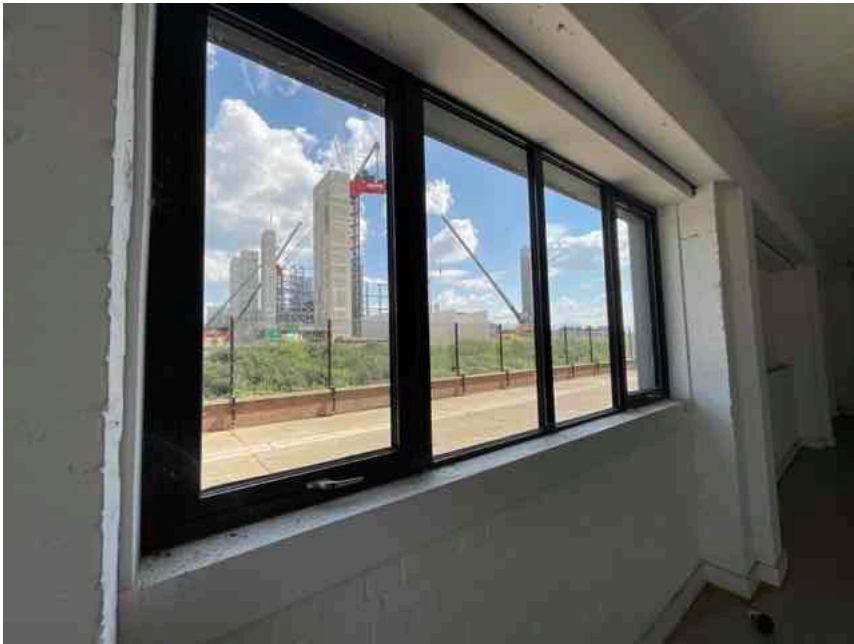
**Photo 132**  
C1  
Windows

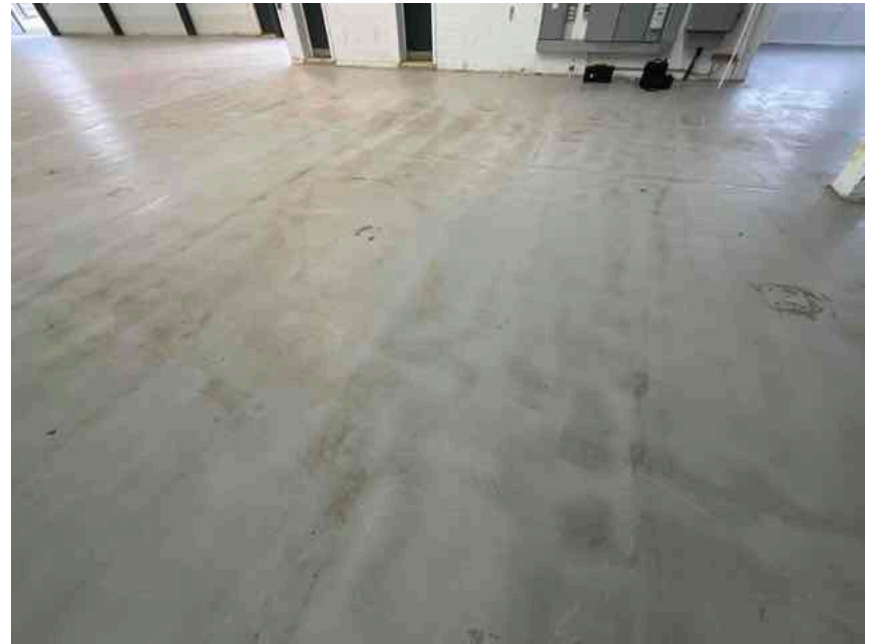
**Photo 133**

C1  
Windows

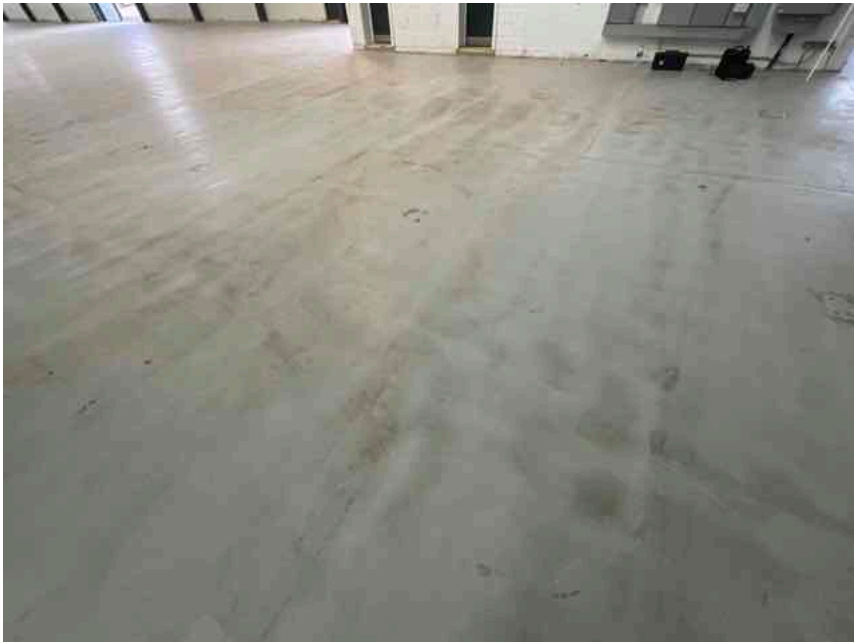
**Photo 134**

C2  
Floor coverings

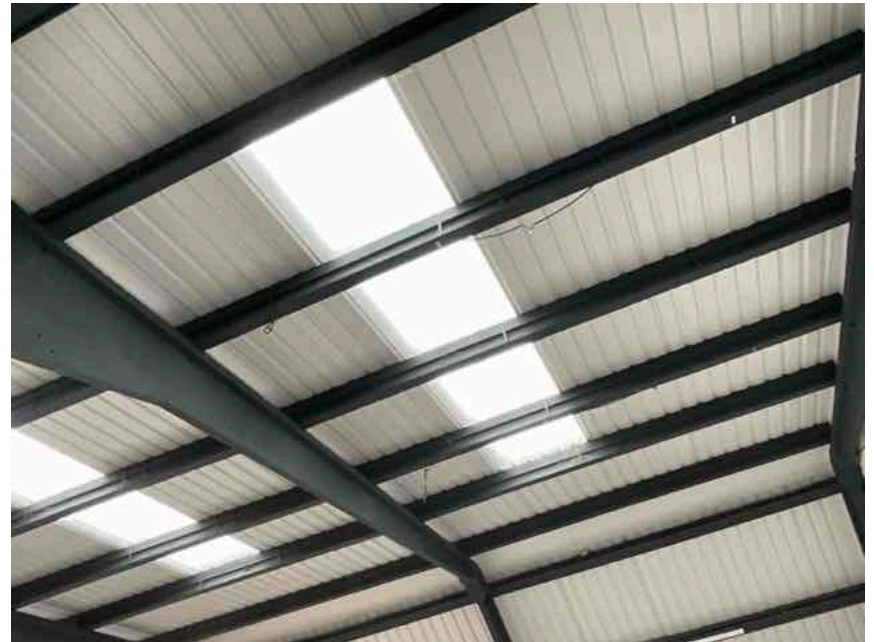
**Photo 135**

C2  
Floor structure

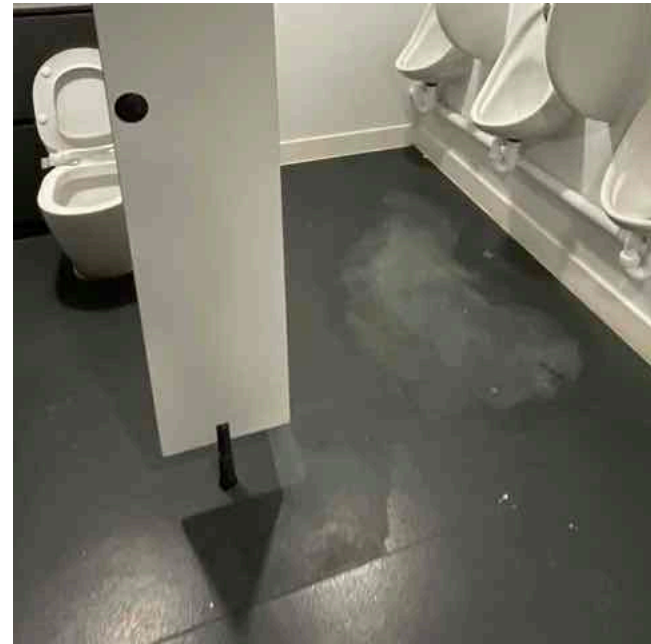
**Photo 177**

W/C  
Walls

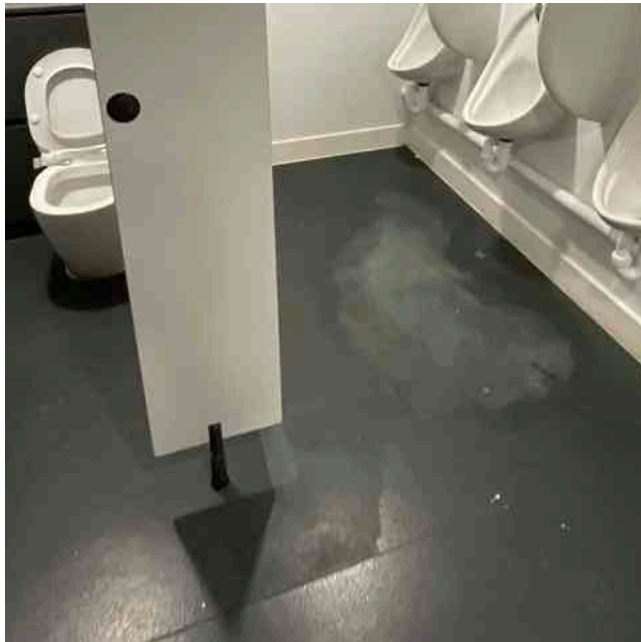
**Photo 178**

W/C  
Floor structure

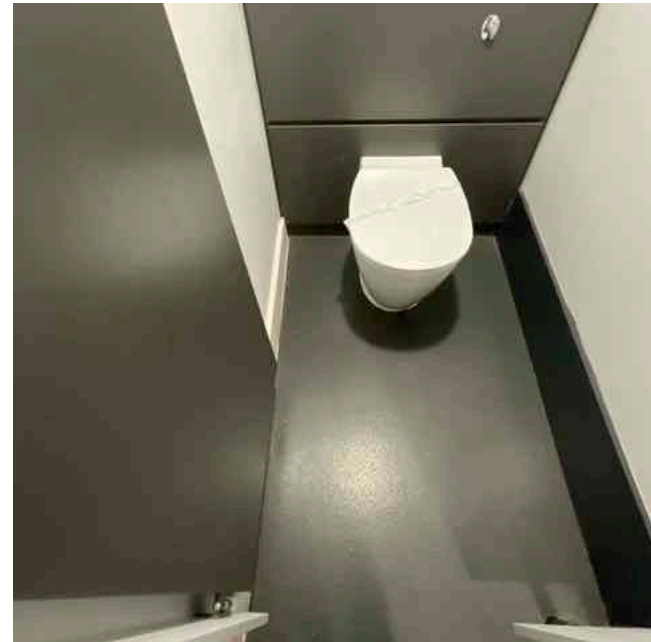
**Photo 179**

W/C  
Floor coverings

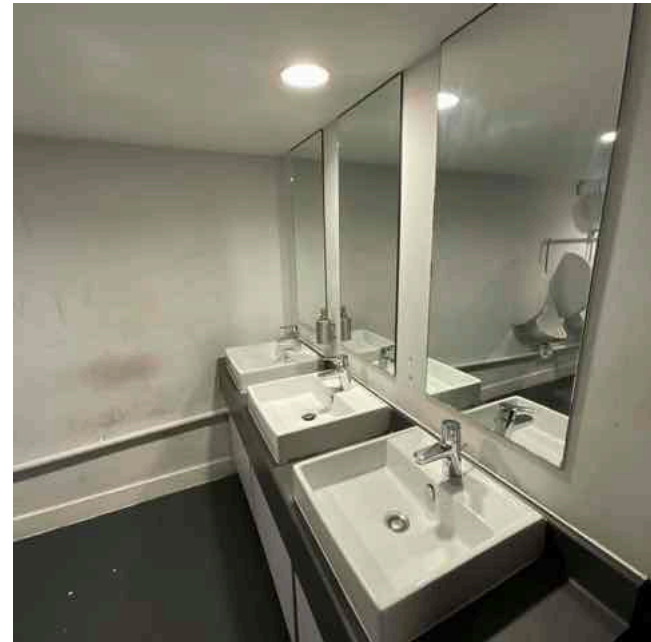
**Photo 183**

W/C  
Triple basin.

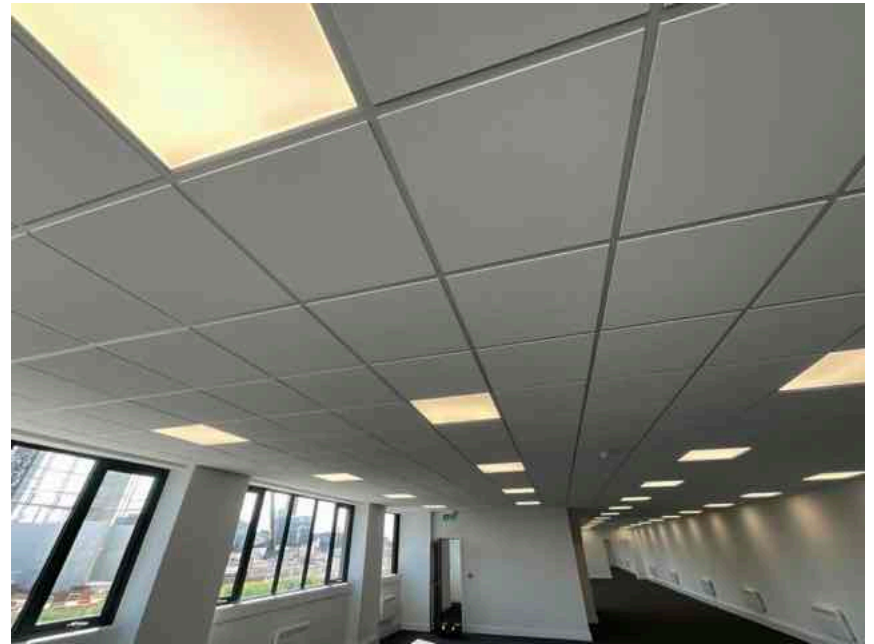
**Photo 2**

1st Floor Office North Recover  
Ceiling

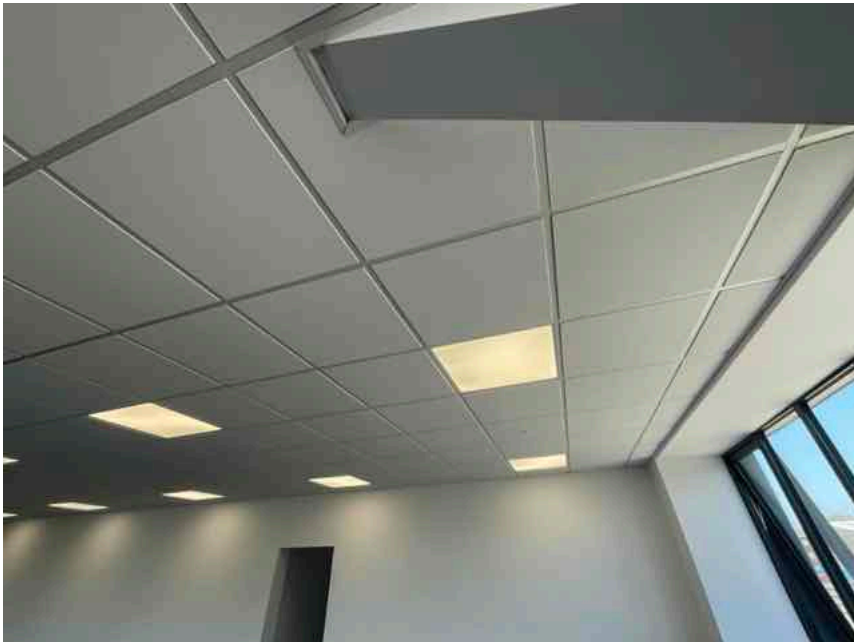
**Photo 3**

1st Floor Office North Recover  
Ceiling

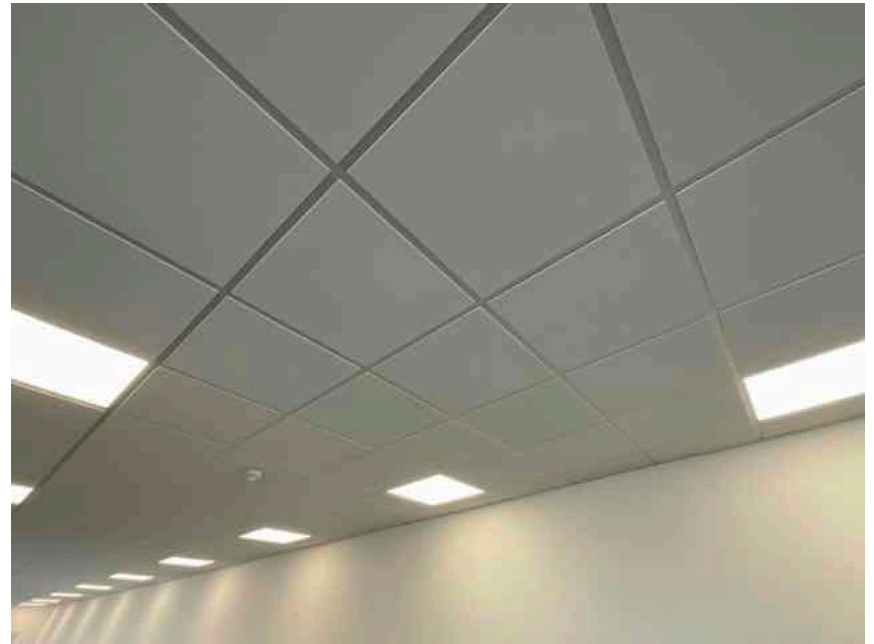
**Photo 6**

1st Floor Office North Recover  
Ceiling

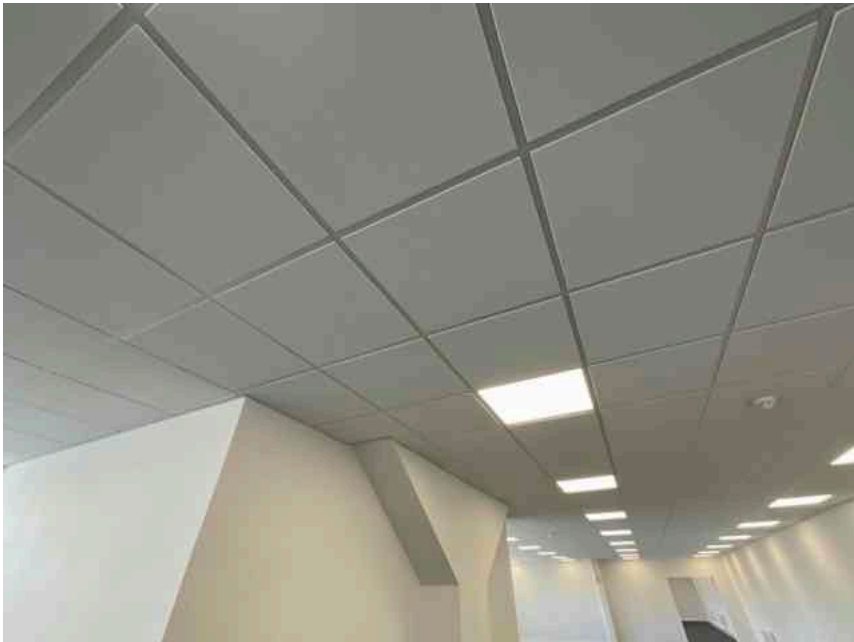
**Photo 7**

1st Floor Office North Recover  
Ceiling

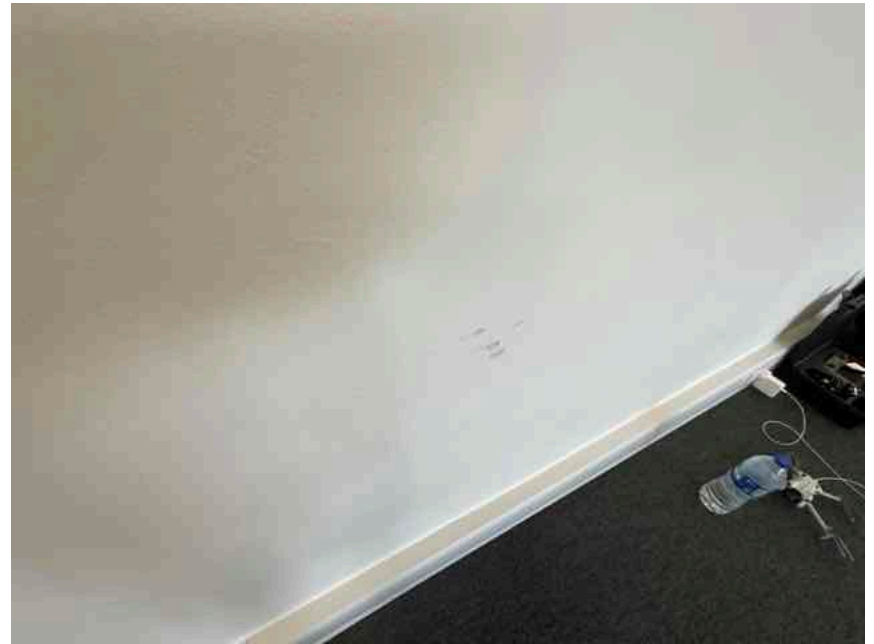
**Photo 10**

1st Floor Office North Recover  
Walls

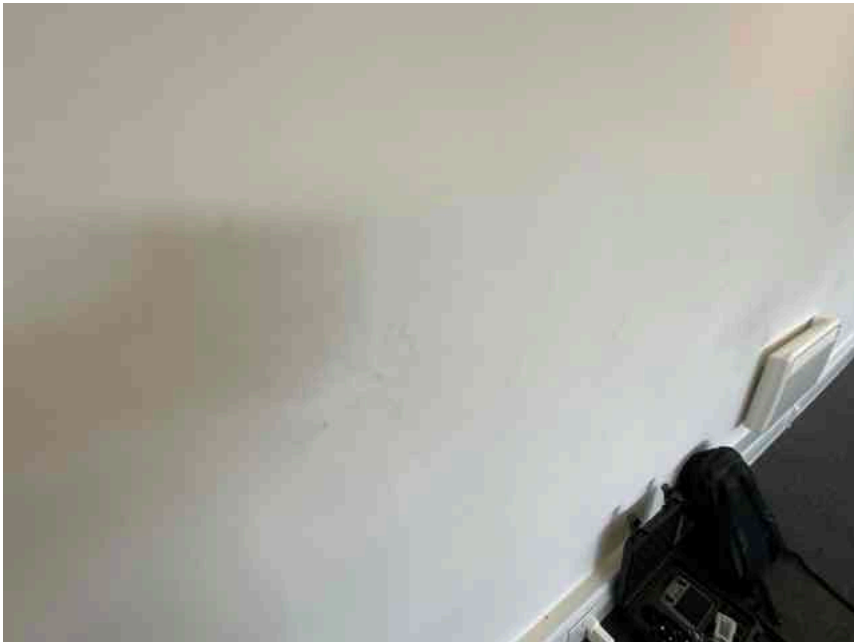
**Photo 11**

1st Floor Office North Recover  
Walls

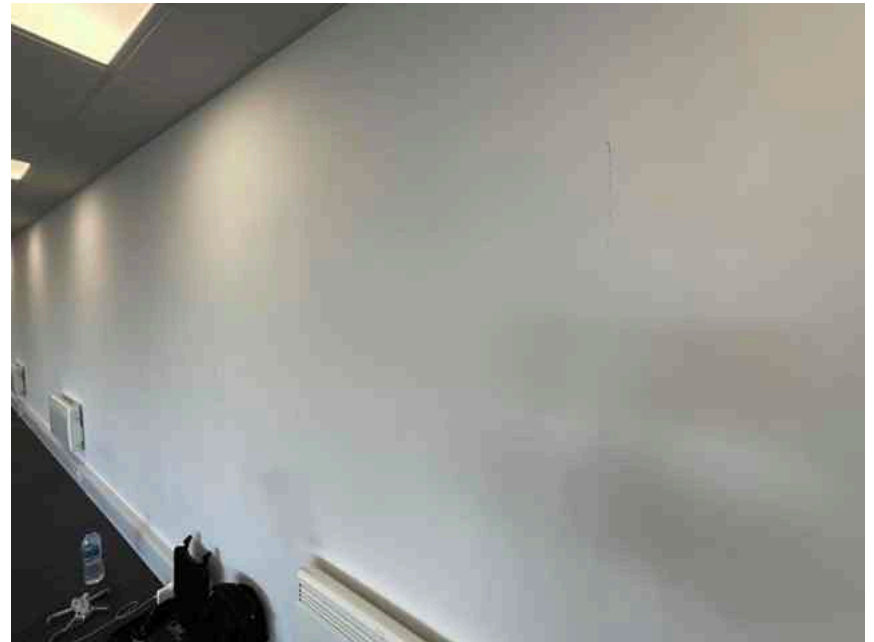
**Photo 12**

1st Floor Office North Recover  
Walls

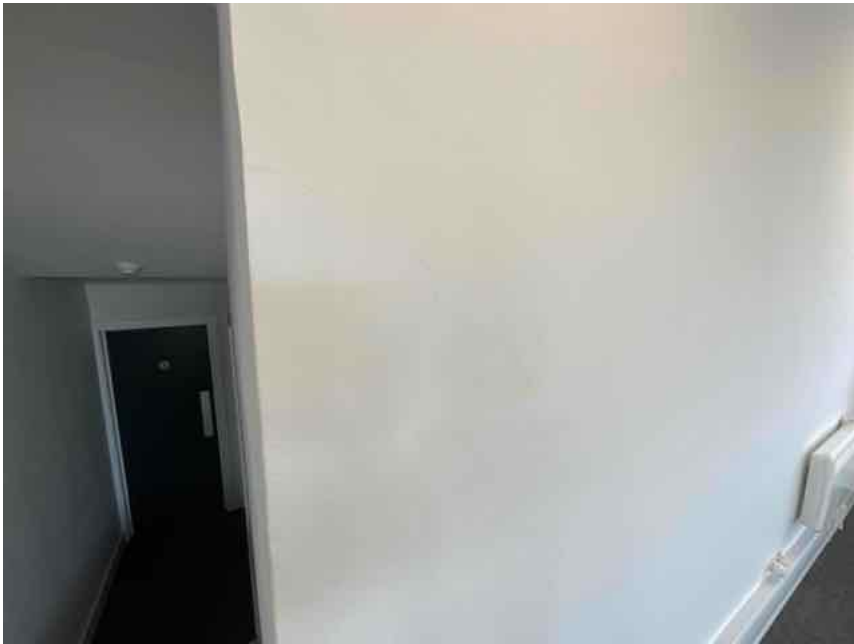
**Photo 13**

1st Floor Office North Recover  
Walls

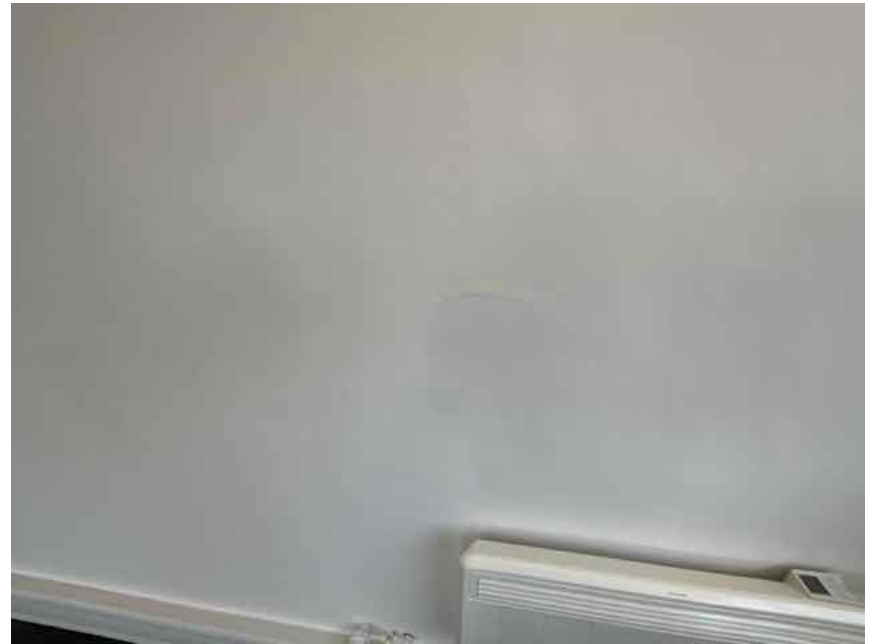
**Photo 14**

1st Floor Office North Recover  
Walls

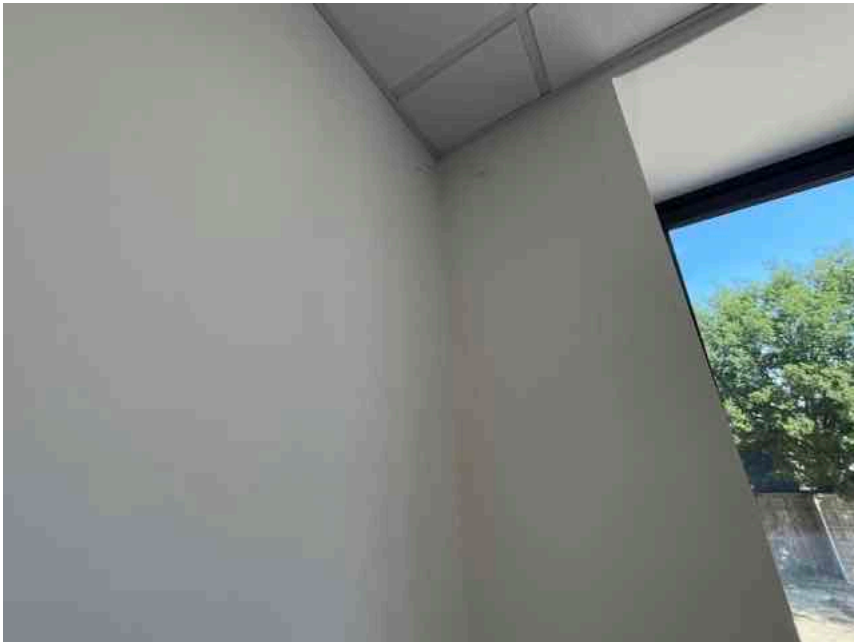
**Photo 15**

1st Floor Office North Recover  
Walls

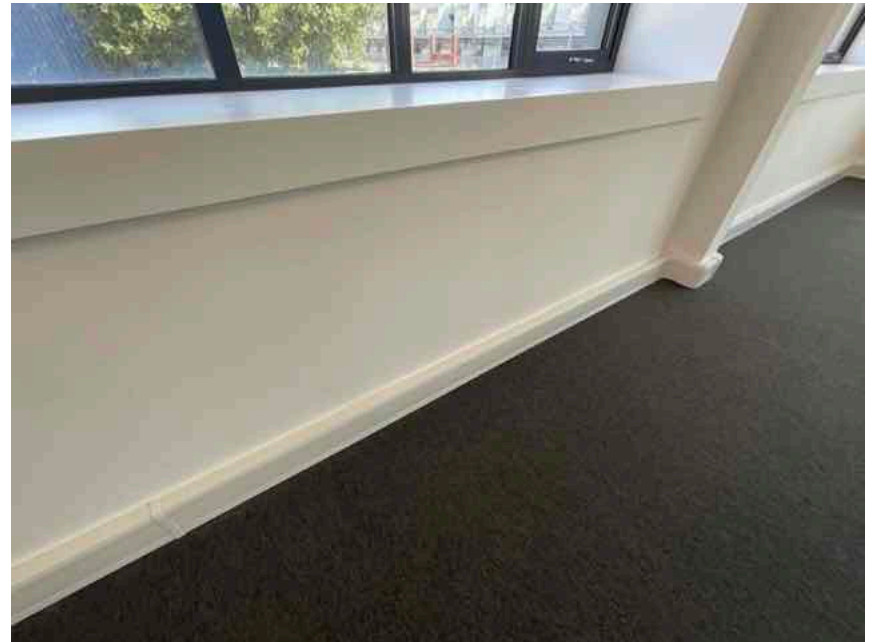
**Photo 16**

1st Floor Office North Recover  
Walls

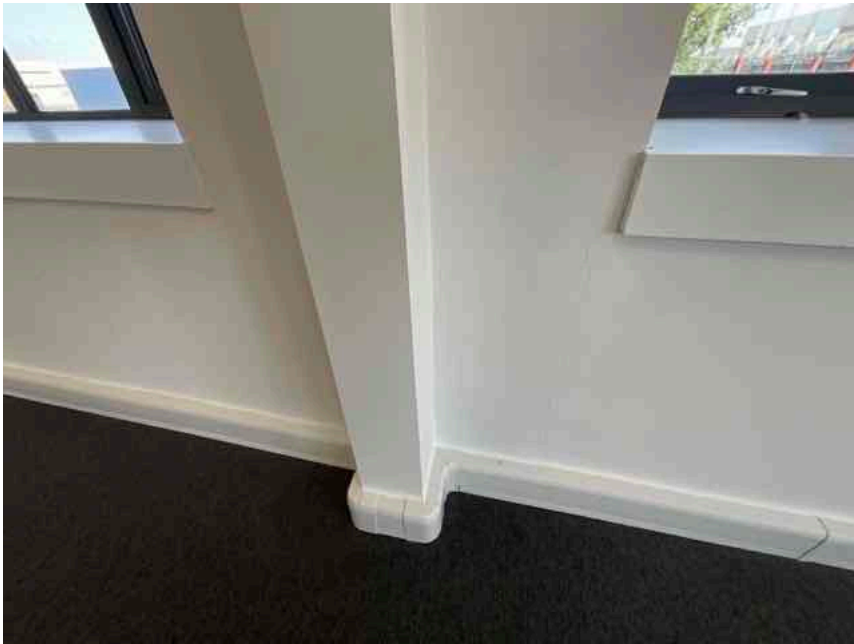
**Photo 17**

1st Floor Office North Recover  
Walls

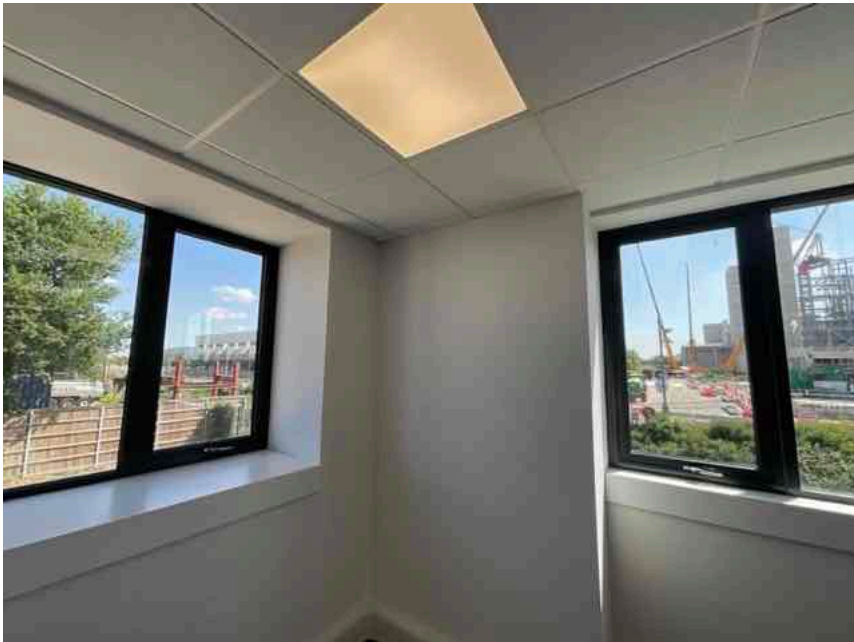
**Photo 19**

1st Floor Office North Recover  
Walls

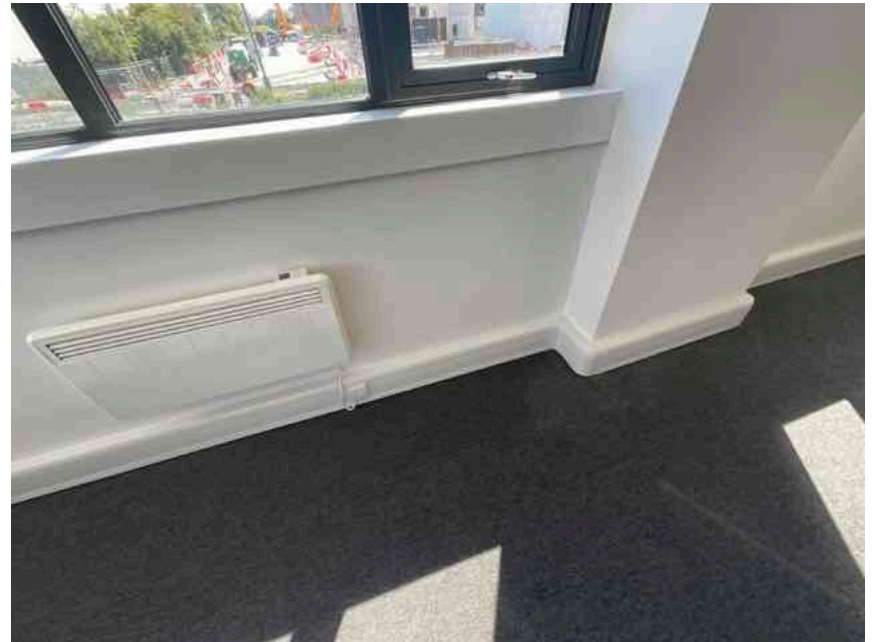
**Photo 20**

1st Floor Office North Recover  
Walls

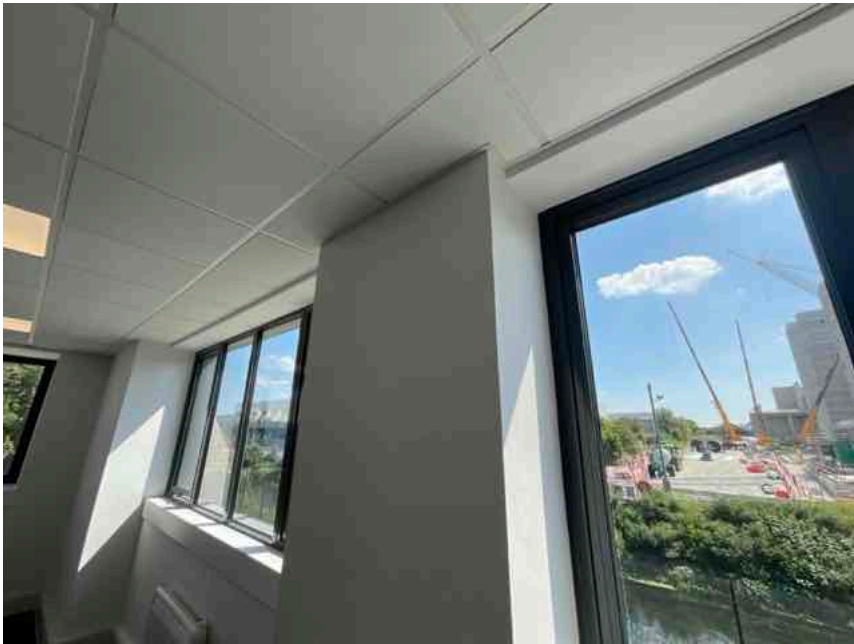
**Photo 21**

1st Floor Office North Recover  
Walls

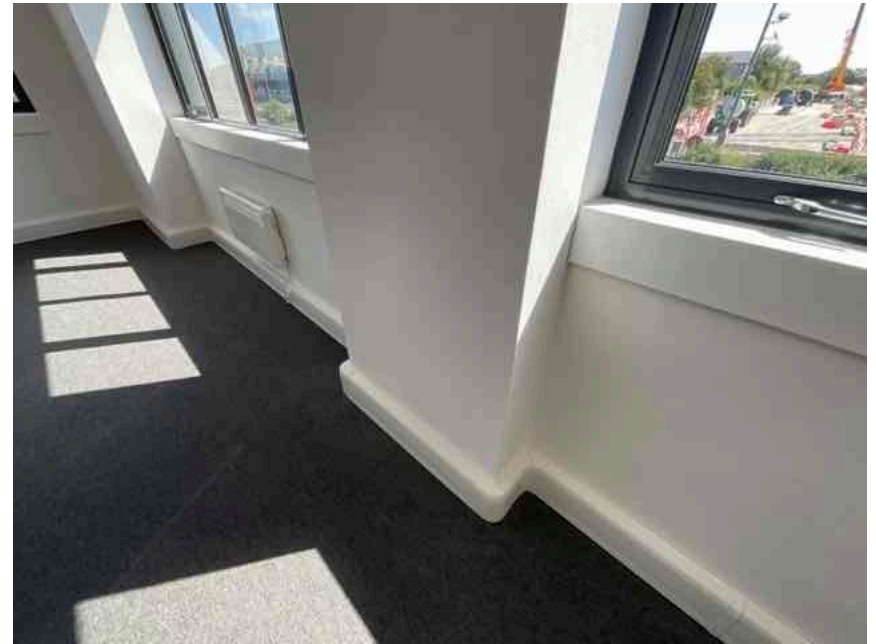
**Photo 22**

1st Floor Office North Recover  
Walls

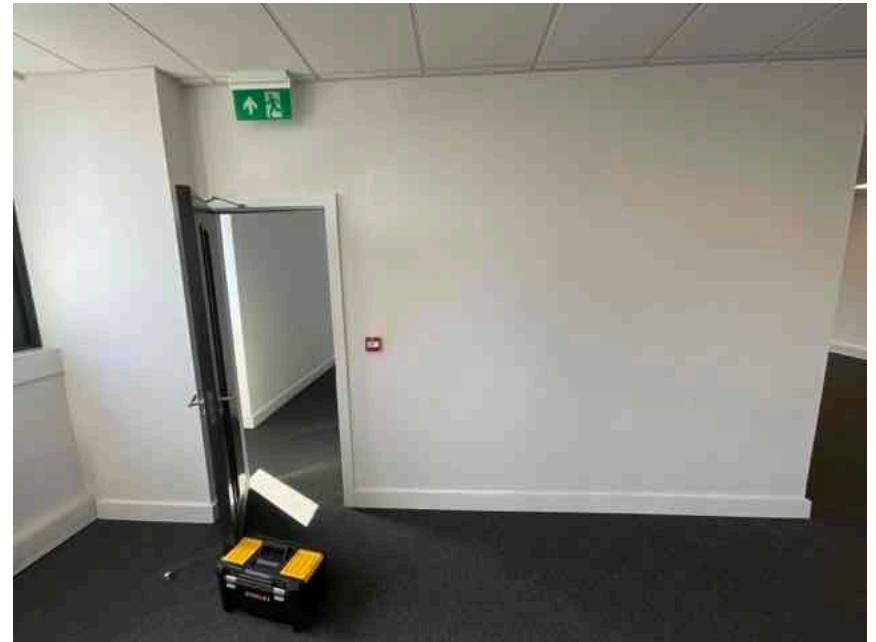
**Photo 24**

1st Floor Office North Recover  
Walls

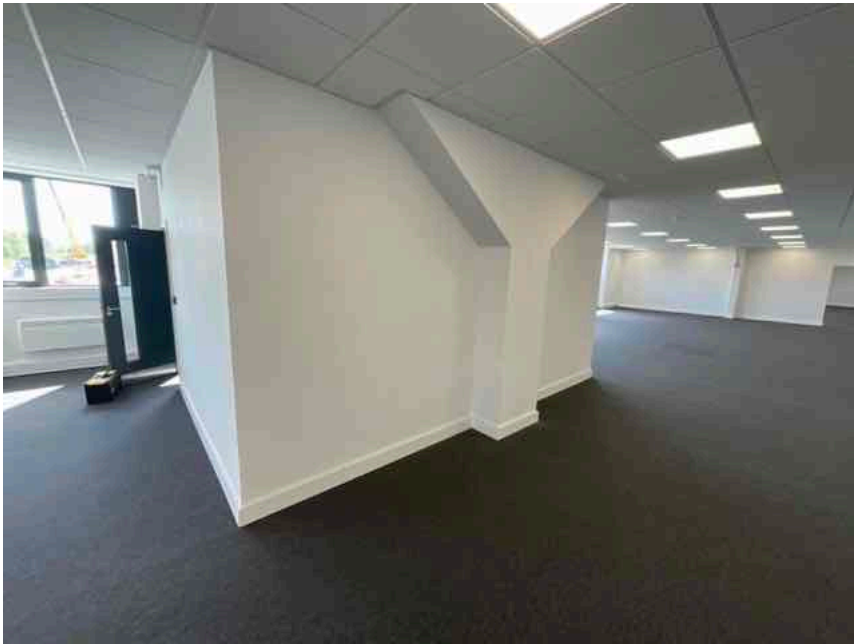
**Photo 25**

1st Floor Office North Recover  
Walls

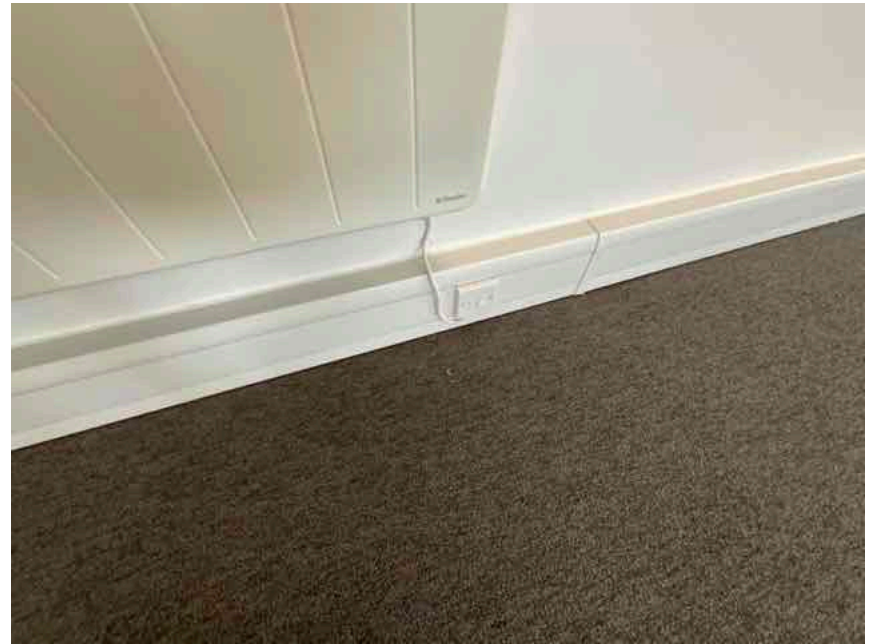
**Photo 26**

1st Floor Office North Recover  
Electrical distribution trunki

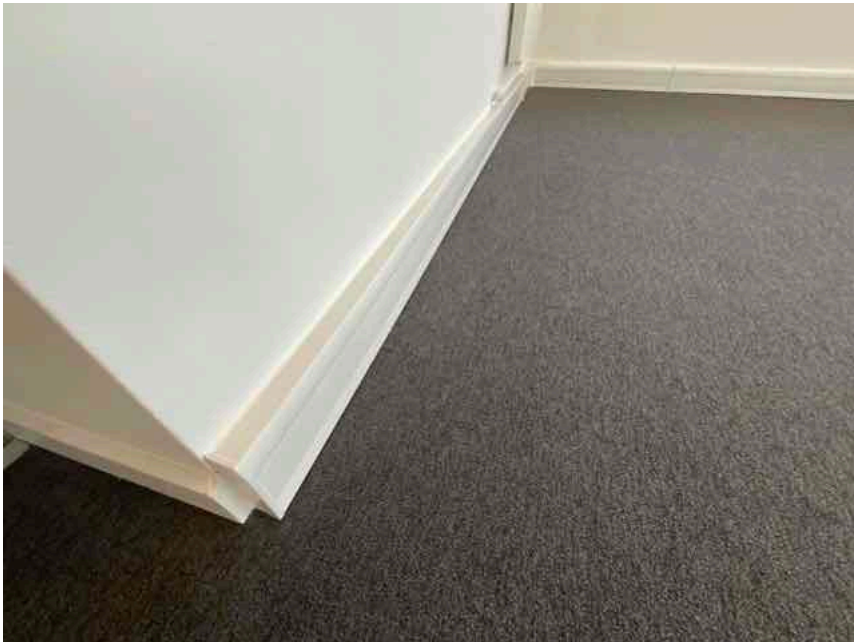
**Photo 27**

1st Floor Office North Recover  
Electrical distribution trunki

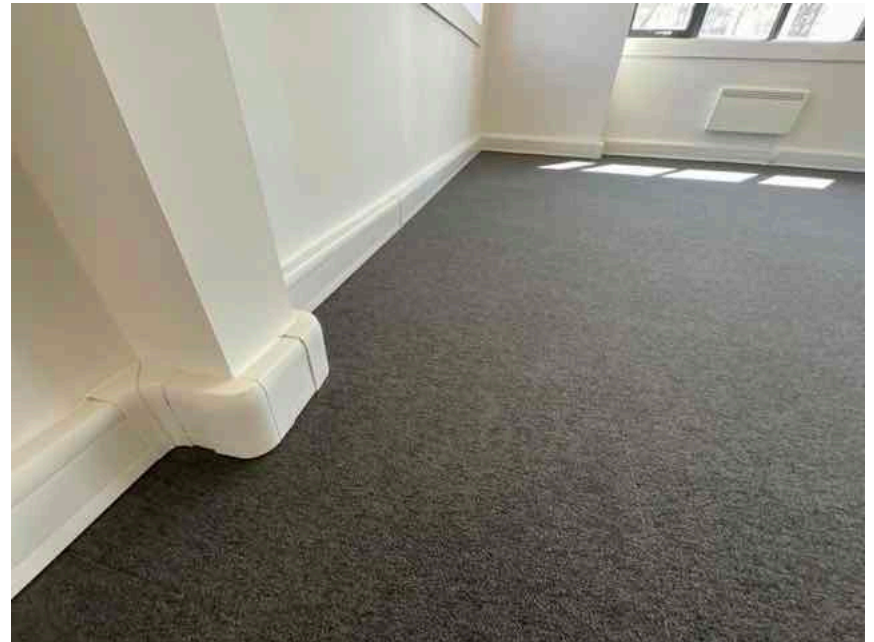
**Photo 28**

1st Floor Office North Recover  
Electrical distribution trunki

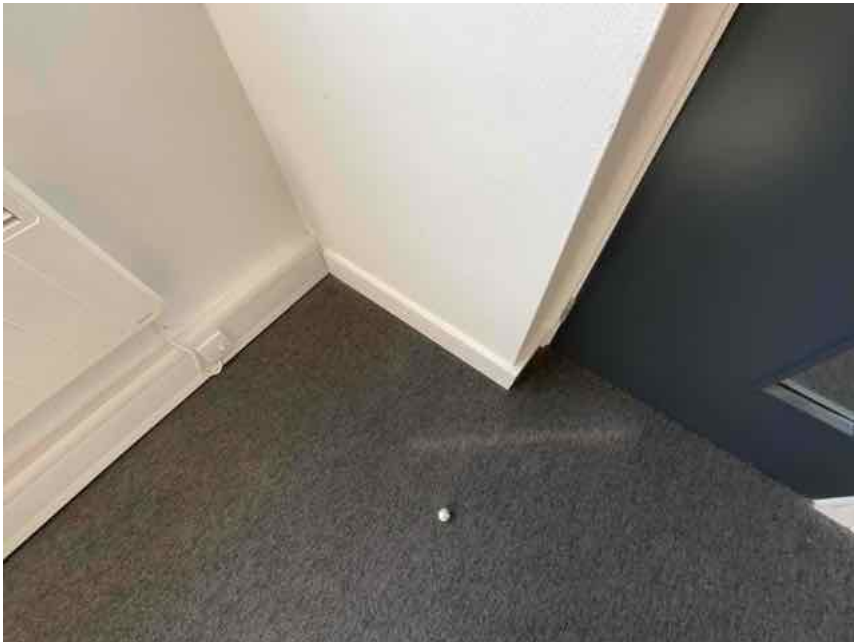
**Photo 31**

1st Floor Office North Recover  
Joinery

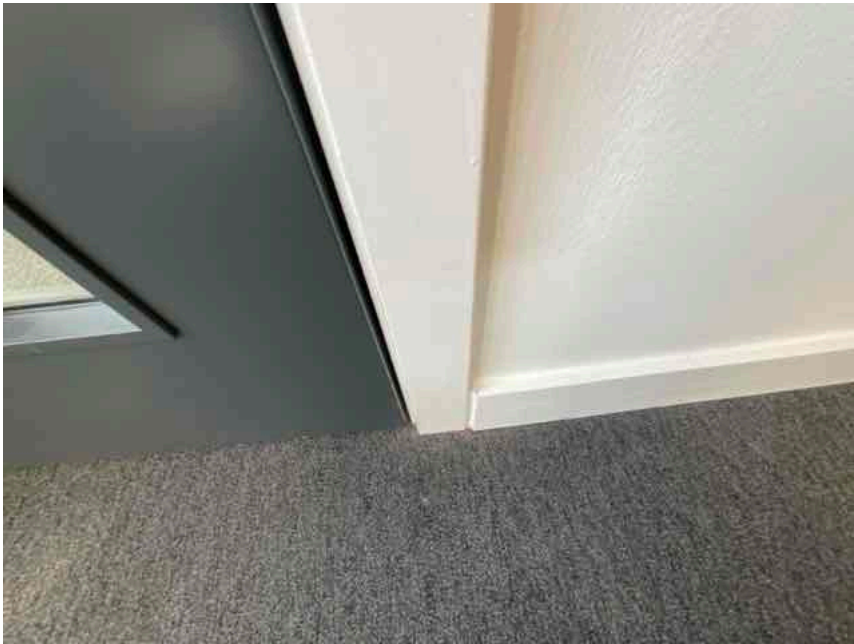
**Photo 33**

1st Floor Office North Recover  
Joinery

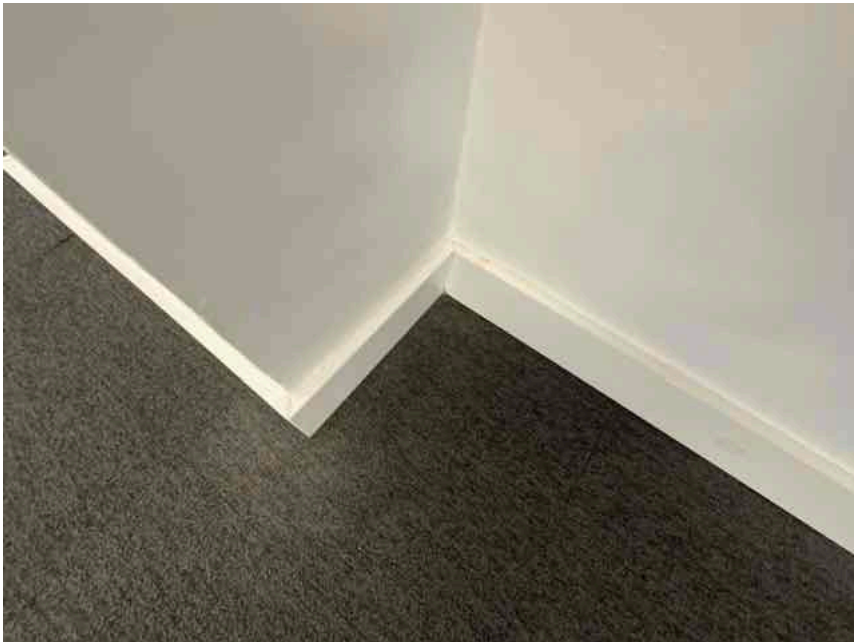
**Photo 34**

1st Floor Office North Recover  
Joinery
