## Schedule of Condition

Date: 13<sup>th</sup> May 2025

## B Schedule of Condition Shop Floor

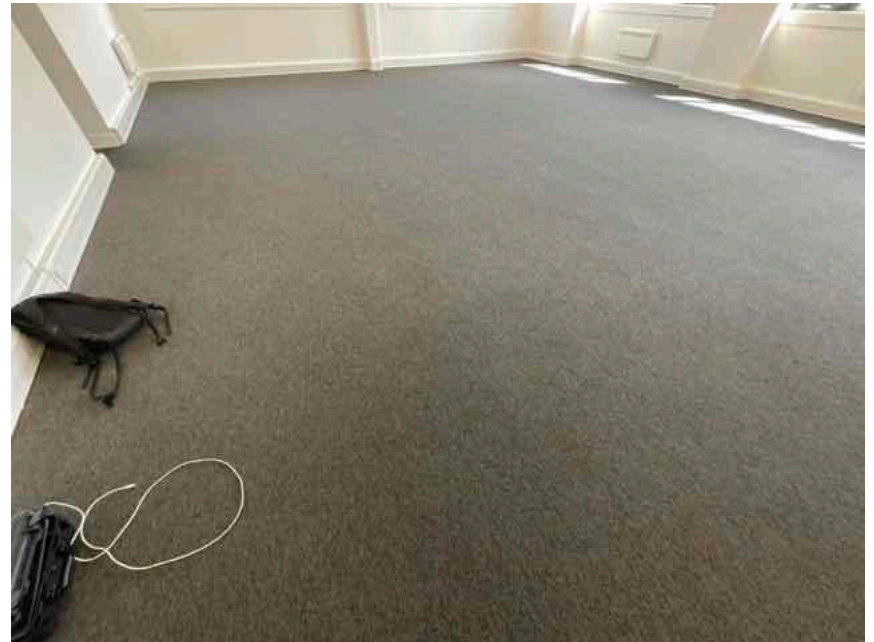
**Photo 35**

1st Floor Office North Recover  
Joinery

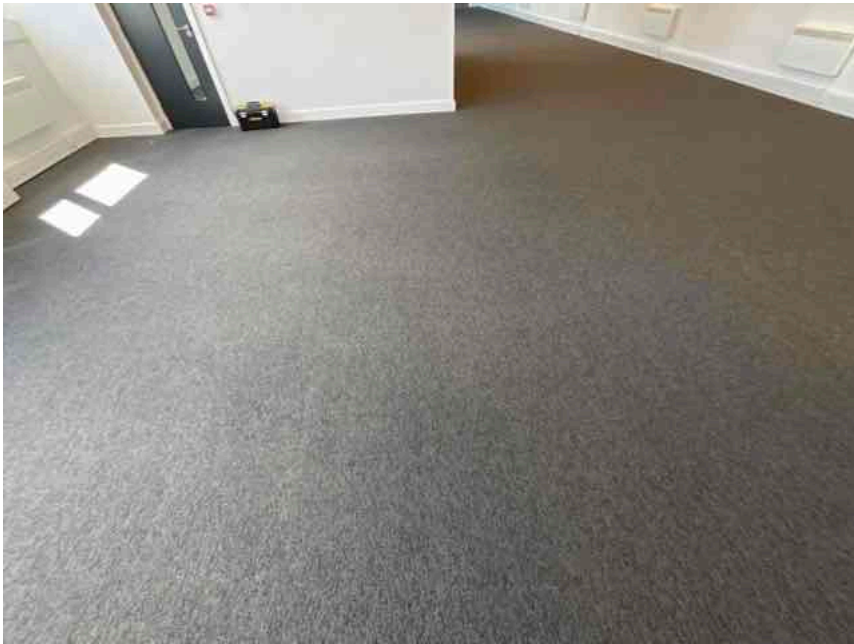
**Photo 36**

1st Floor Office North Recover  
Floor structure

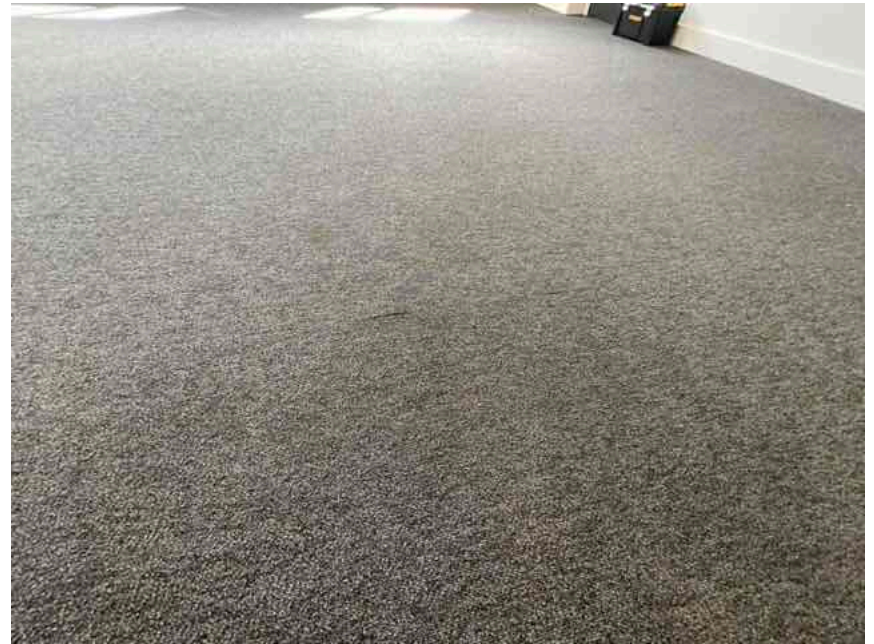
**Photo 37**

1st Floor Office North Recover  
Floor coverings

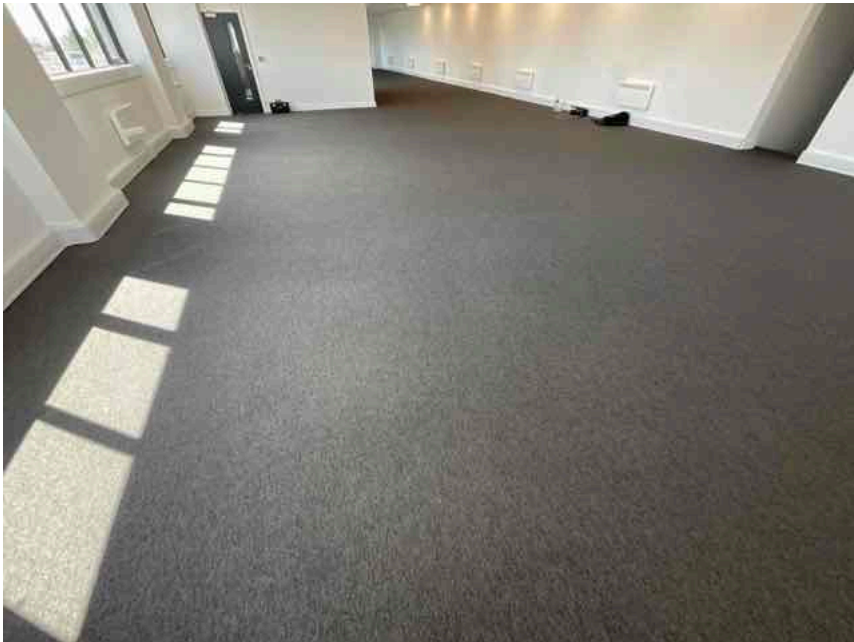
**Photo 38**

1st Floor Office North Recover  
Floor coverings

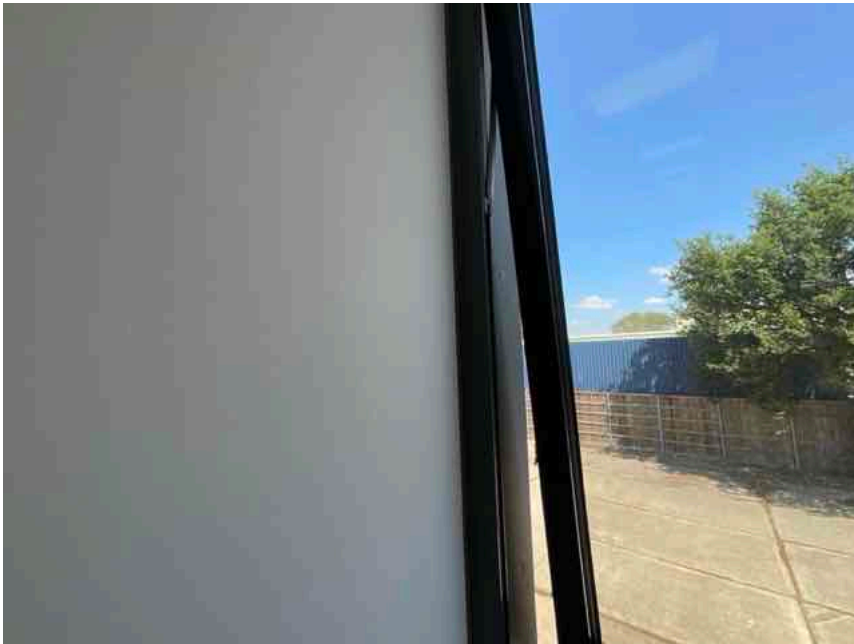
**Photo 40**

1st Floor Office North Recover  
Windows

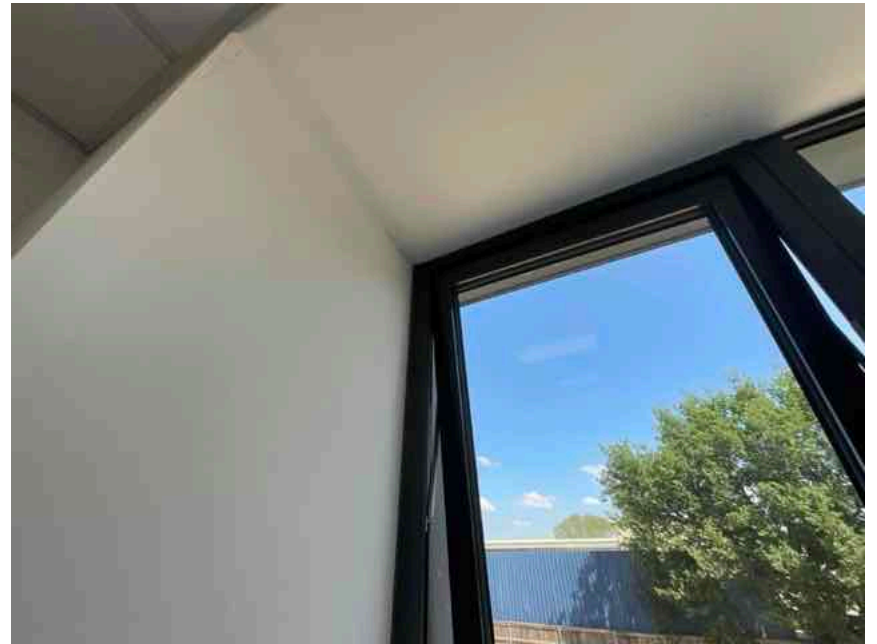
**Photo 41**

1st Floor Office North Recover  
Windows

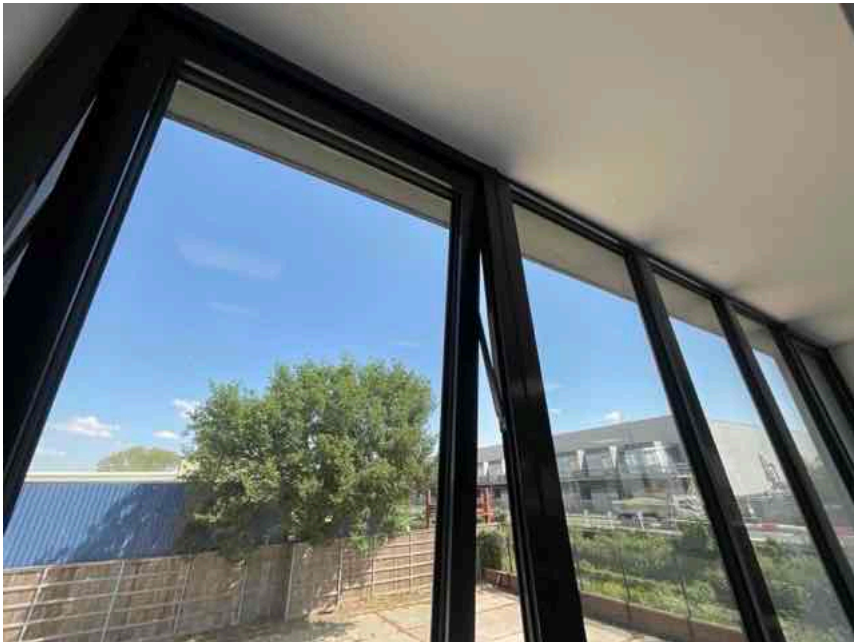
**Photo 42**

1st Floor Office North Recover  
Windows

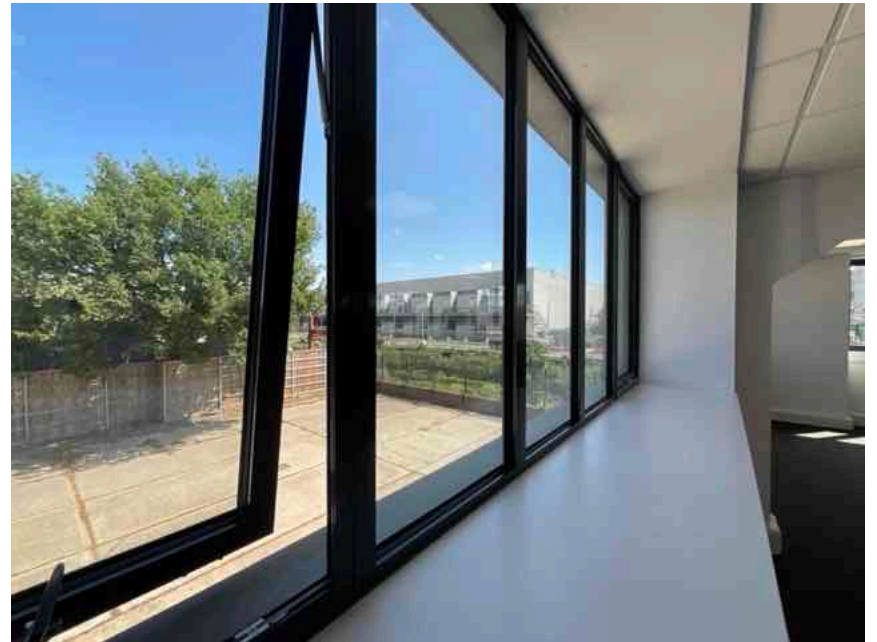
**Photo 43**

1st Floor Office North Recover  
Windows

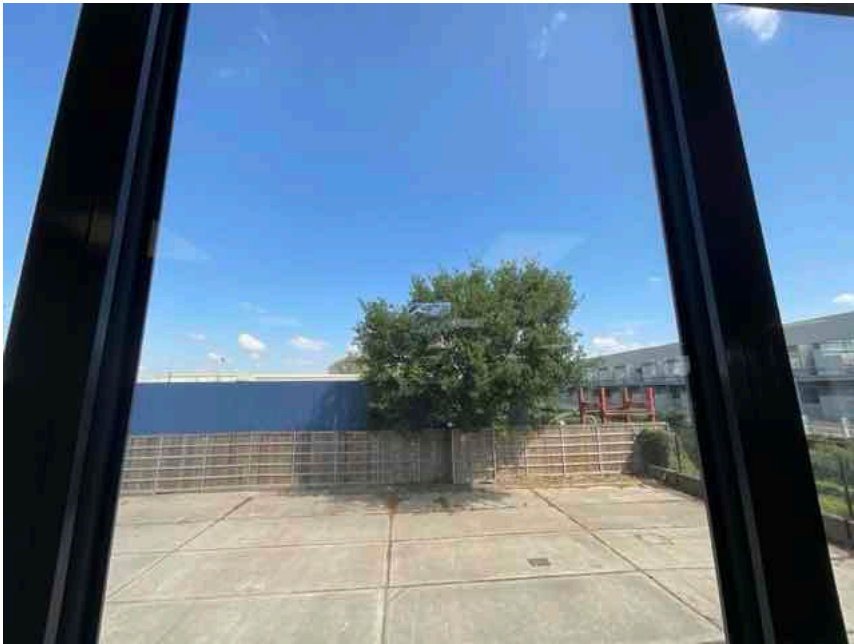
**Photo 44**

1st Floor Office North Recover  
Windows

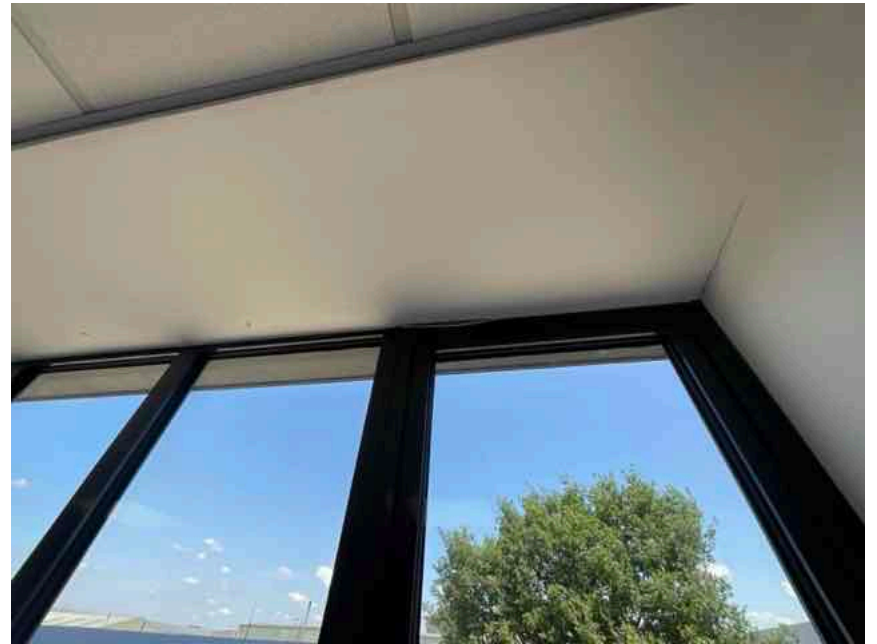
**Photo 45**

1st Floor Office North Recover  
Windows

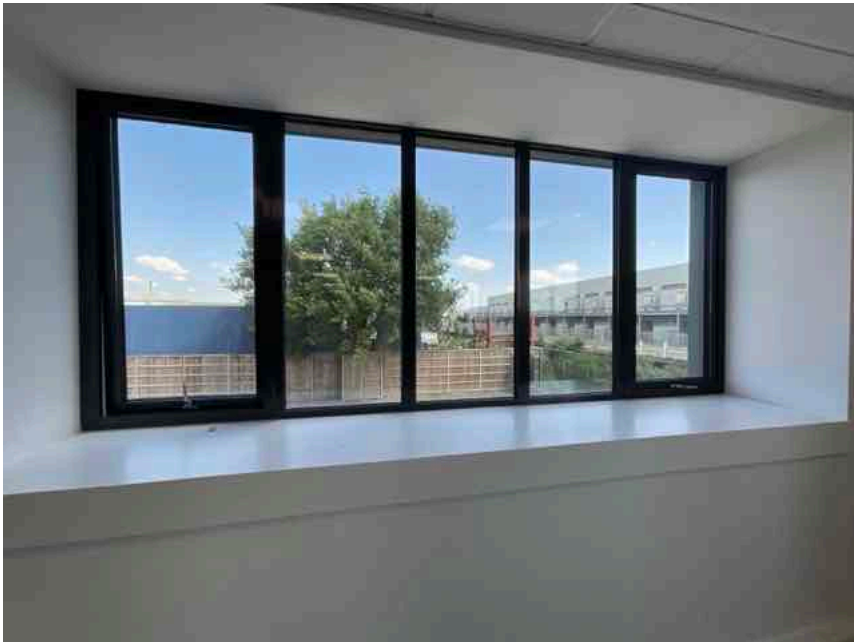
**Photo 46**

1st Floor Office North Recover  
Windows

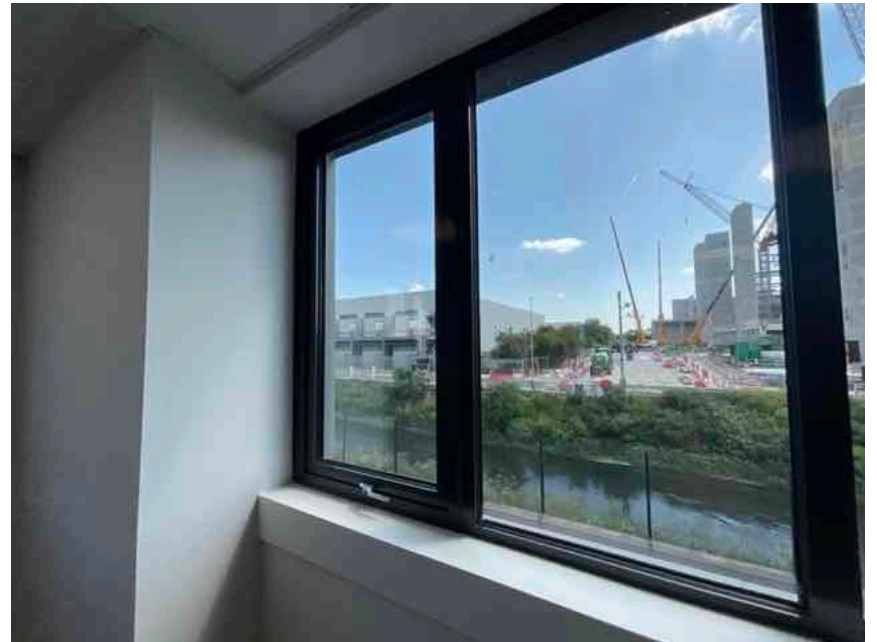
**Photo 47**

1st Floor Office North Recover  
Windows

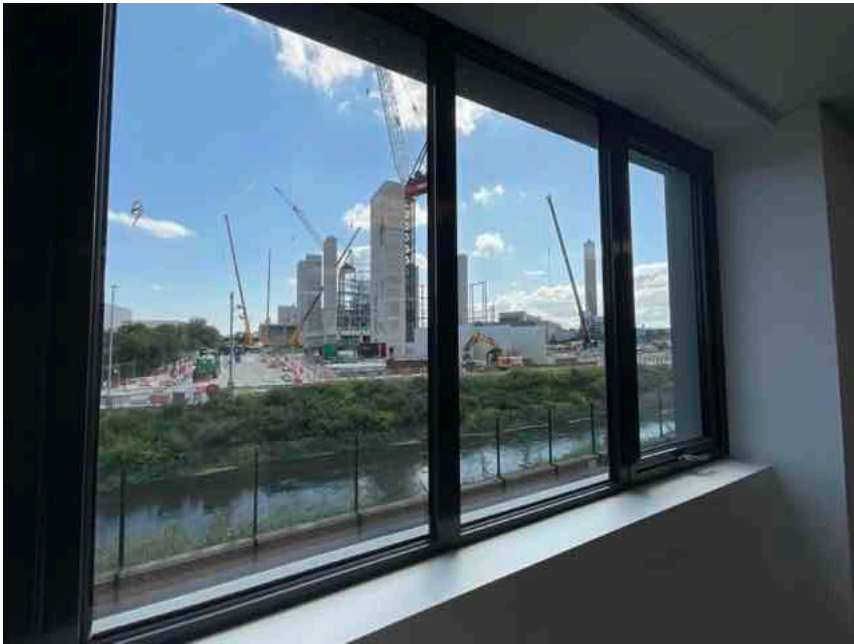
**Photo 48**

1st Floor Office North Recover  
Windows

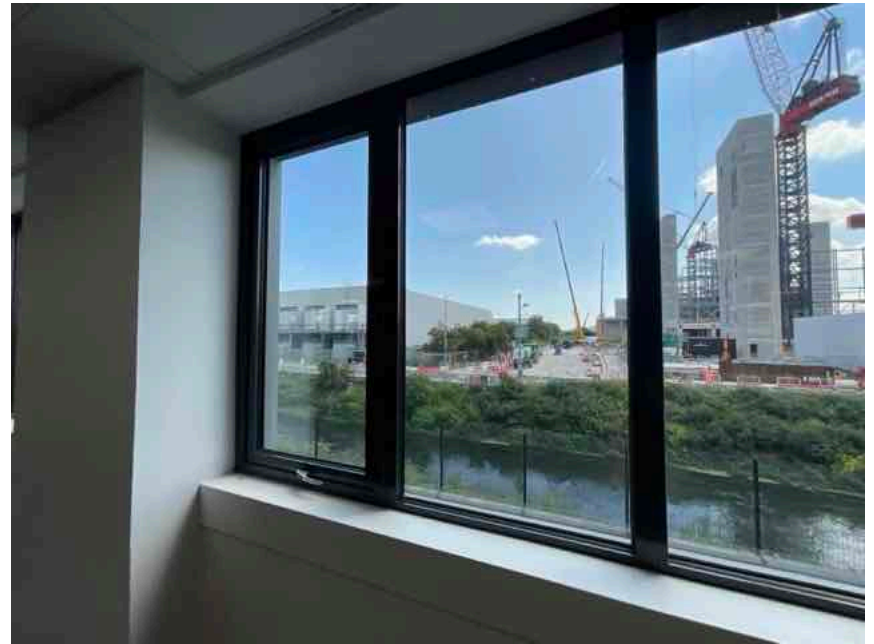
**Photo 49**

1st Floor Office North Recover  
Windows

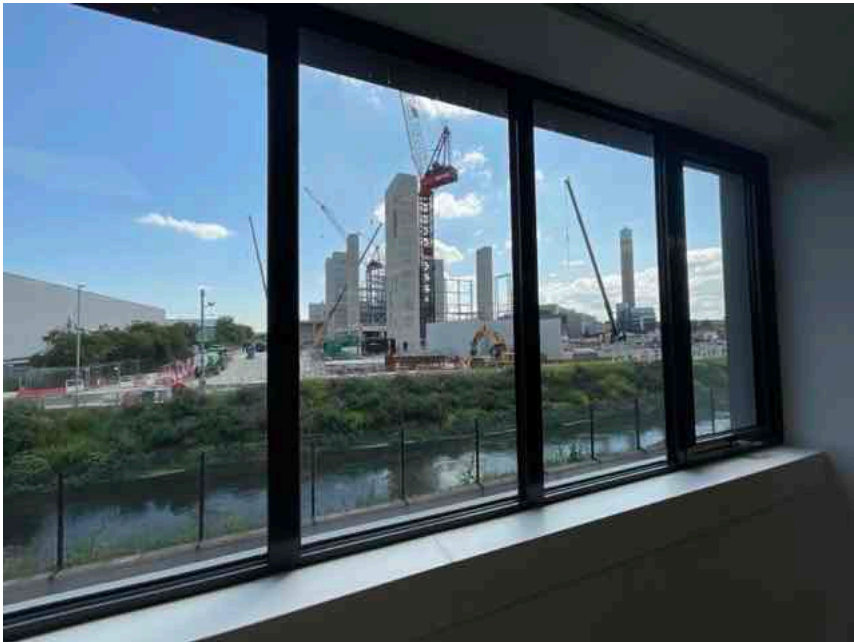
**Photo 50**

1st Floor Office North Recover  
Windows

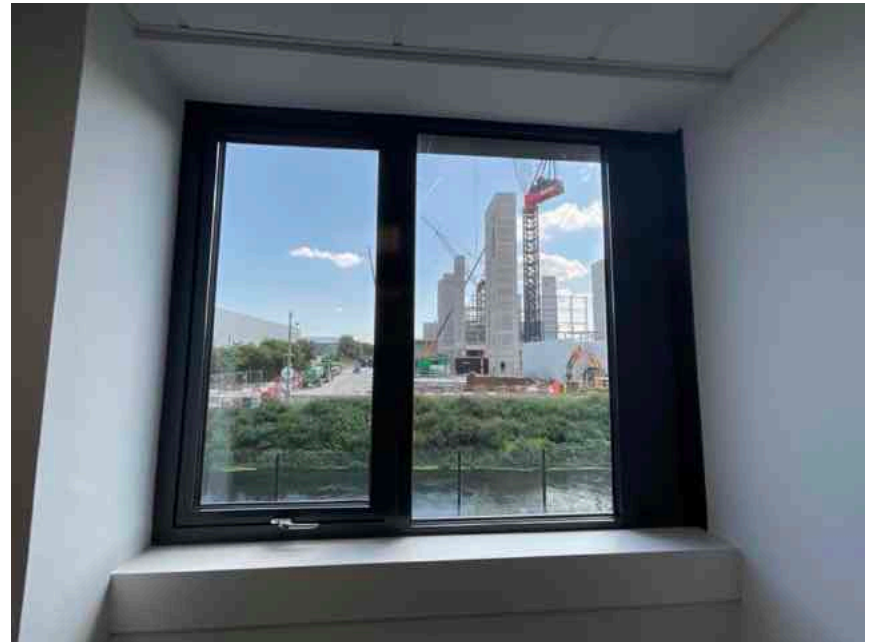
**Photo 51**

1st Floor Office North Recover  
Windows

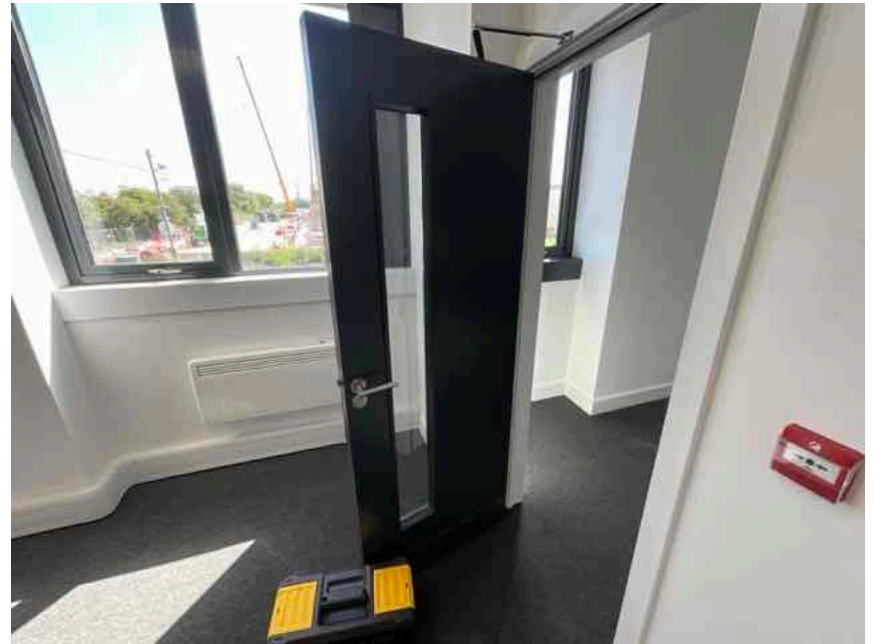
**Photo 53**

1st Floor Office North Recover  
Doors

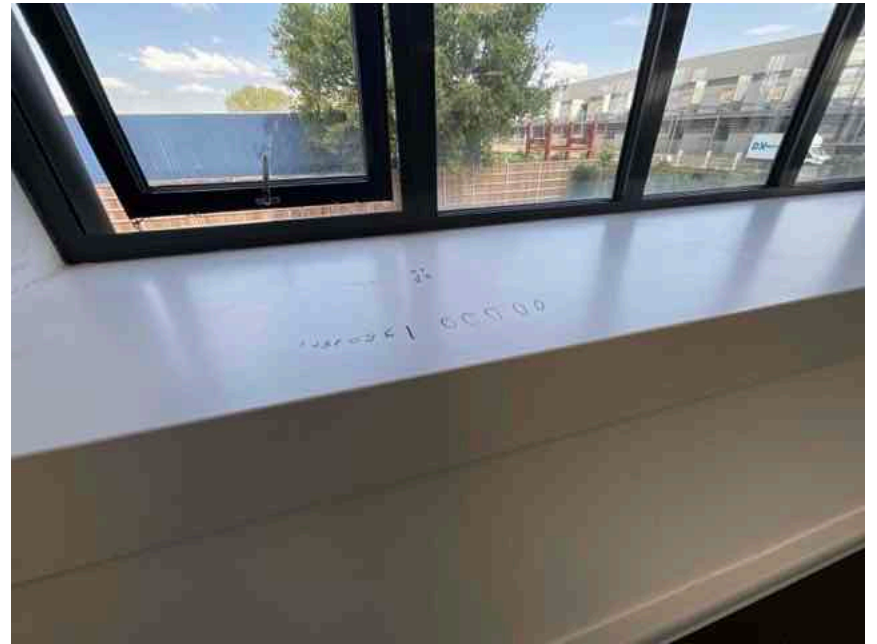
**Photo 57**

1st Floor Office North Recover  
Windowsill

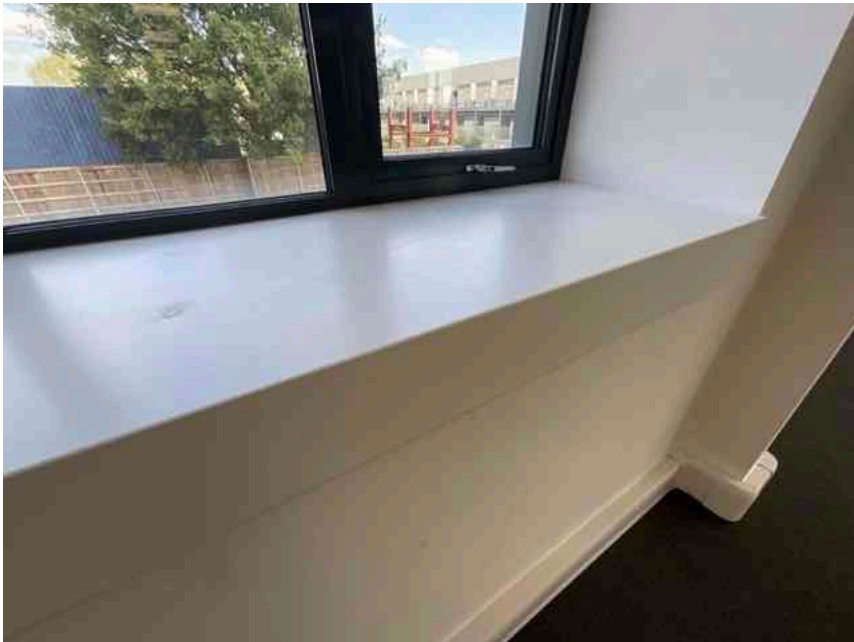
**Photo 58**

1st Floor Office North Recover  
Windowsill

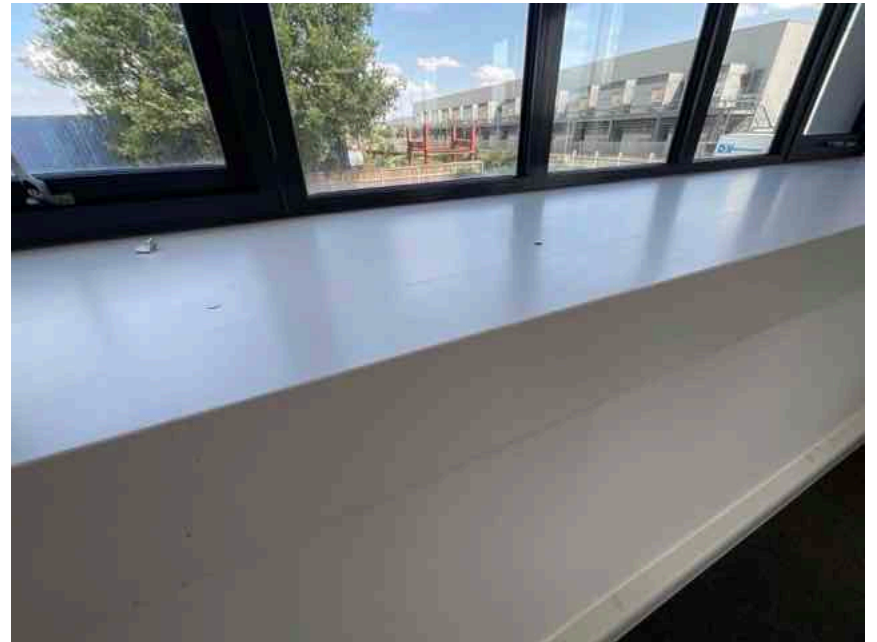
**Photo 59**

1st Floor Office North Recover  
Windowsill

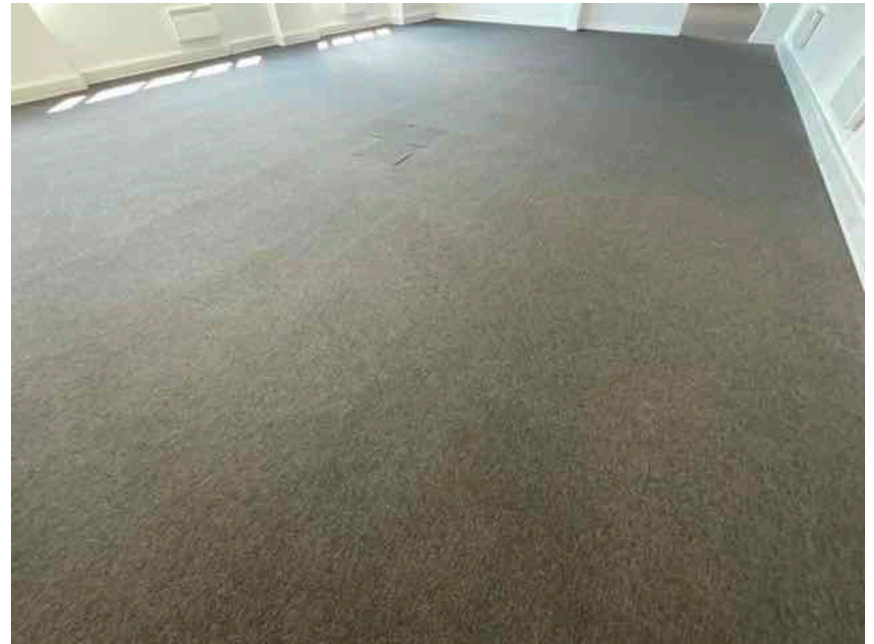
**Photo 61**

1st Floor Office Central  
Floor structure

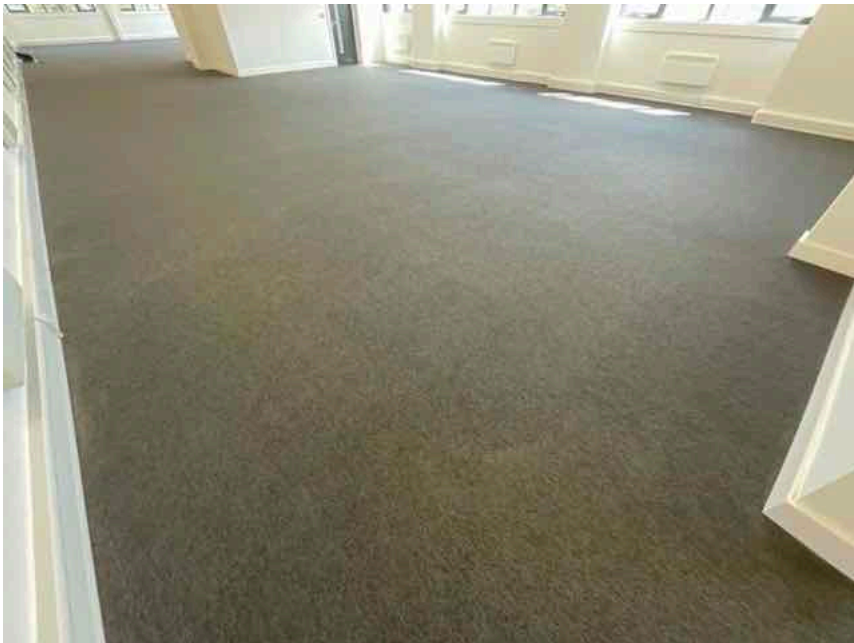
**Photo 62**

1st Floor Office Central  
Floor structure

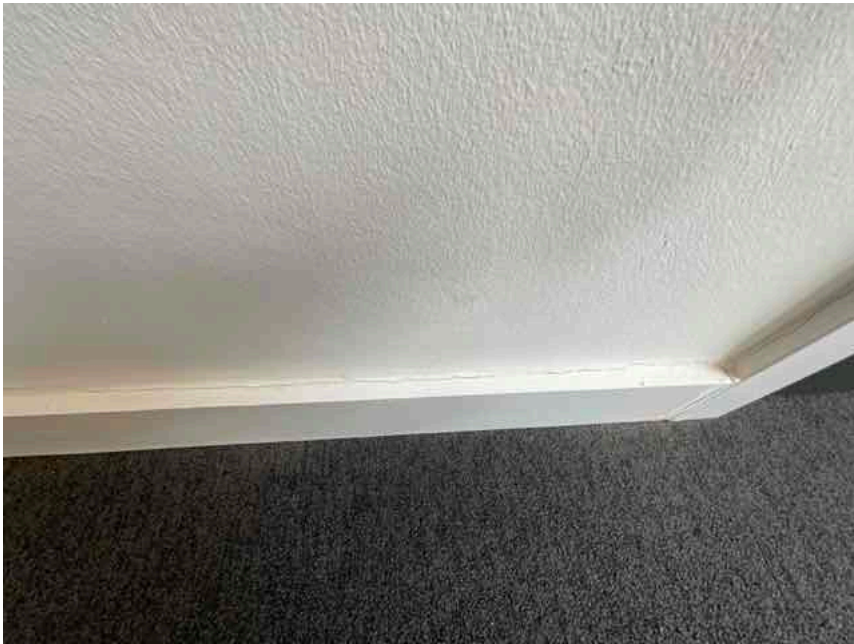
**Photo 64**

1st Floor Office Central  
Joinery

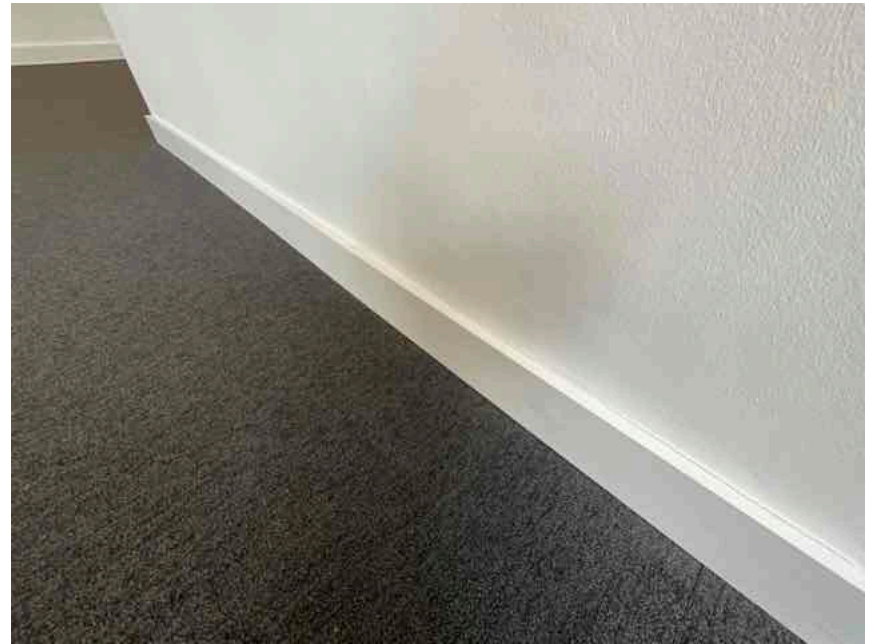
**Photo 65**

1st Floor Office Central  
Joinery

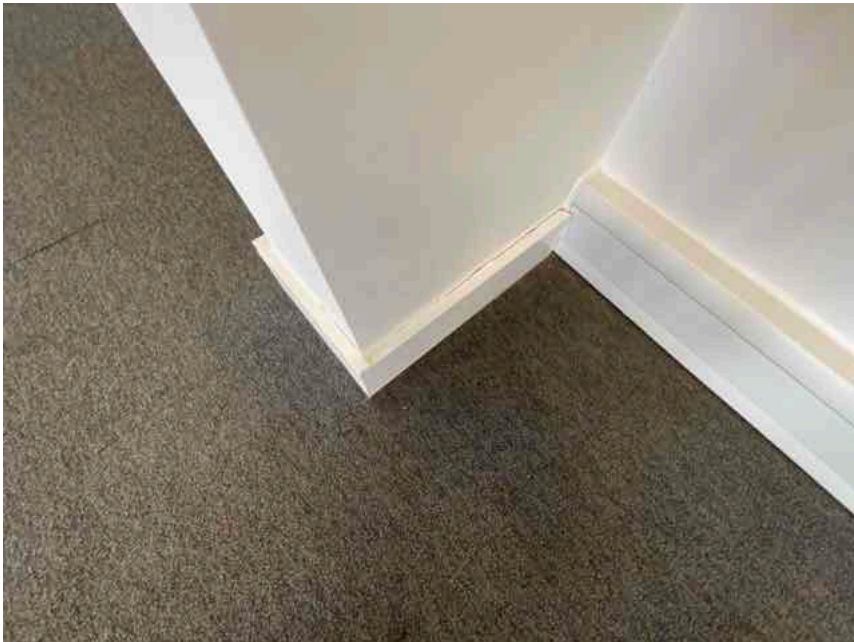
**Photo 66**

1st Floor Office Central  
Joinery

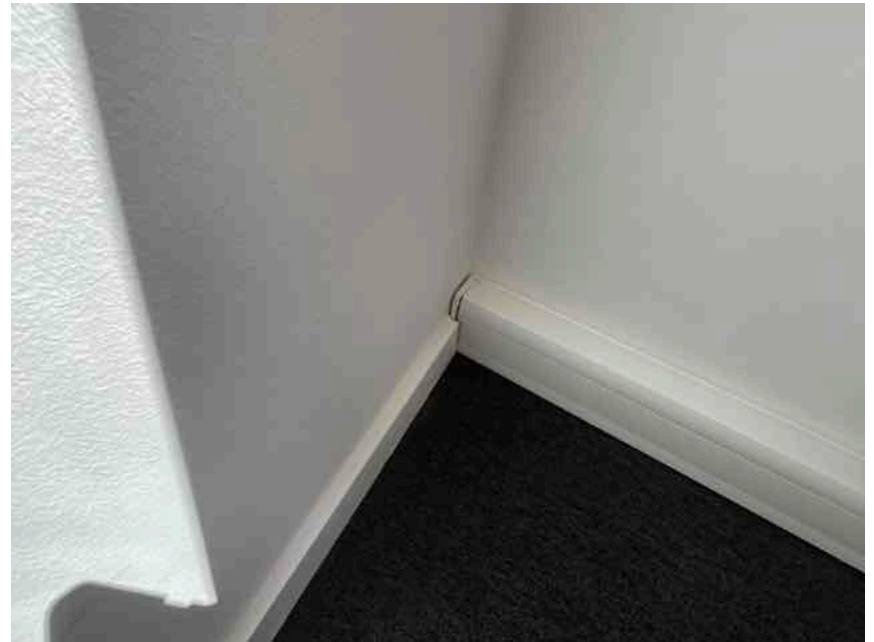
**Photo 67**

1st Floor Office Central  
Joinery

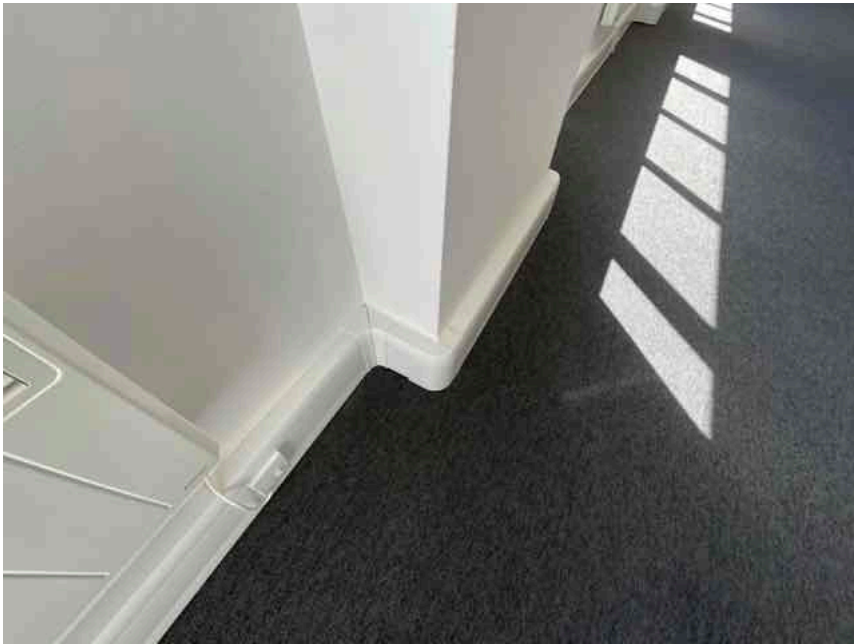
**Photo 68**

1st Floor Office Central  
Electrical distribution trunki

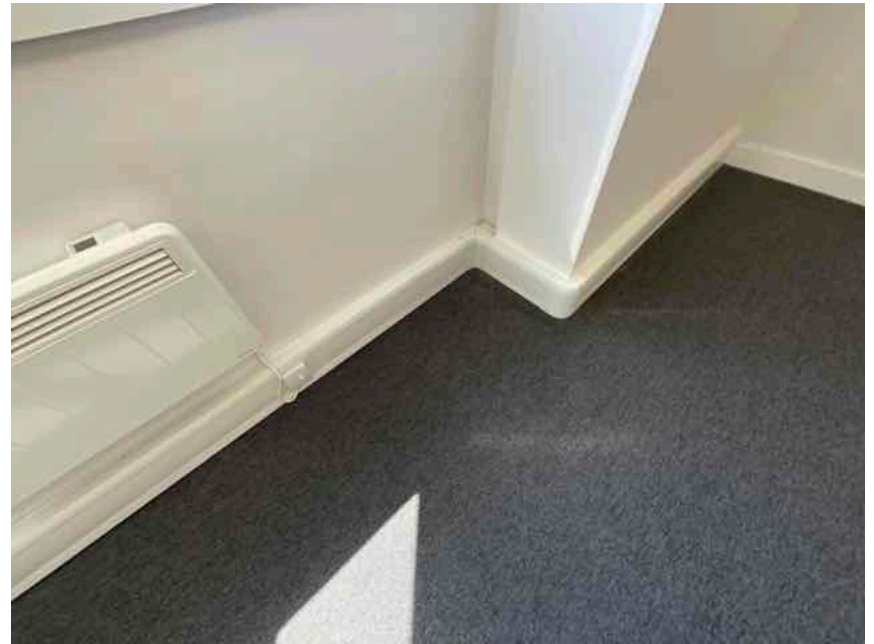
**Photo 69**

1st Floor Office Central  
Electrical distribution trunki

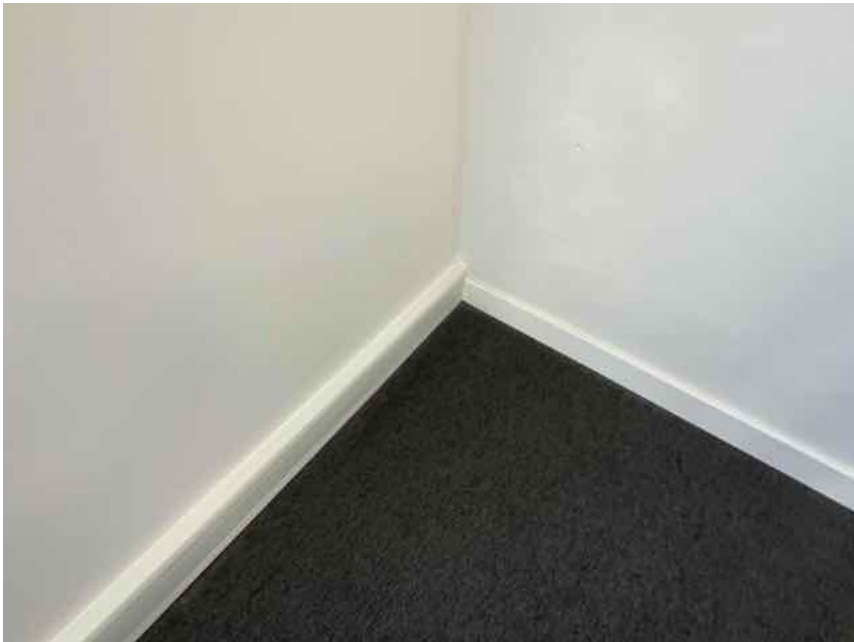
**Photo 70**

1st Floor Office Central  
Electrical distribution trunki

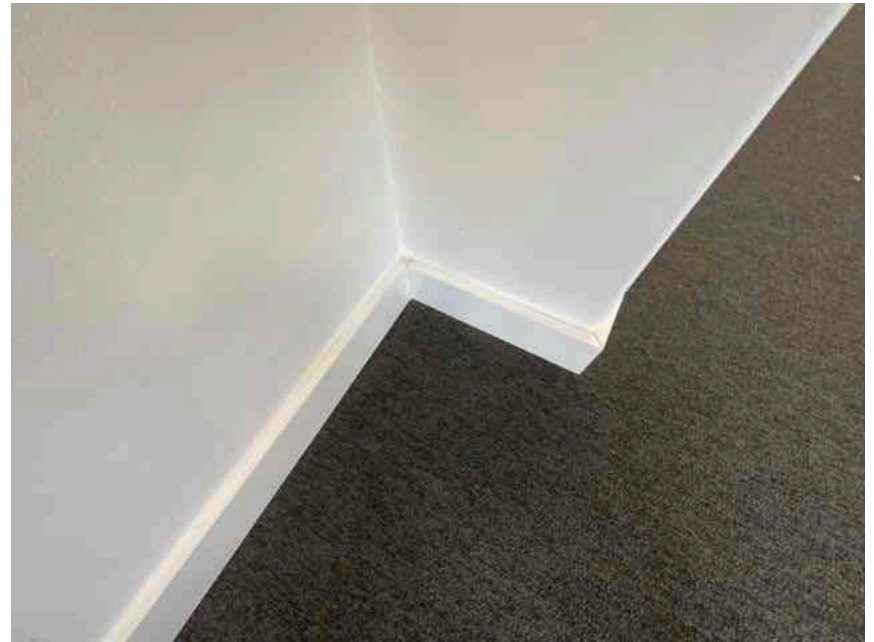
**Photo 71**

1st Floor Office Central  
Electrical distribution trunki

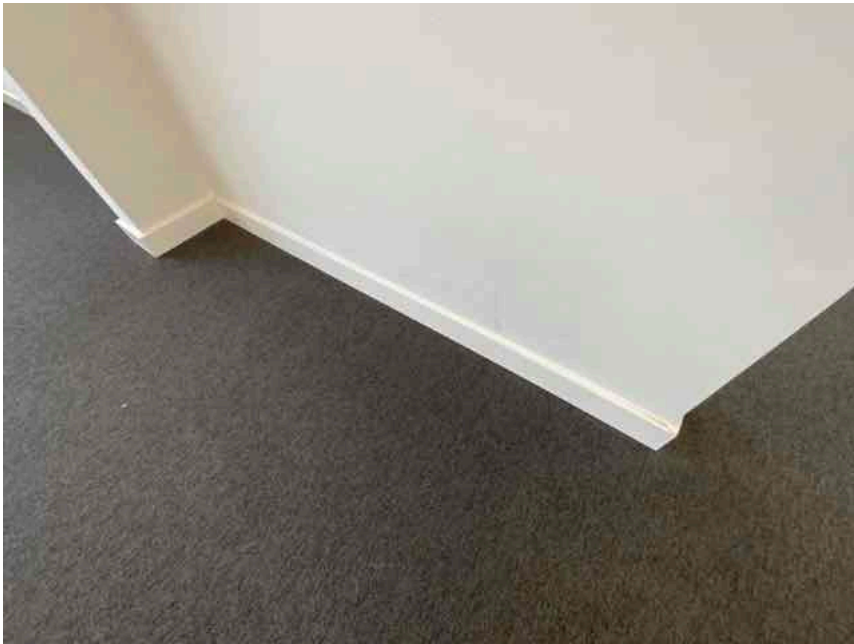
**Photo 72**

1st Floor Office Central  
Electrical distribution trunki

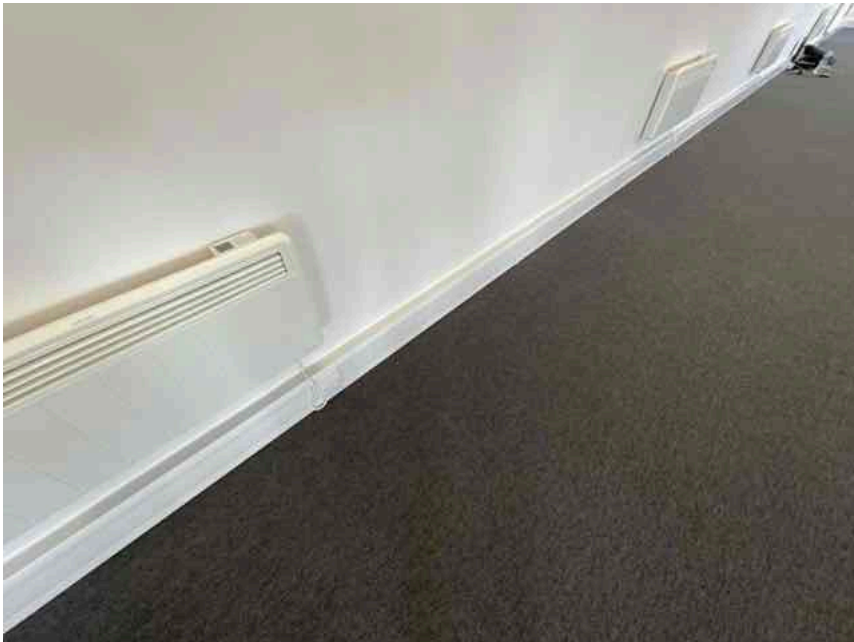
**Photo 74**

1st Floor Office Central  
Electrical distribution trunki

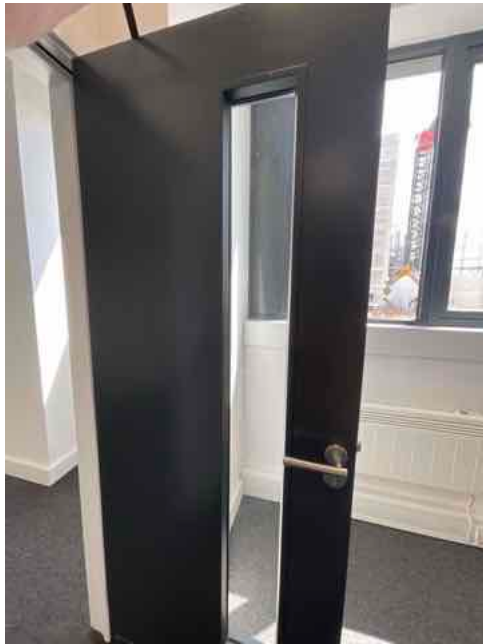
**Photo 76**

1st Floor Office Central  
Doors

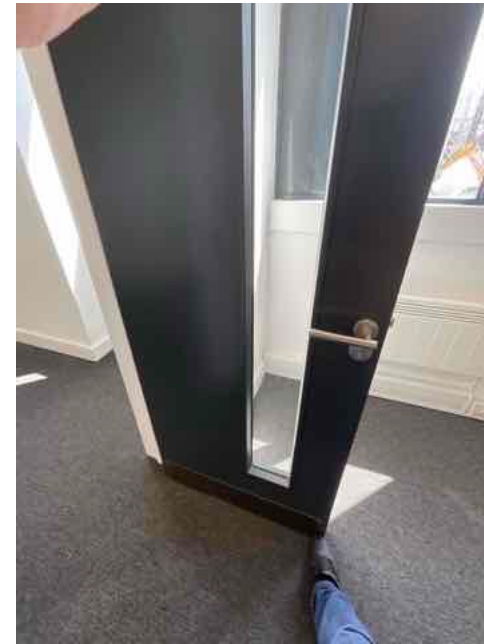
**Photo 77**

1st Floor Office Central  
Doors

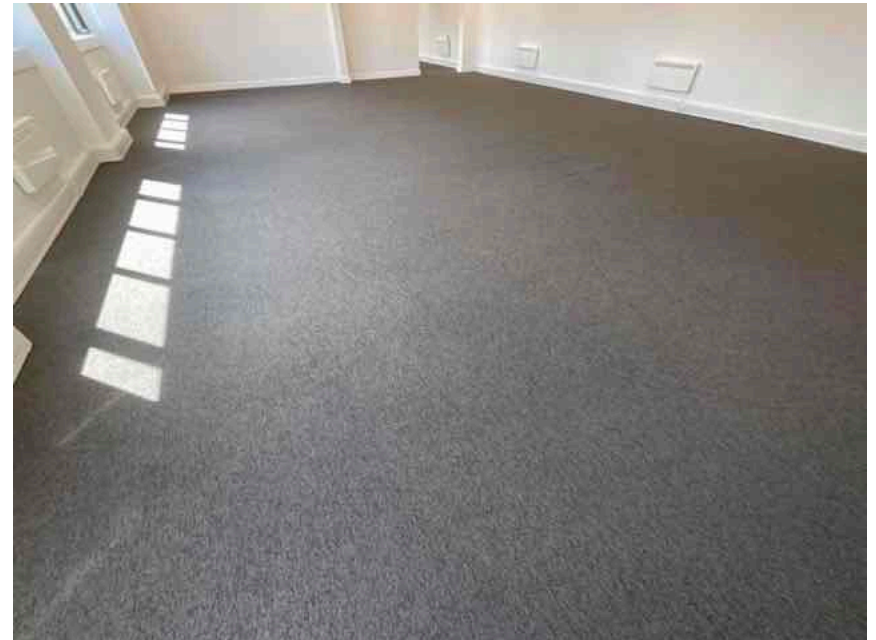
**Photo 79**

1st Floor Office Central  
Floor coverings

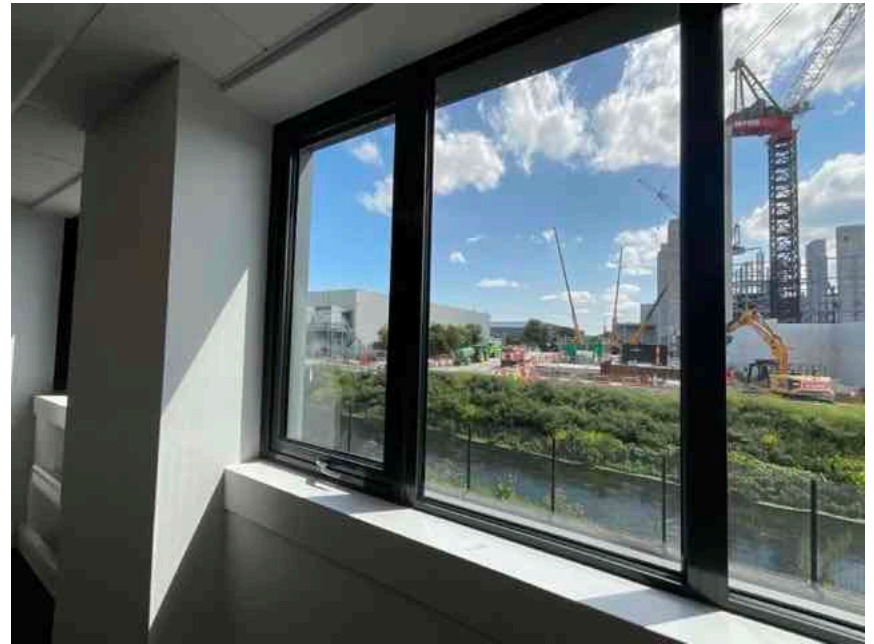
**Photo 81**

1st Floor Office Central  
Windows

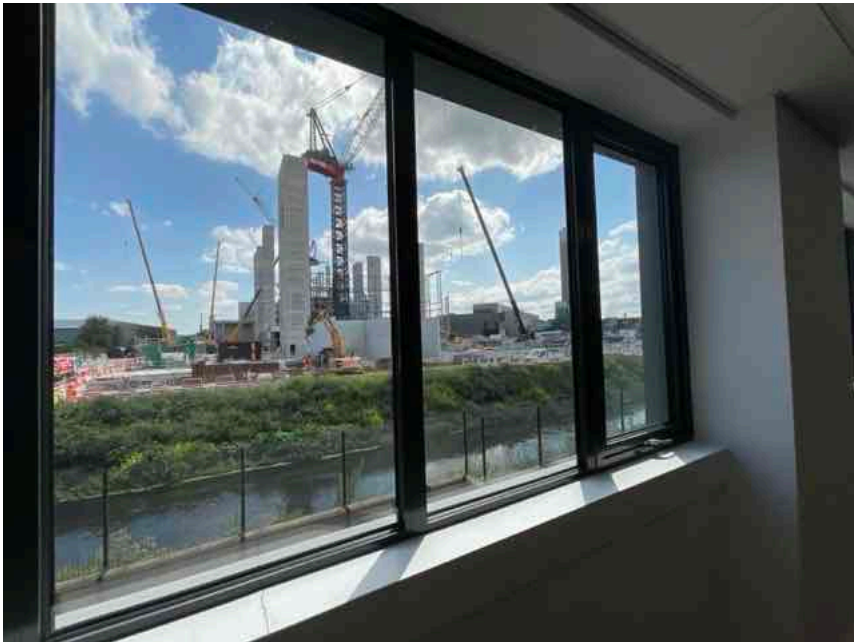
**Photo 82**

1st Floor Office Central  
Windows

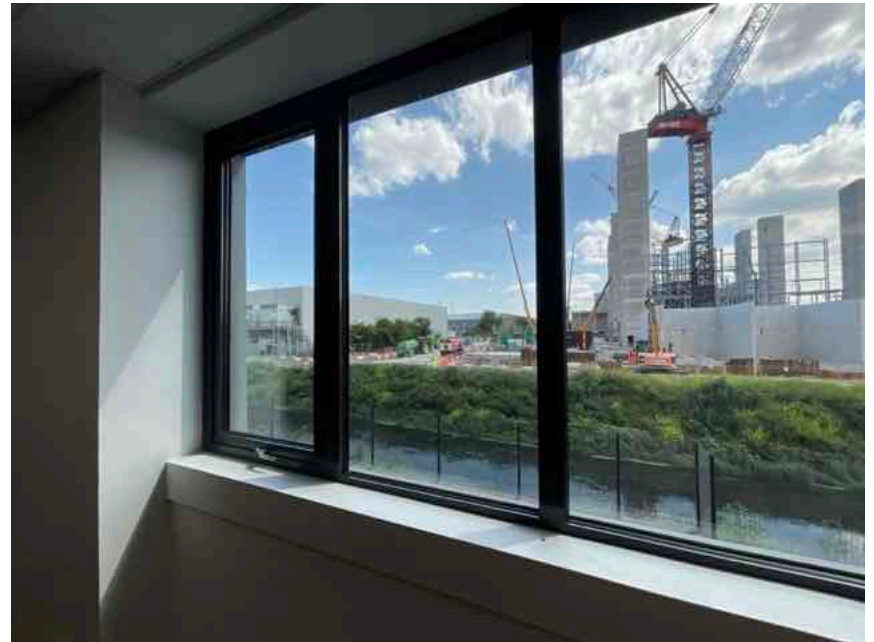
**Photo 83**

1st Floor Office Central  
Windows

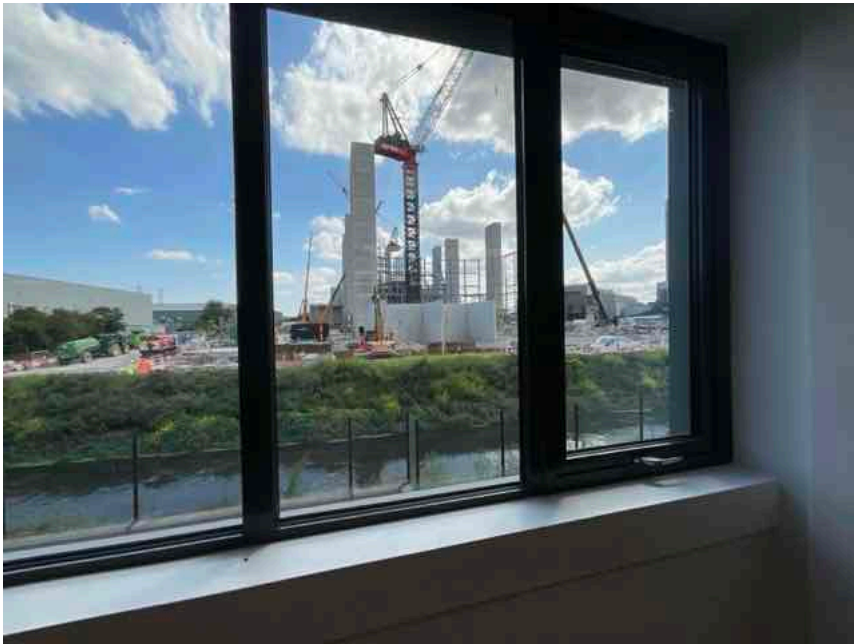
**Photo 84**

1st Floor Office Central  
Windows

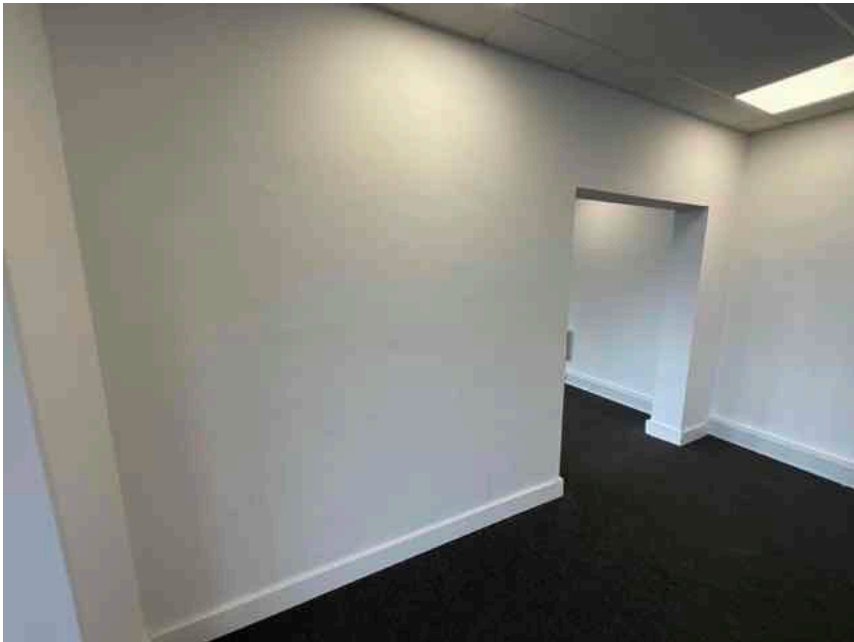
**Photo 86**

1st Floor Office Central  
Walls

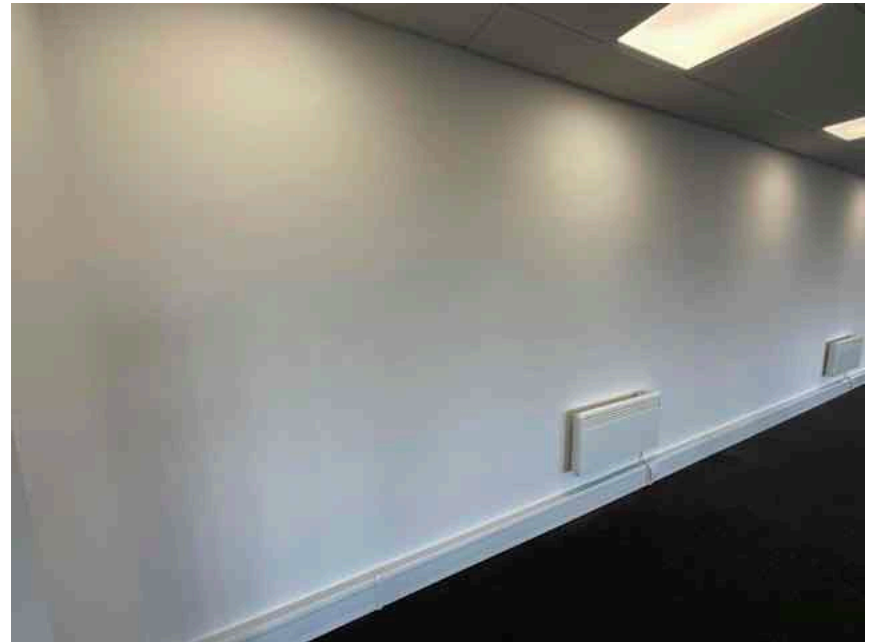
**Photo 87**

1st Floor Office Central  
Walls
