## Schedule of Condition

Date: 13<sup>th</sup> May 2025

## B Schedule of Condition Shop Floor

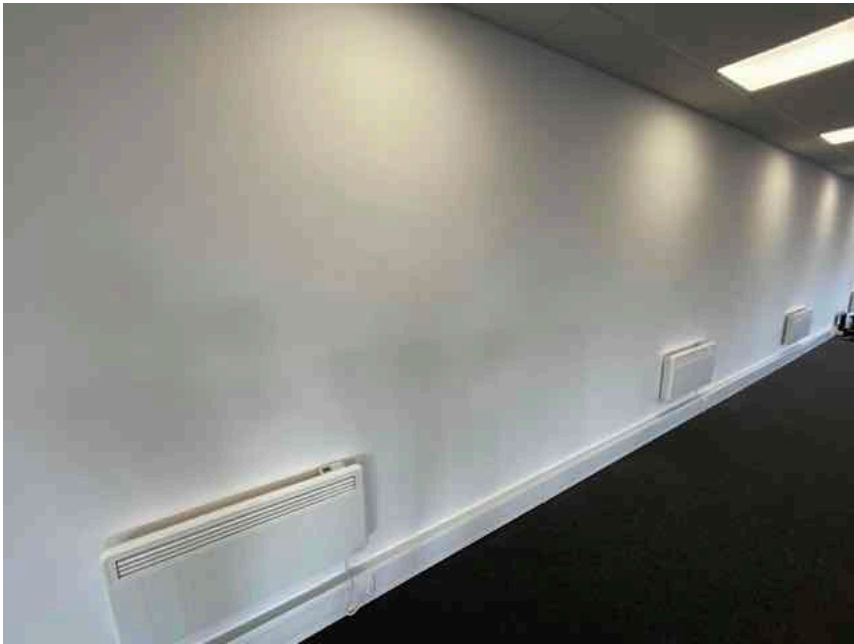
**Photo 88**

1st Floor Office Central  
Walls

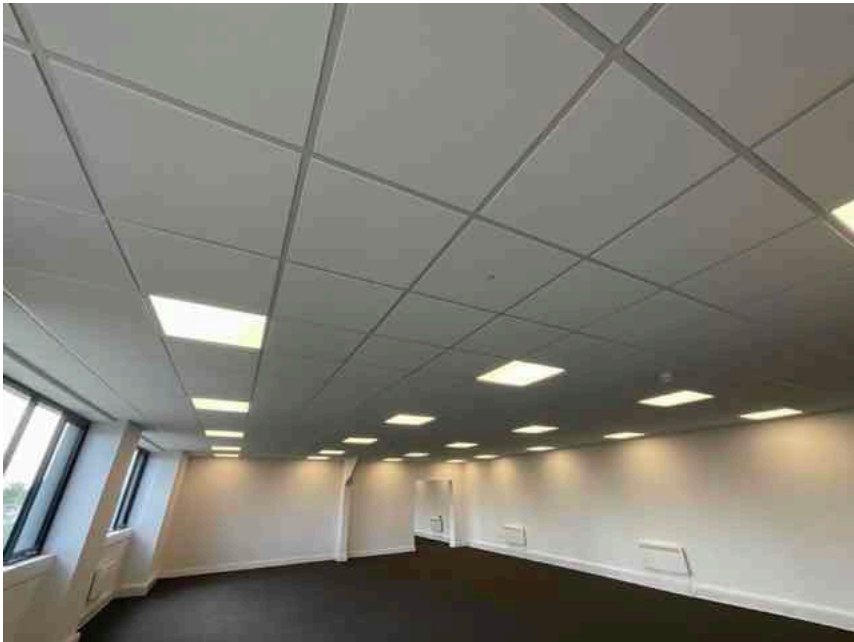
**Photo 90**

1st Floor Office Central  
Ceiling

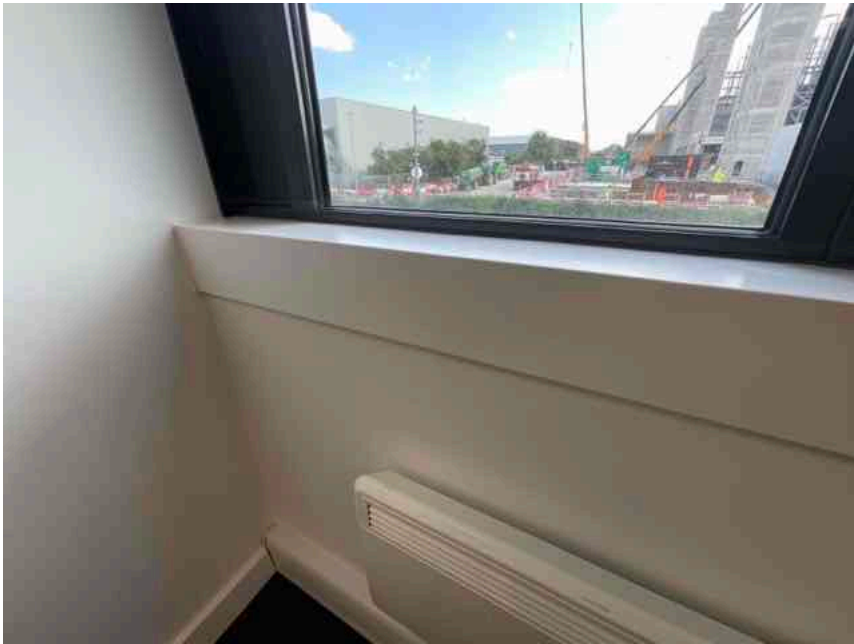
**Photo 92**

1st Floor Office Central  
Radiators

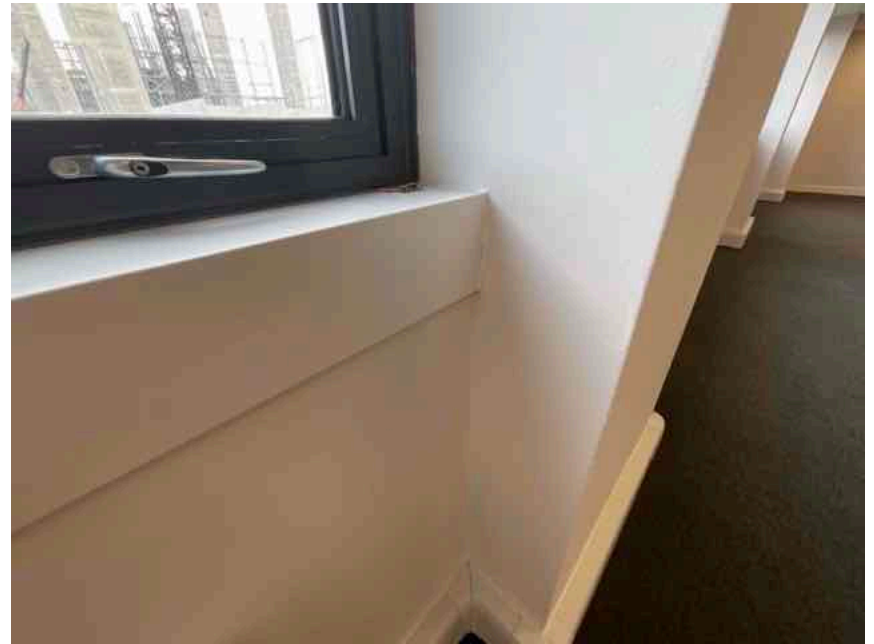
**Photo 93**

1st Floor Office Central  
Windowsills

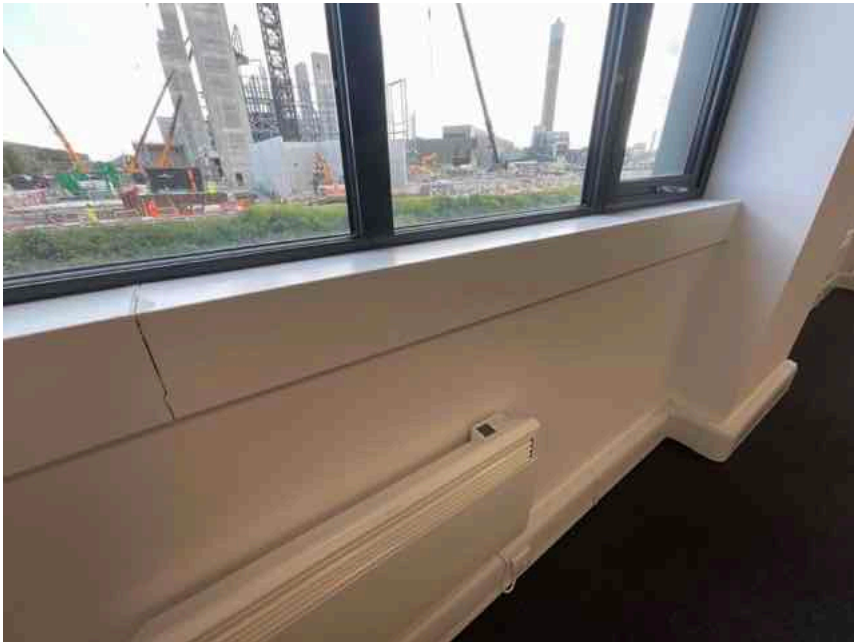
**Photo 94**

1st Floor Office Central  
Windowsills

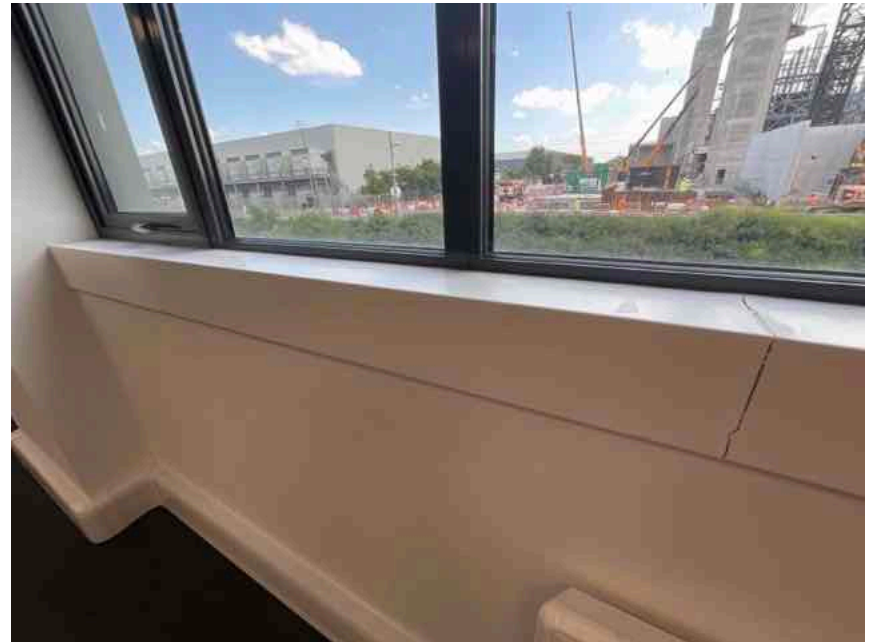
**Photo 95**

1st Floor Office Central  
Windowsills

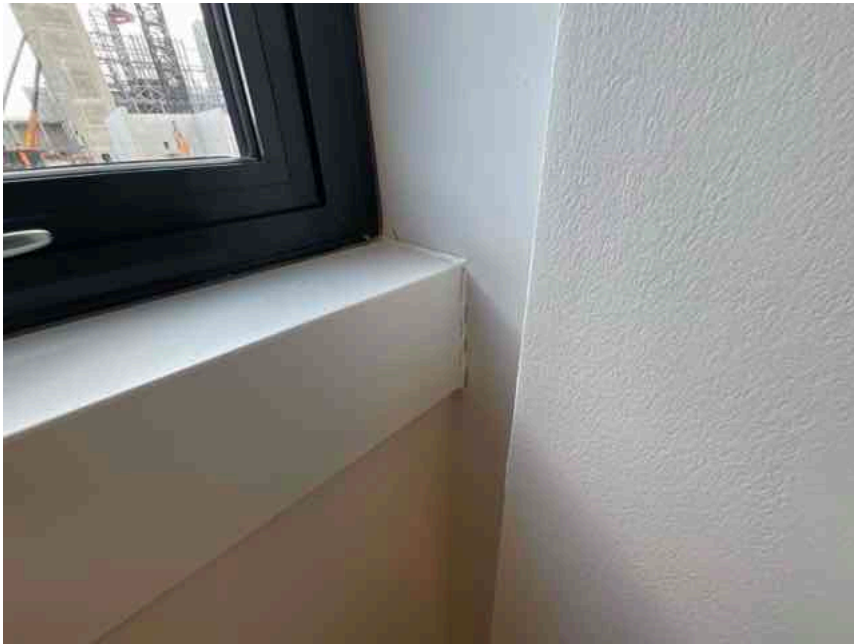
**Photo 96**

1st Floor Office Central  
Windowsills

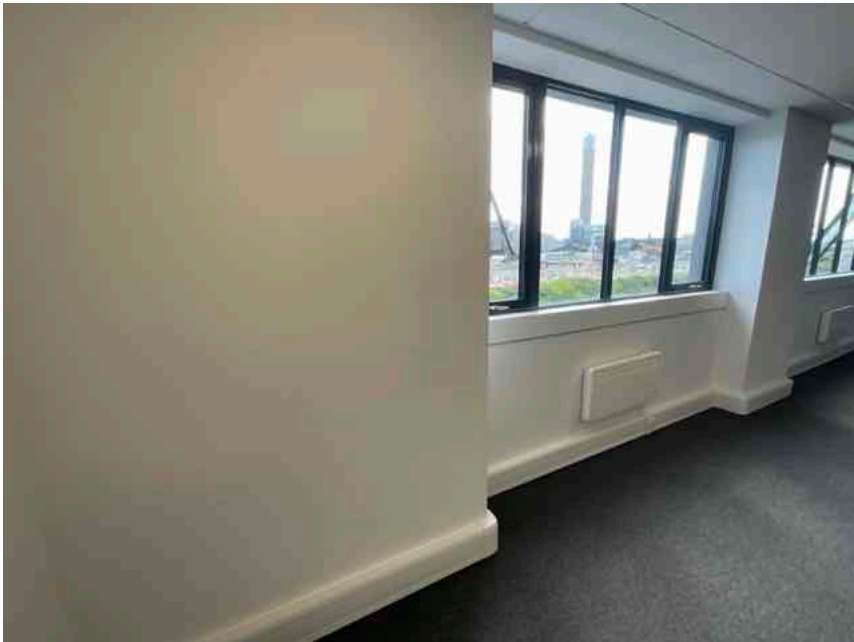
**Photo 98**

1st Floor Office South  
Walls

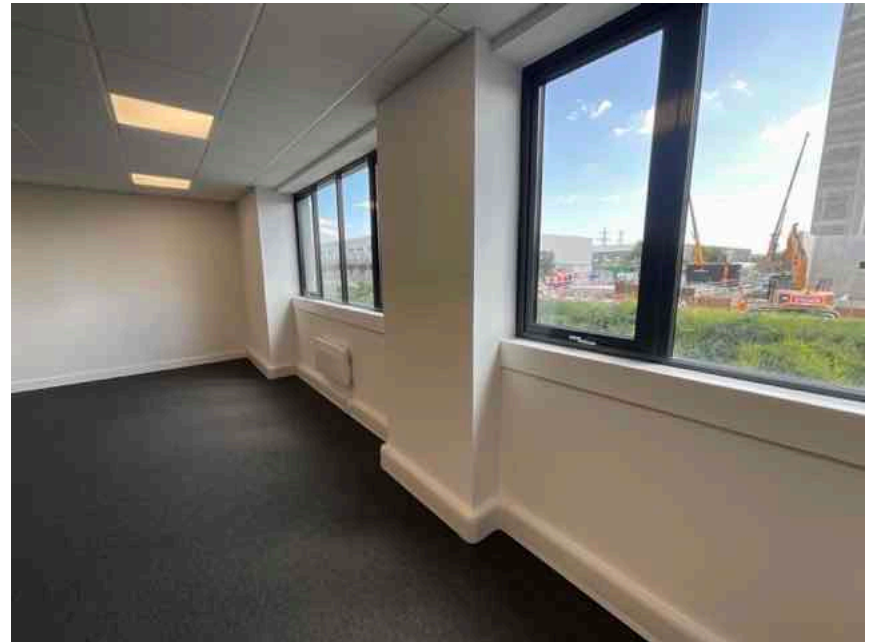
**Photo 99**

1st Floor Office South  
Walls

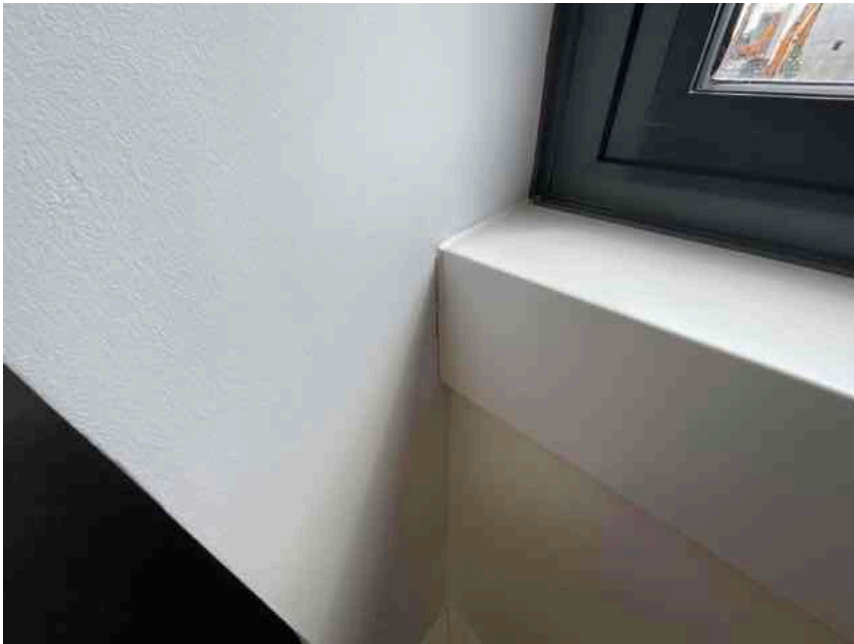
**Photo 100**

1st Floor Office South  
Walls

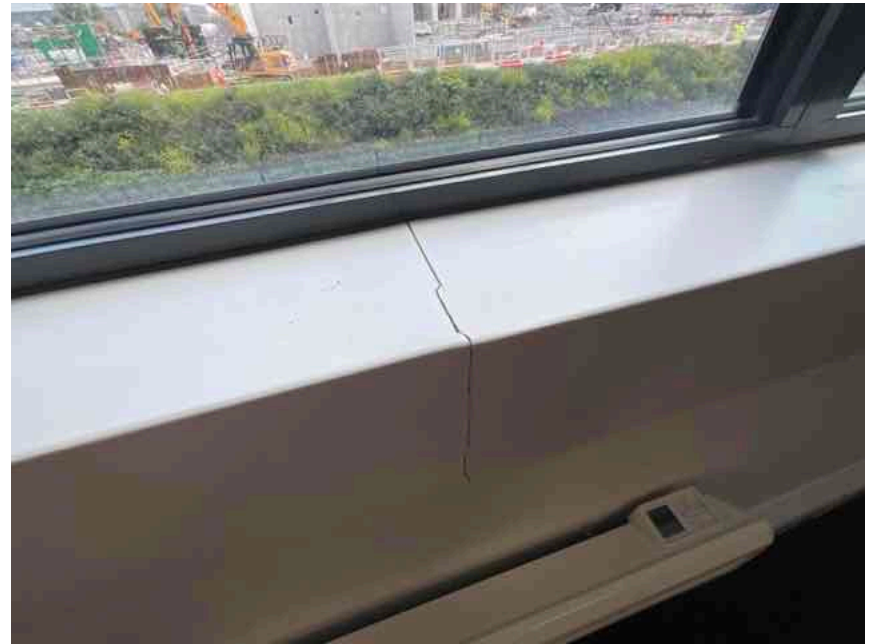
**Photo 101**

1st Floor Office South  
Walls

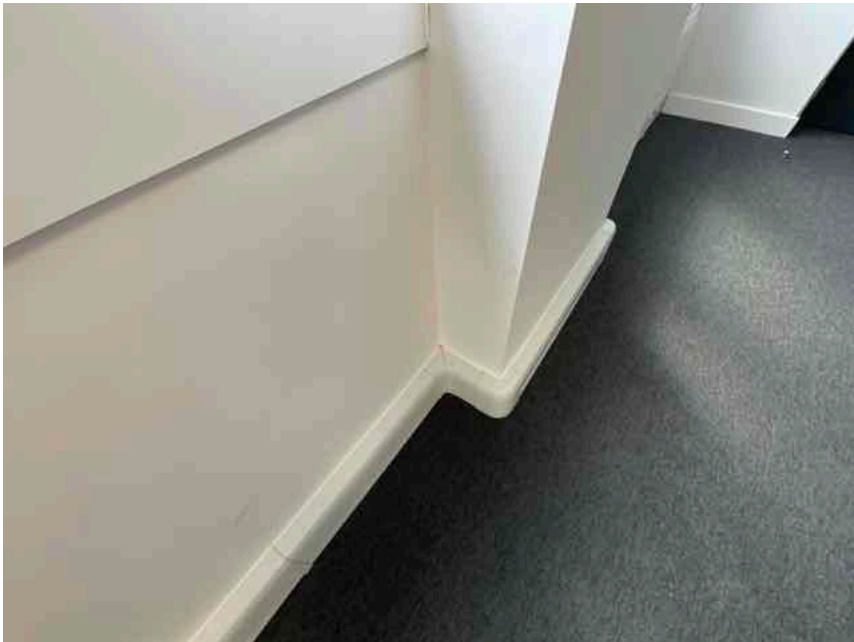
**Photo 102**

1st Floor Office South  
Walls

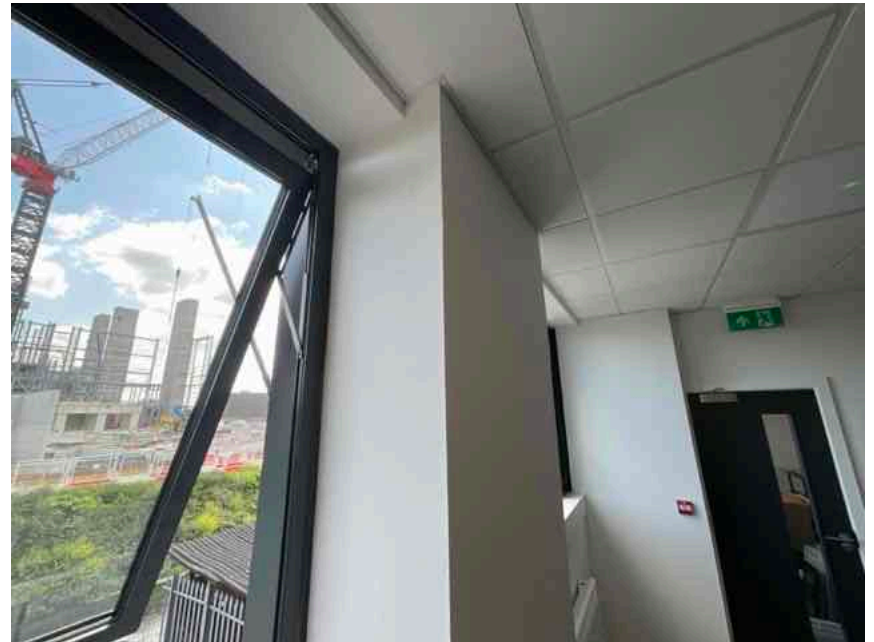
**Photo 103**

1st Floor Office South  
Walls

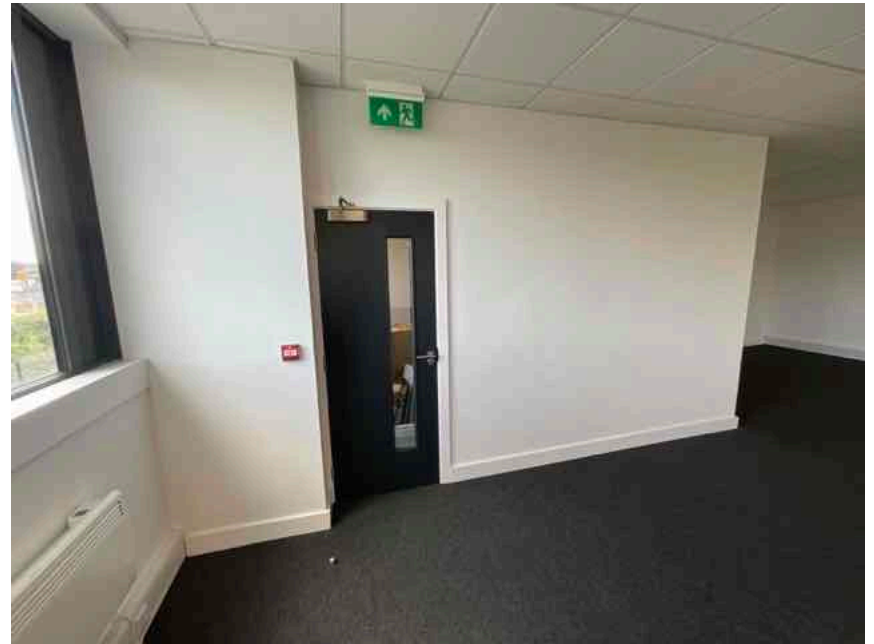
**Photo 105**

1st Floor Office South  
Walls

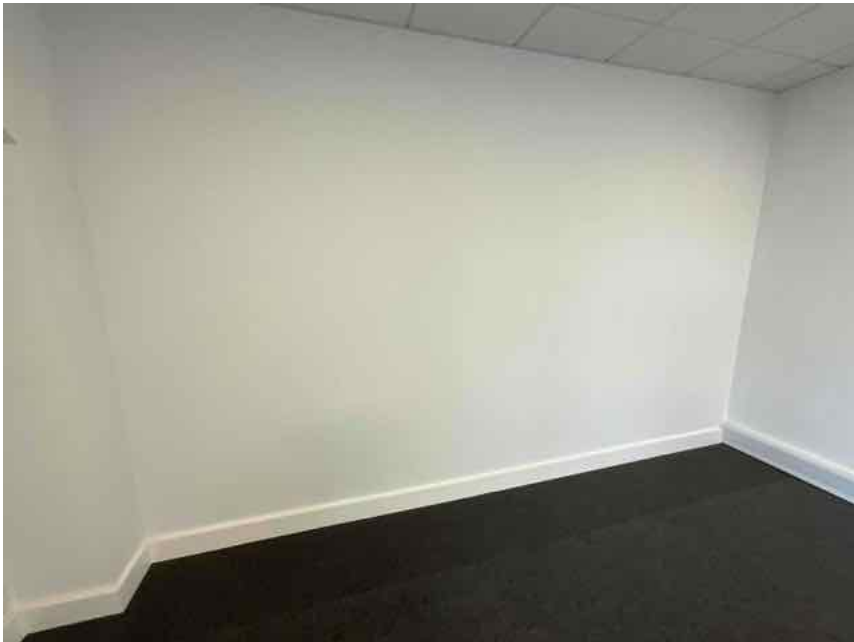
**Photo 106**

1st Floor Office South  
Walls

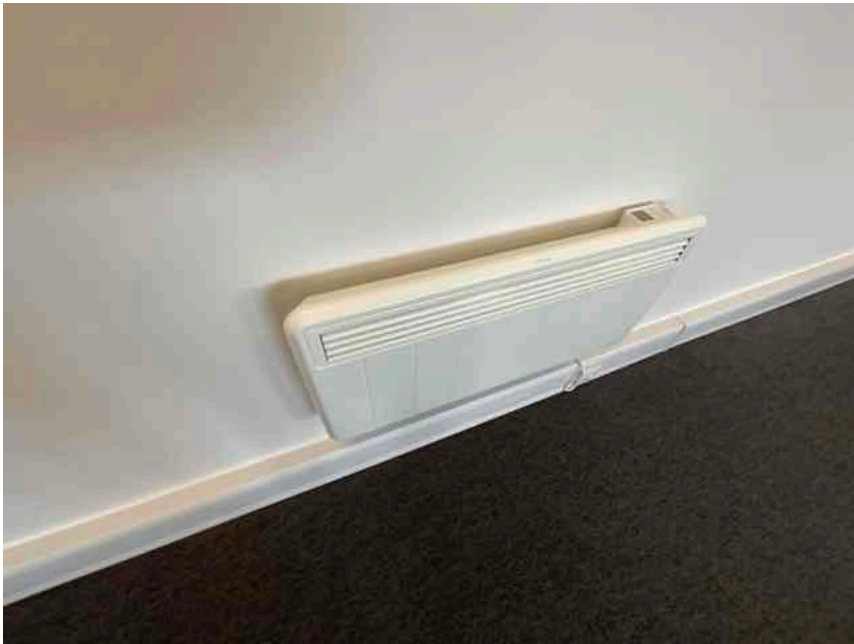
**Photo 108**

1st Floor Office South  
Walls

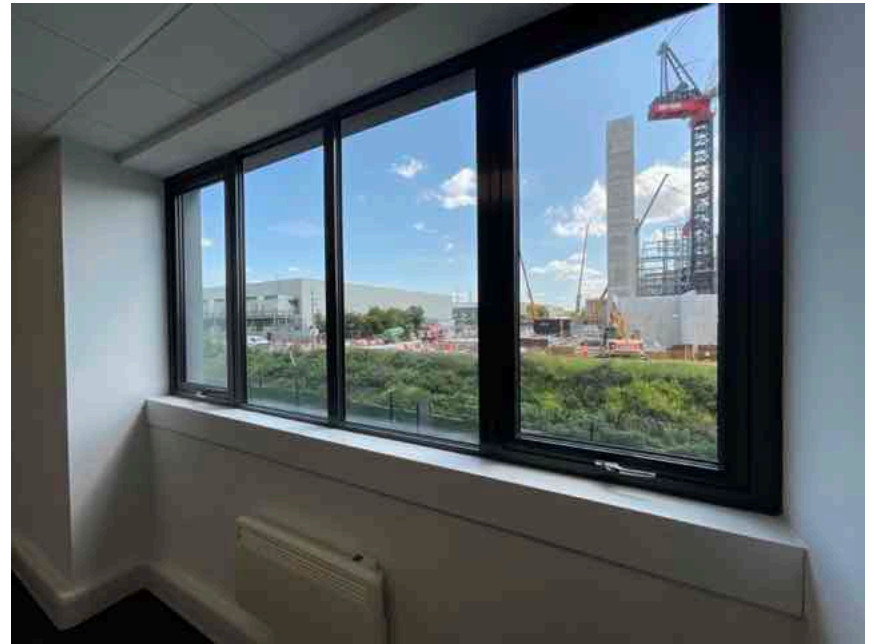
**Photo 109**

1st Floor Office South  
Radiators

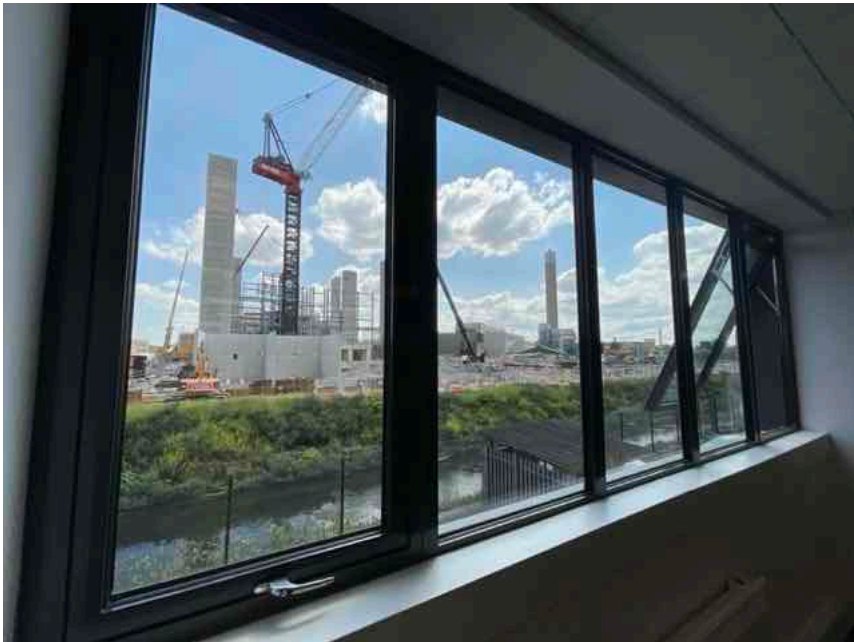
**Photo 110**

1st Floor Office South  
Windows

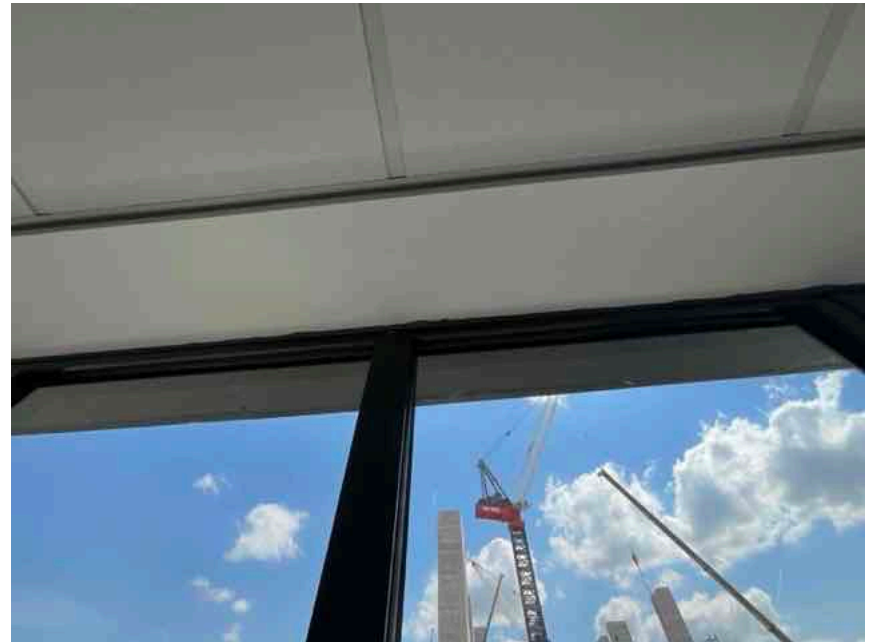
**Photo 111**

1st Floor Office South  
Windows

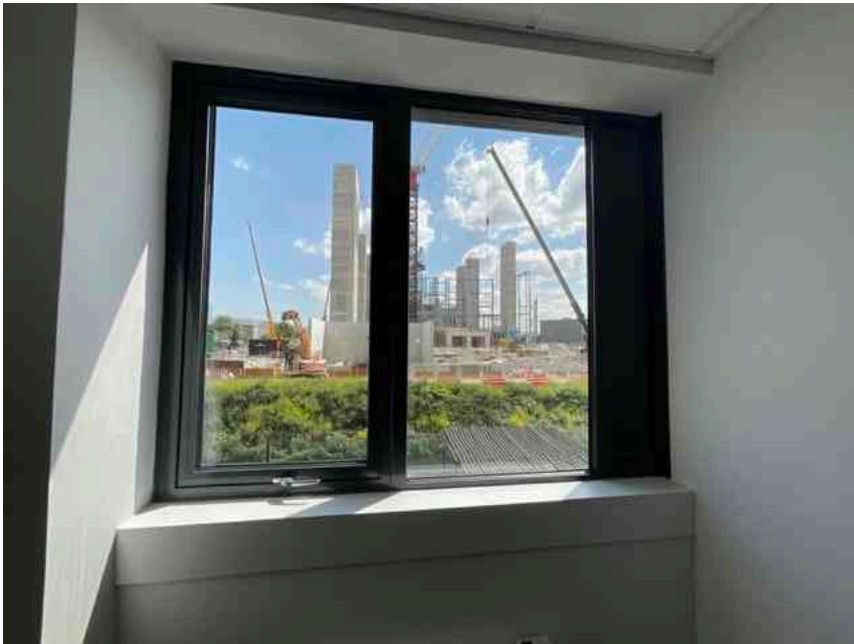
**Photo 112**

1st Floor Office South  
Windows

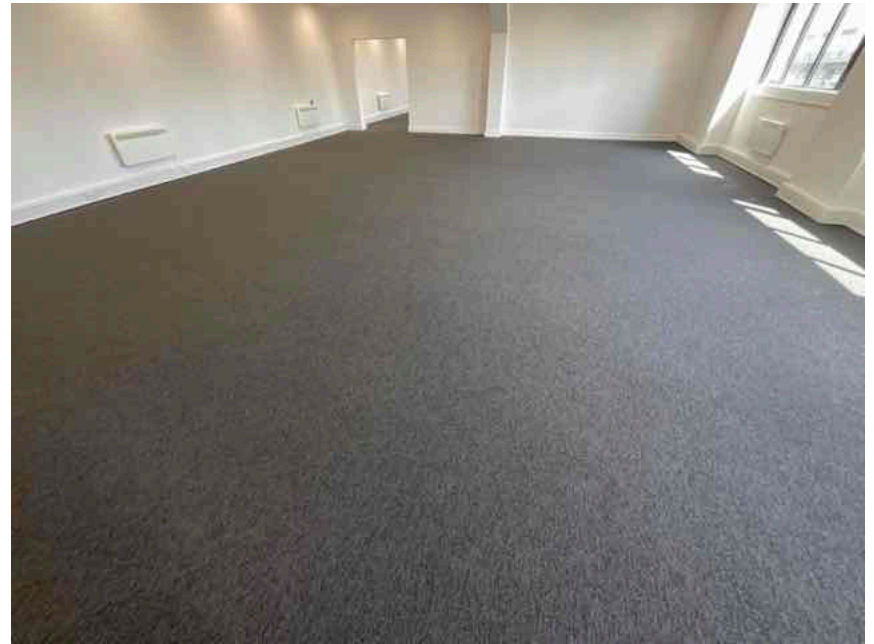
**Photo 113**

1st Floor Office South  
Windows

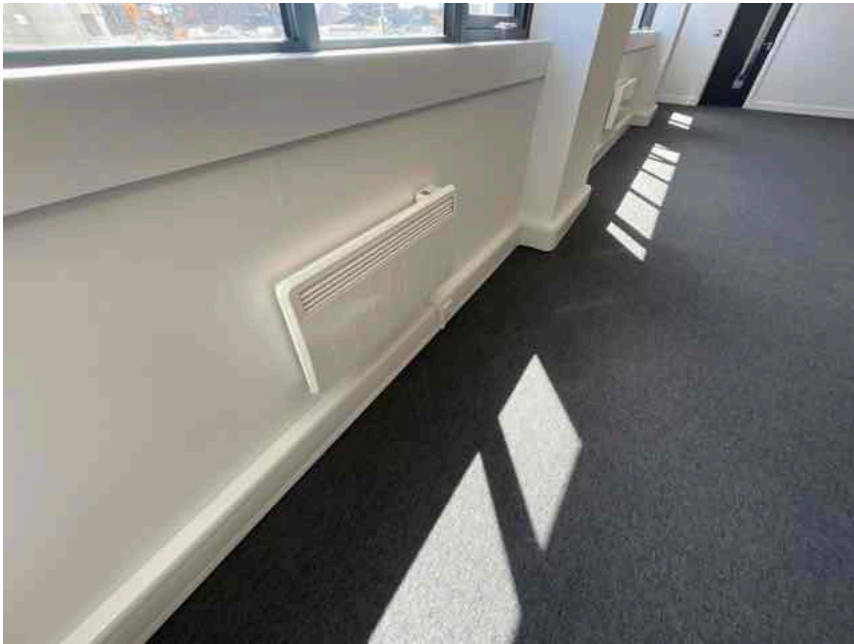
**Photo 116**

1st Floor Office South  
Electrical distribution trunk

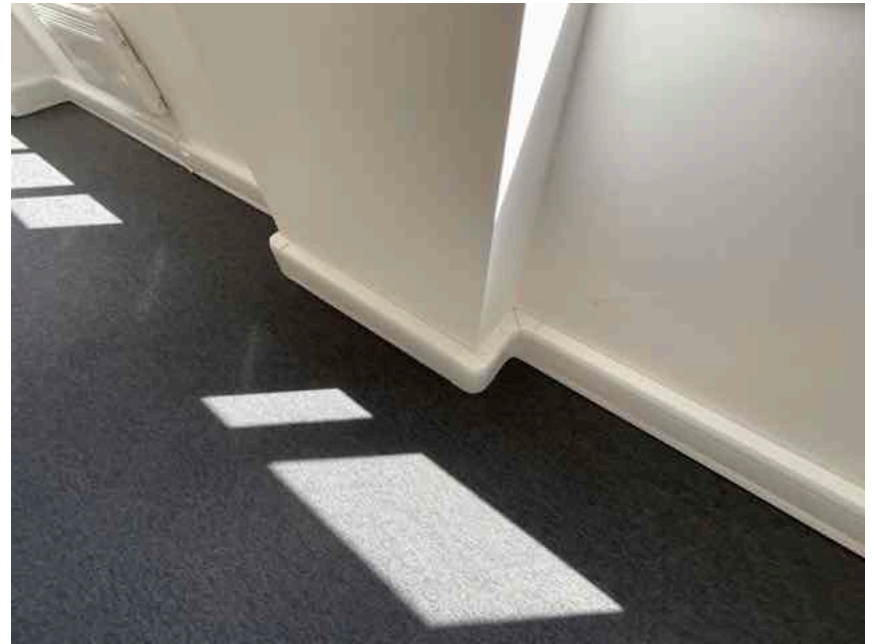
**Photo 117**

1st Floor Office South  
Electrical distribution trunki

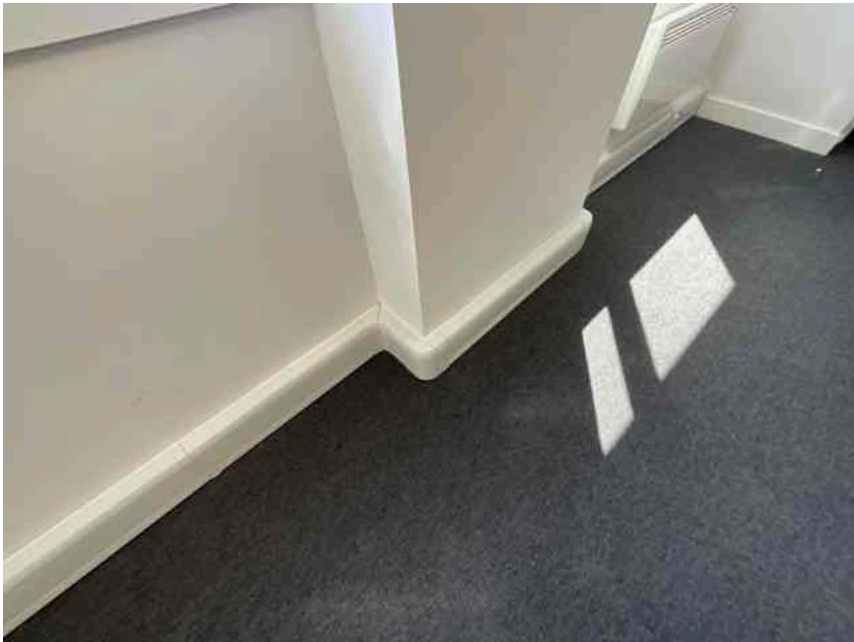
**Photo 118**

1st Floor Office South  
Electrical distribution trunki

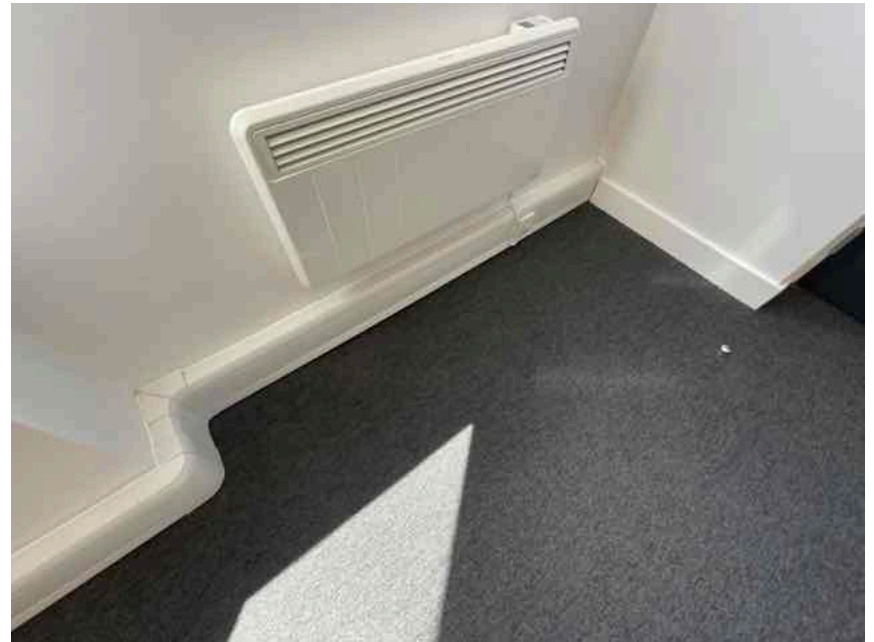
**Photo 119**

1st Floor Office South  
Electrical distribution trunki

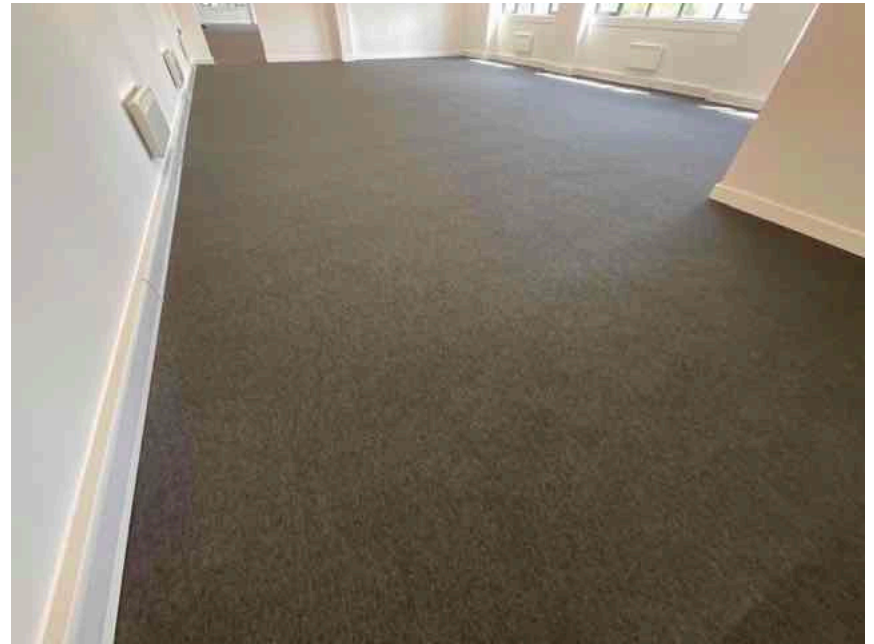
**Photo 121**

1st Floor Office South  
Electrical distribution trunk

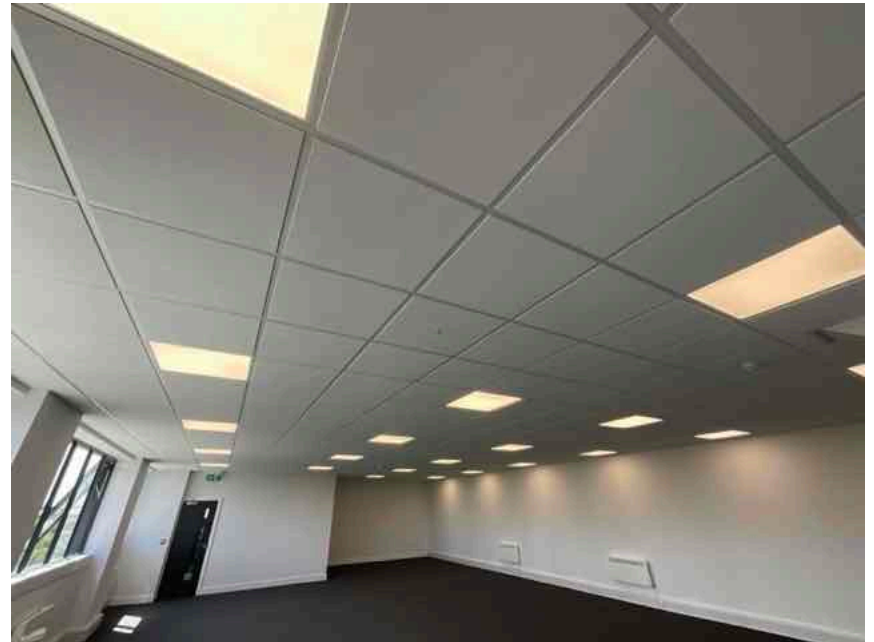
**Photo 123**

1st Floor Office South  
Ceiling

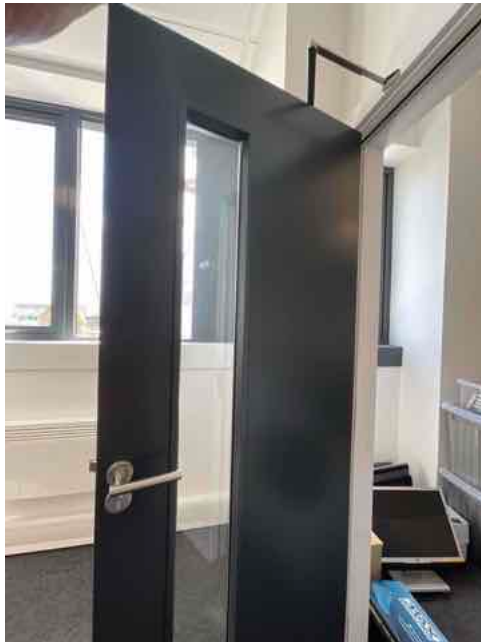
**Photo 126**

1st Floor Office South  
Doors

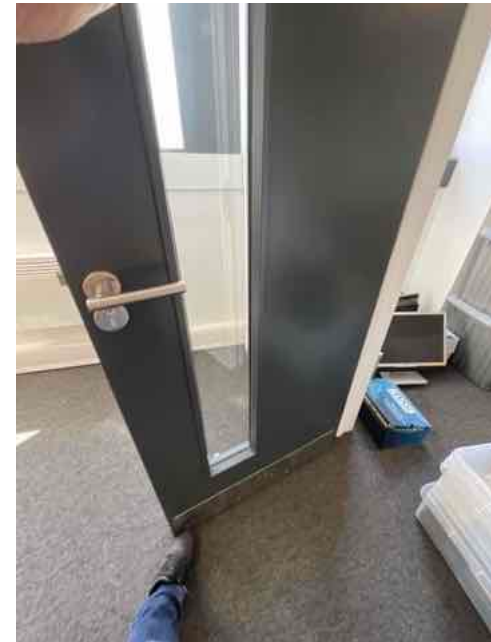
**Photo 127**

1st Floor Office South  
Doors

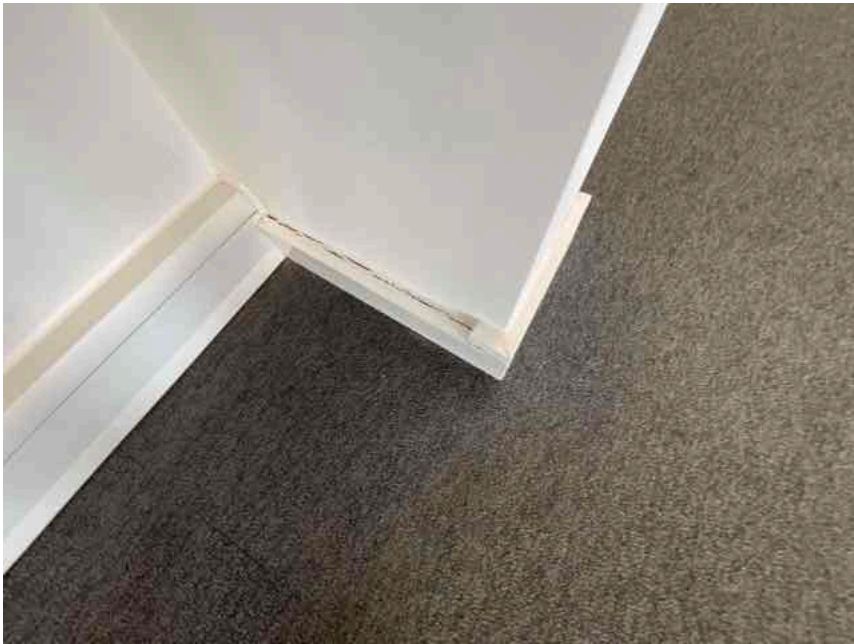
**Photo 128**

1st Floor Office South  
Doors

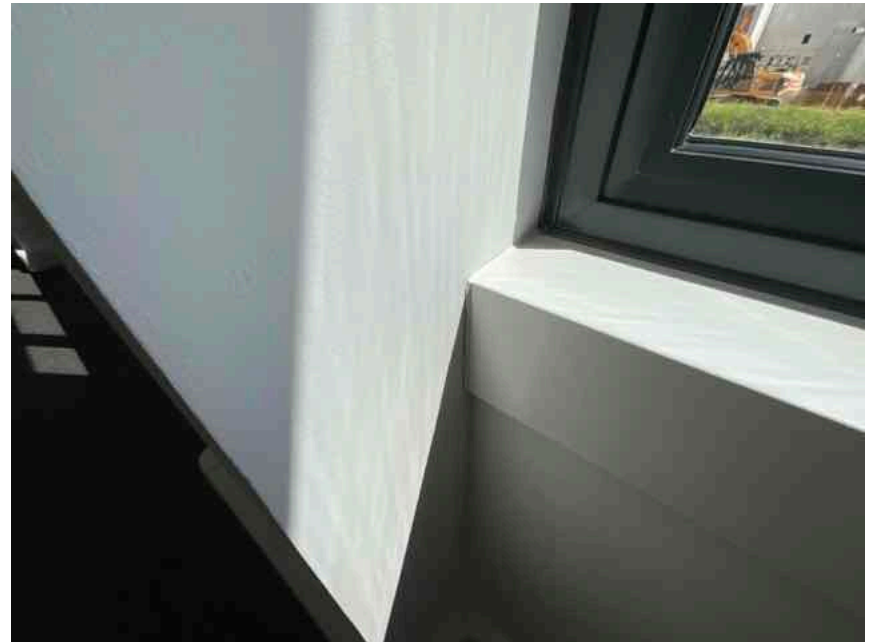
**Photo 131**

1st Floor Office South  
Windowsills

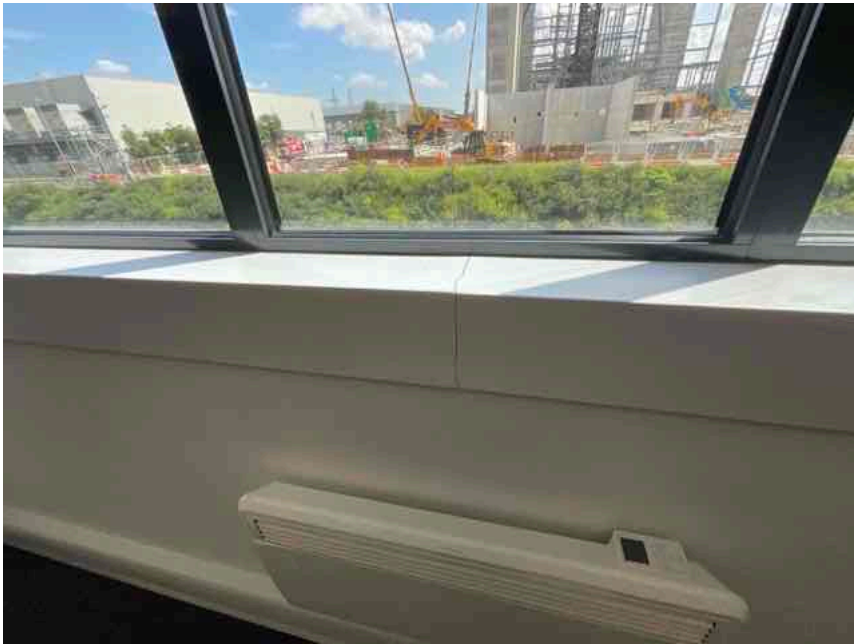
**Photo 132**

1st Floor Office South  
Windowsills

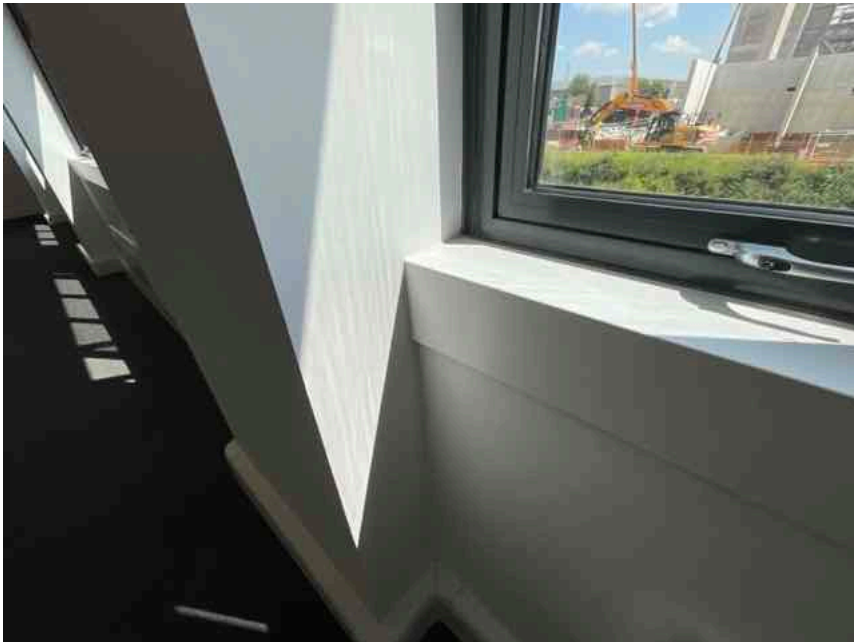
**Photo 134**

1st Floor Office South  
Windowsills

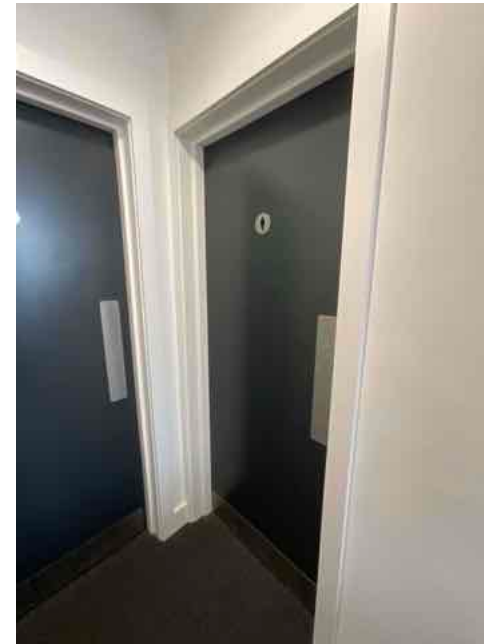
**Photo 137**

Lobby to WC  
Doors

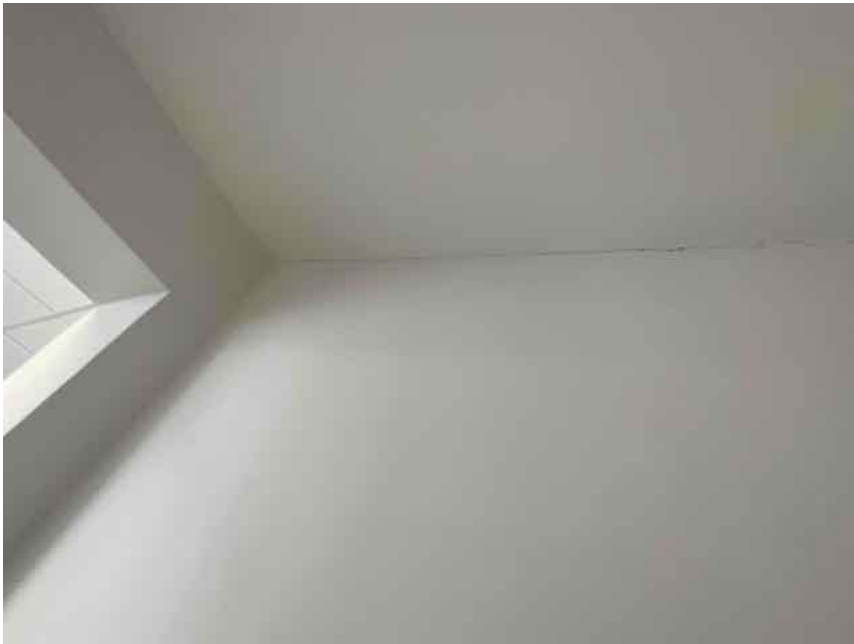
**Photo 140**

Lobby to WC  
Floor structure

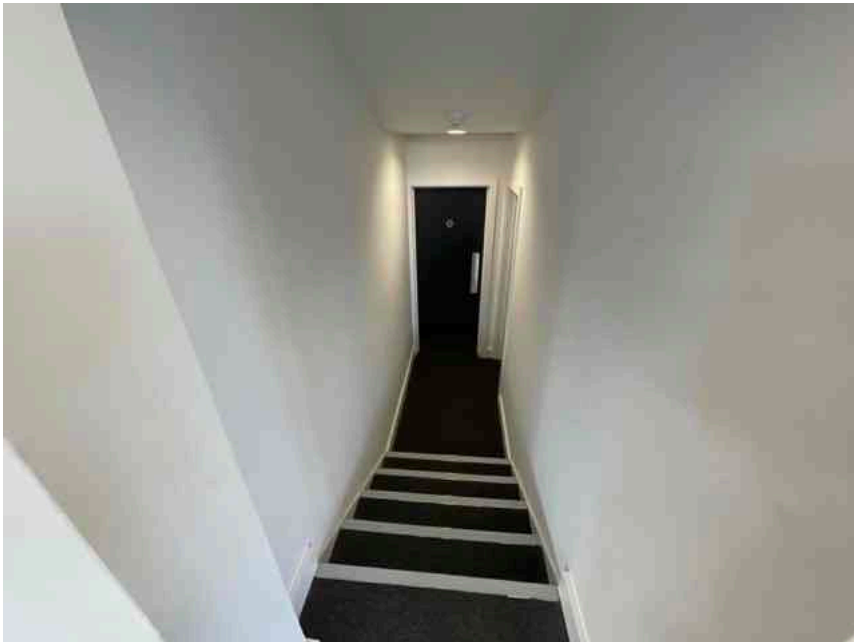
**Photo 142**

Lobby to WC  
Walls

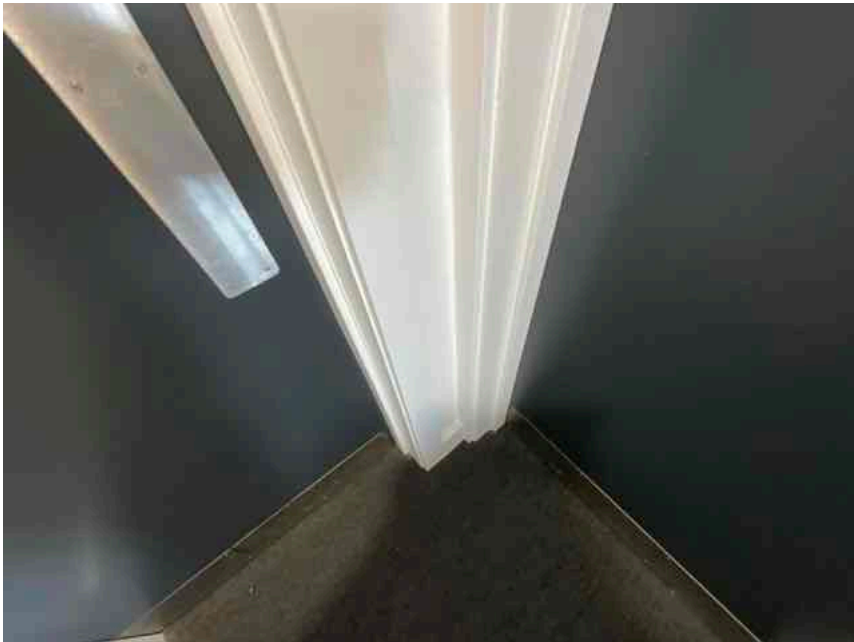
**Photo 146**

Lobby to WC  
Joinery

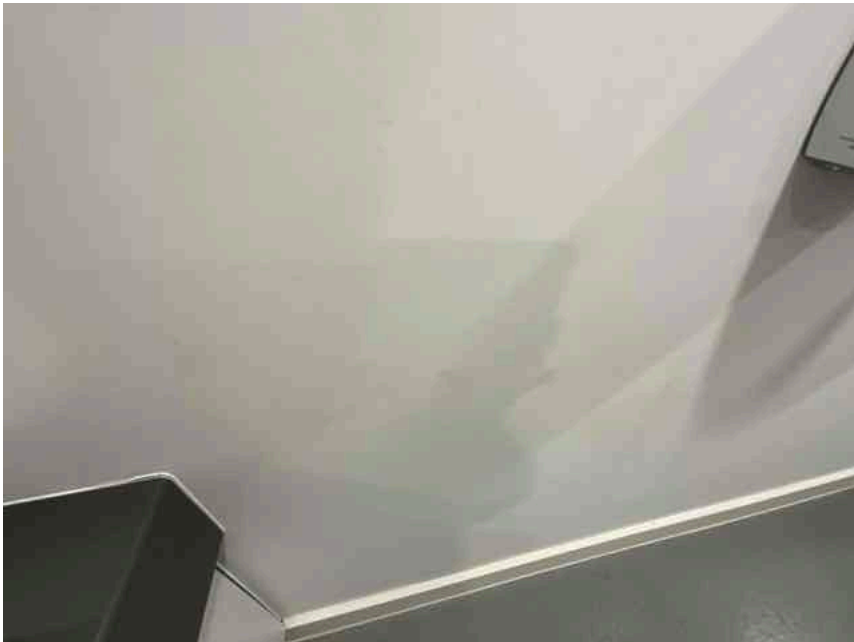
**Photo 150** MWC  
Ceiling

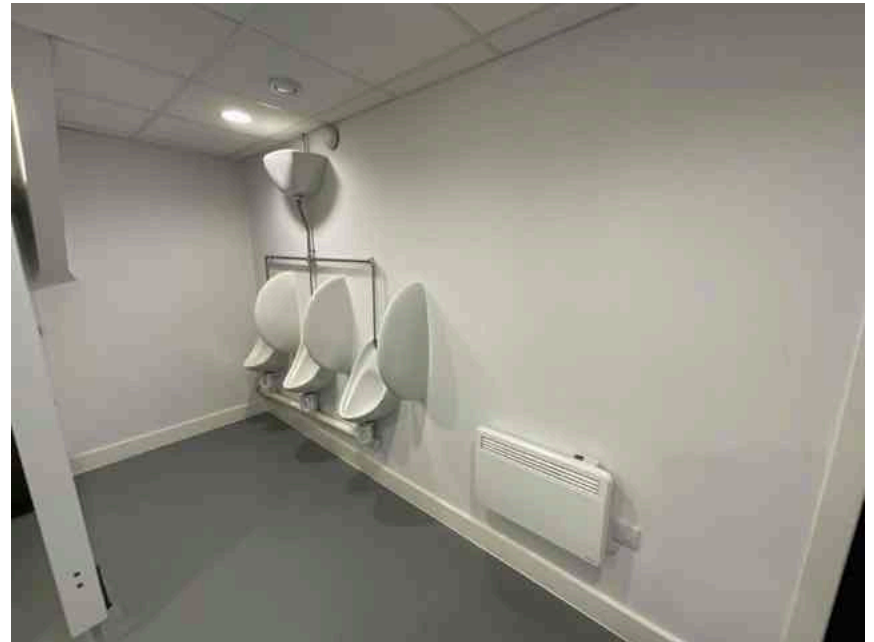
**Photo 151** MWC  
Walls

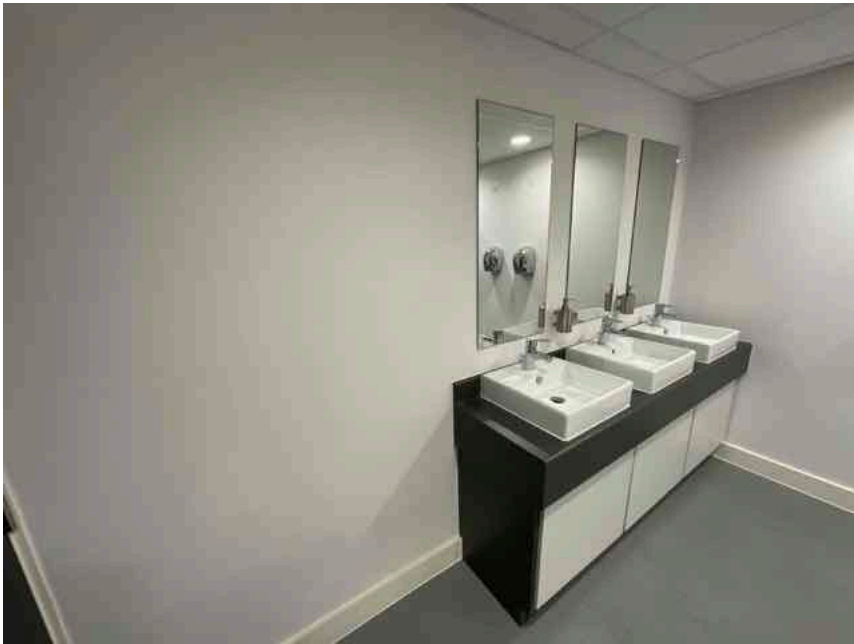
**Photo 152** MWC  
Walls

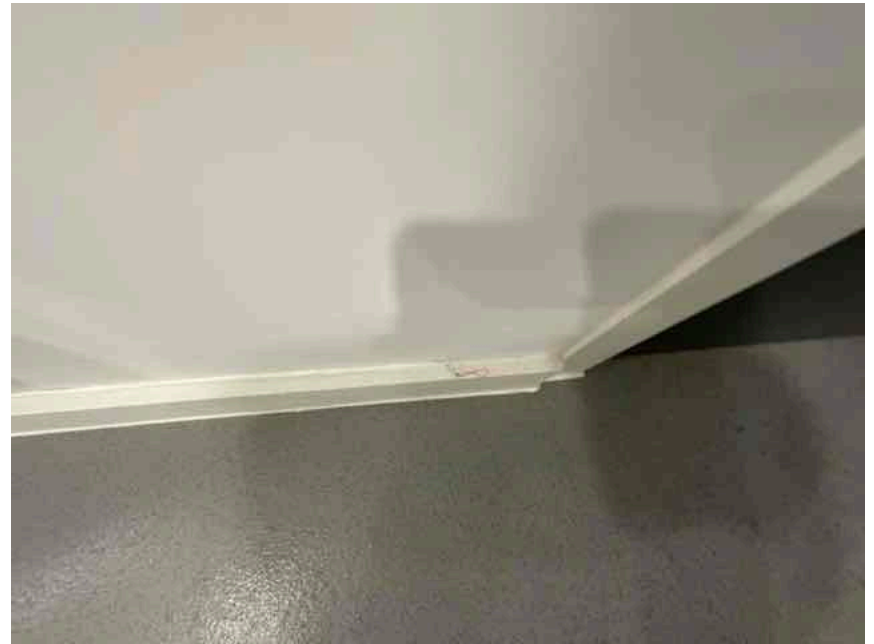
**Photo 153**

MWC  
Walls

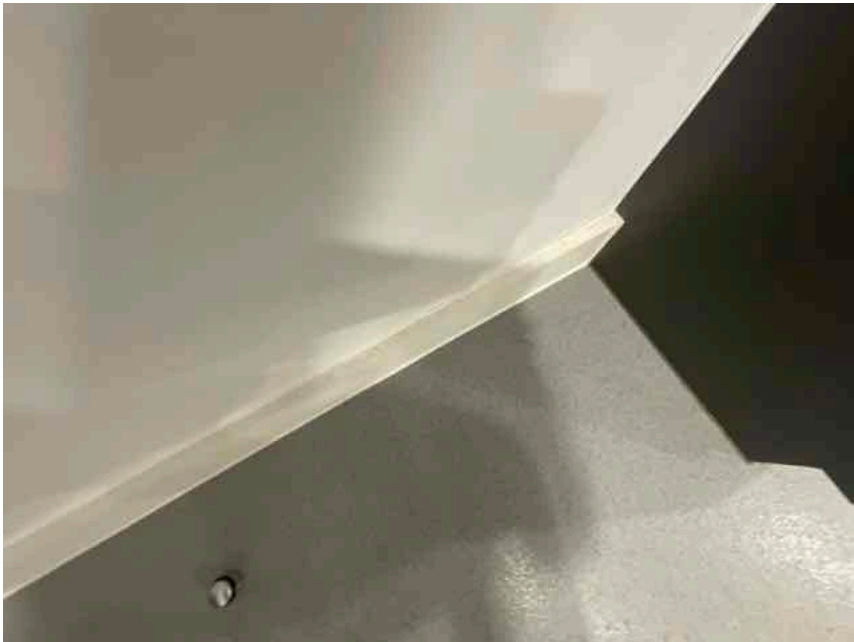
**Photo 154**

MWC  
Woodwork
