## Schedule of Condition

Date: 13<sup>th</sup> May 2025

## B Schedule of Condition Shop Floor

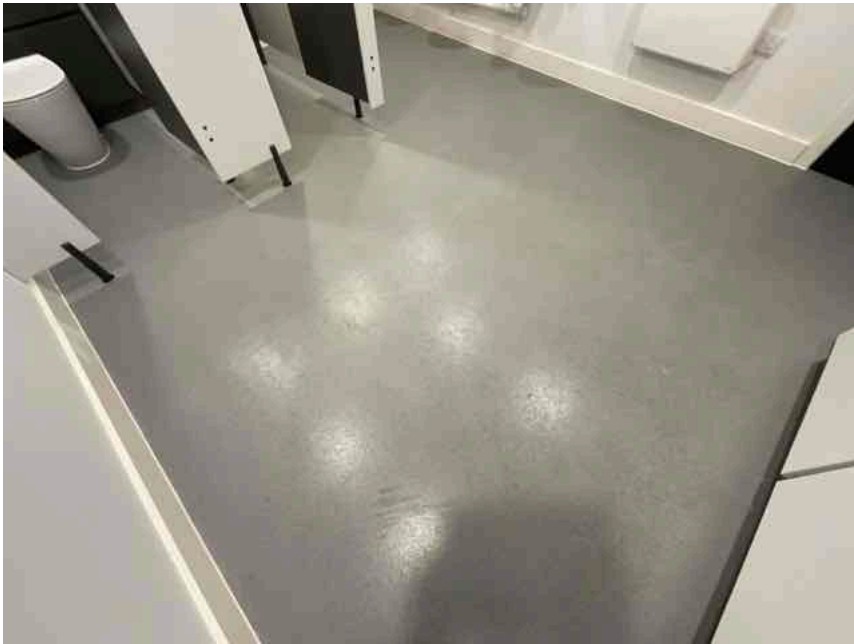
**Photo 156**

MWC  
Floor structure

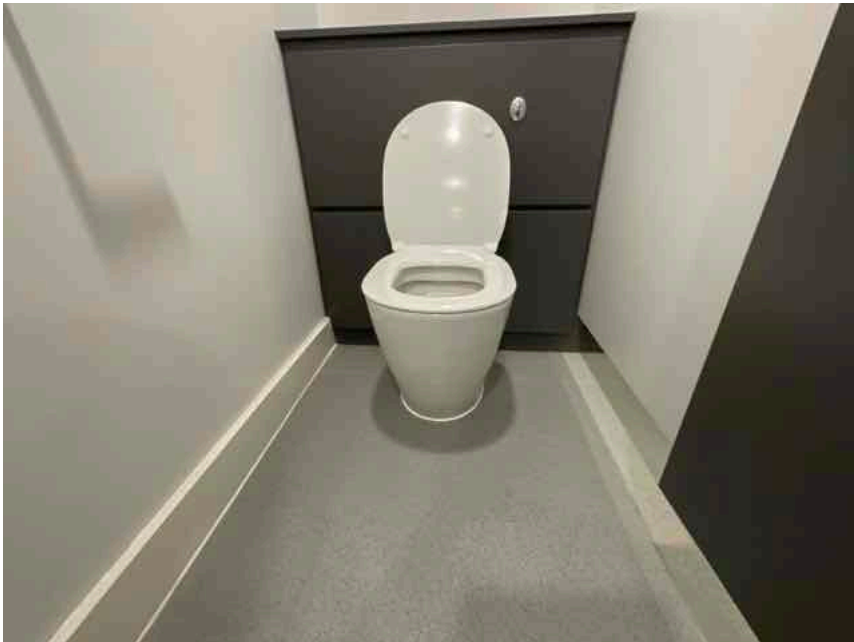
**Photo 158**

MWC  
Toilet

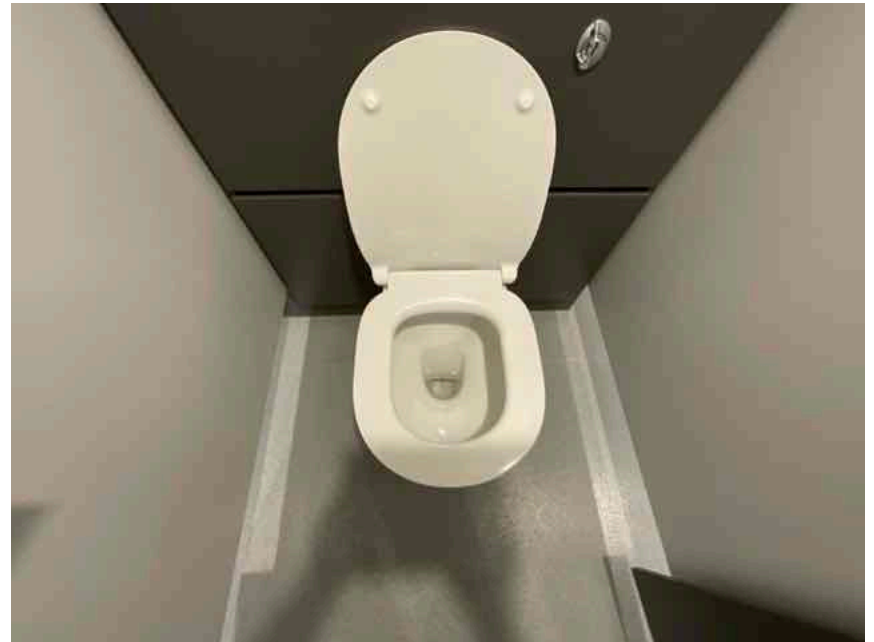
**Photo 159**

MWC  
Toilet

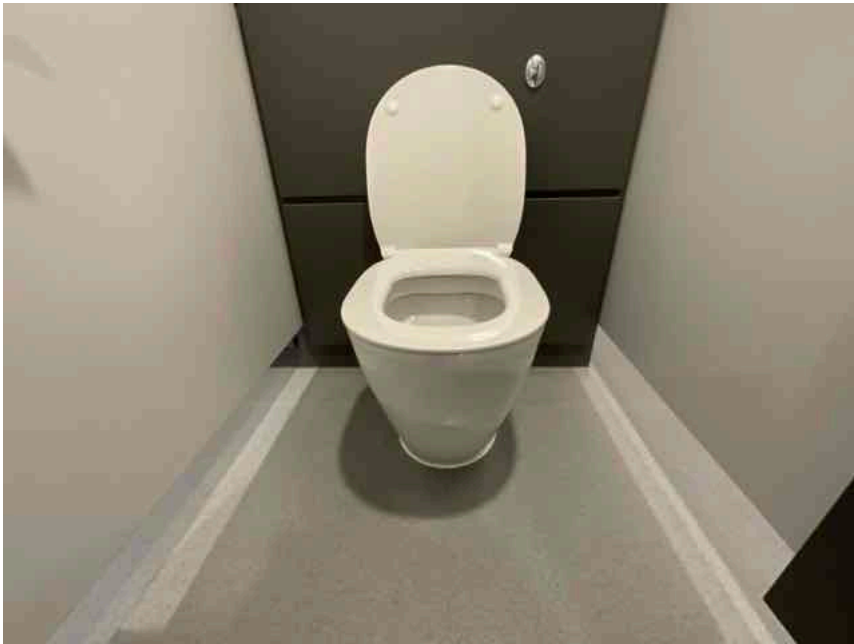
**Photo 160**

MWC  
Toilet

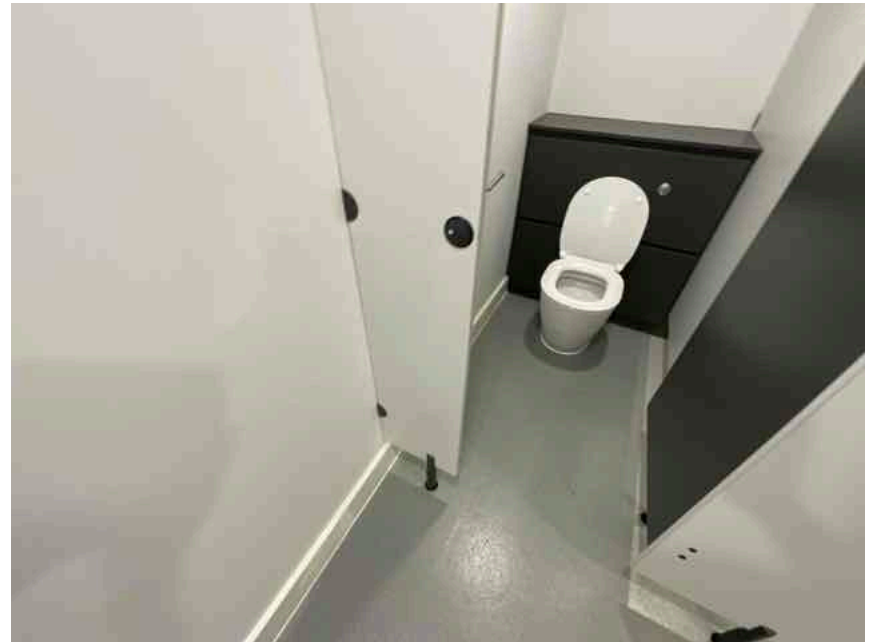
**Photo 163**

MWC  
IPS cubicles

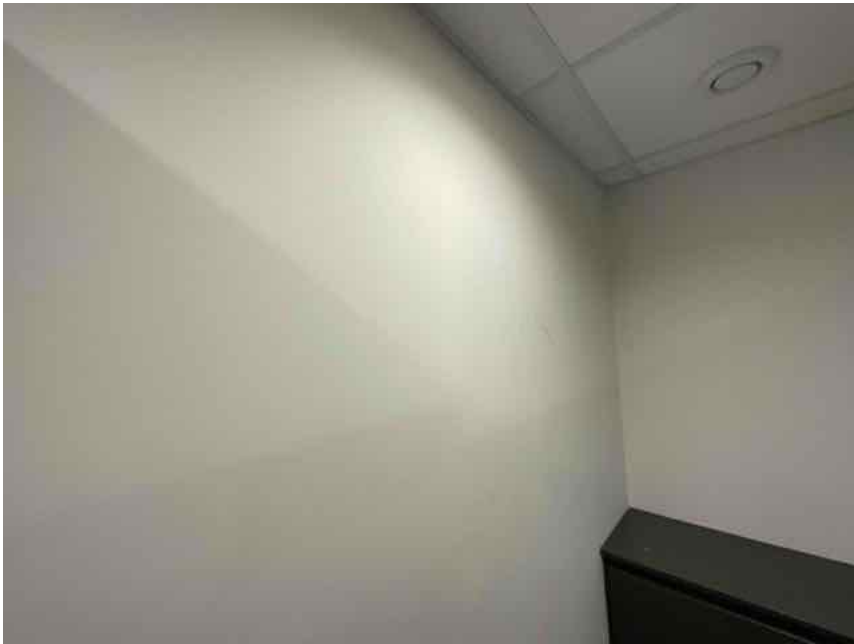
**Photo 164**

MWC  
IPS cubicles

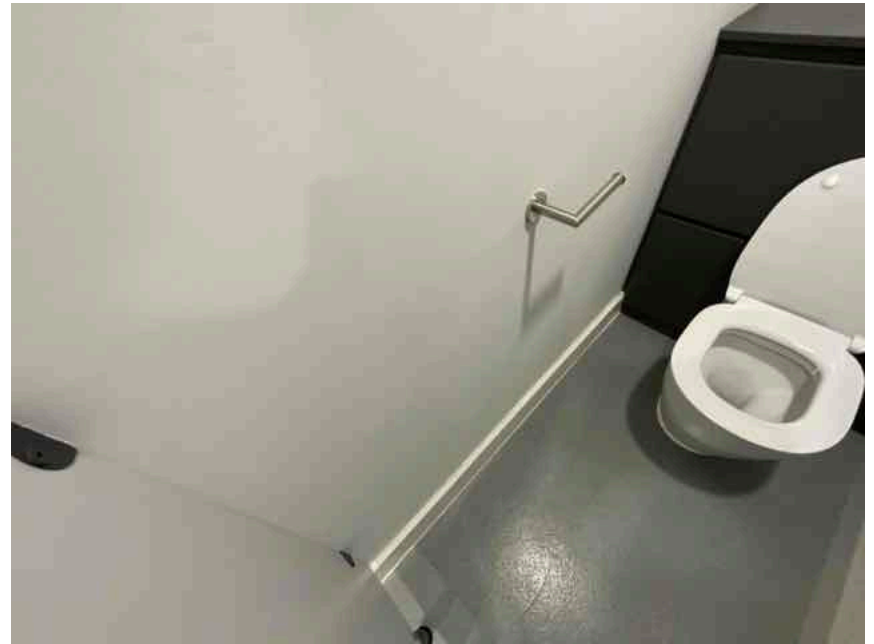
**Photo 165** MWC  
IPS cubicles

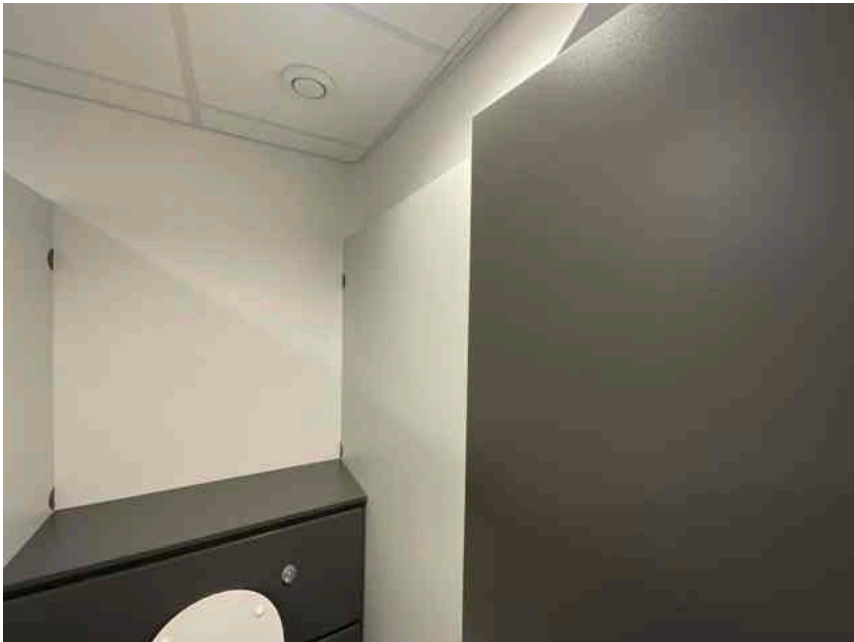
**Photo 166** MWC  
IPS cubicles

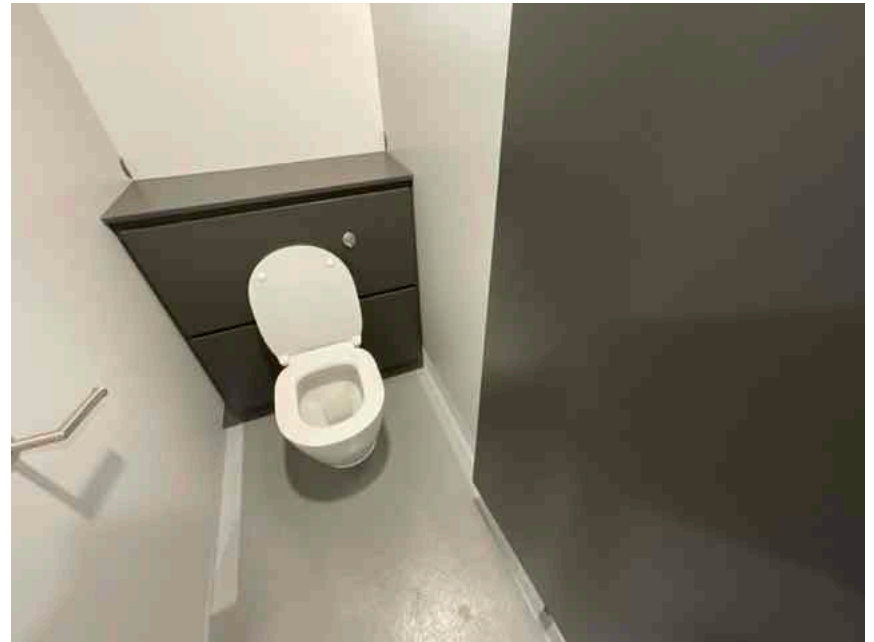
**Photo 167** MWC  
IPS cubicles

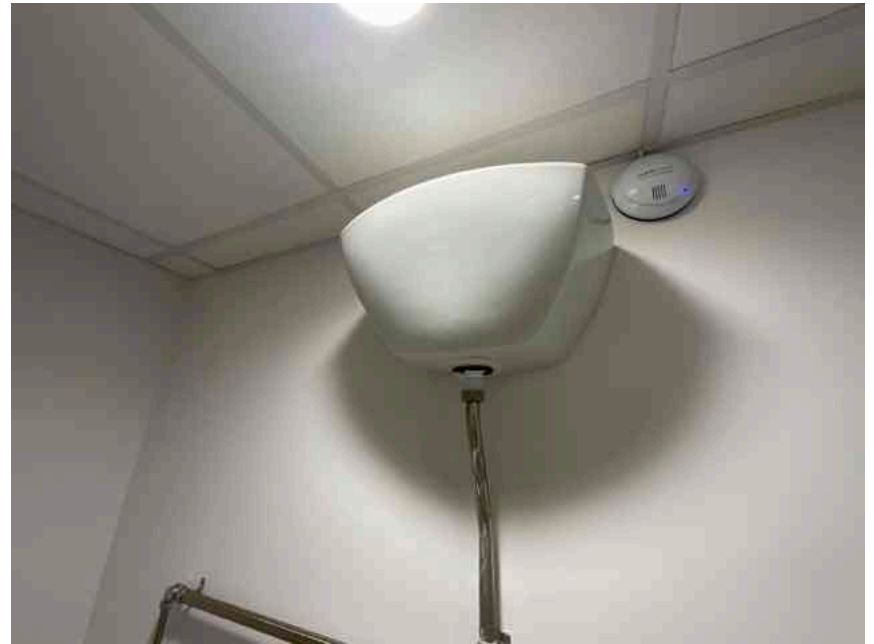
**Photo 169**

MWC  
Urinals

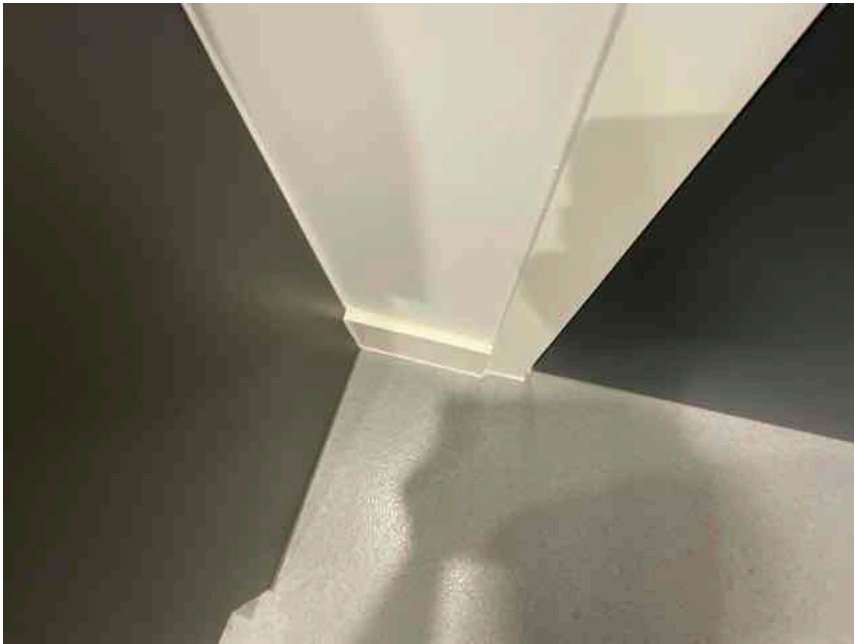
**Photo 172**

WWC  
Floor structure

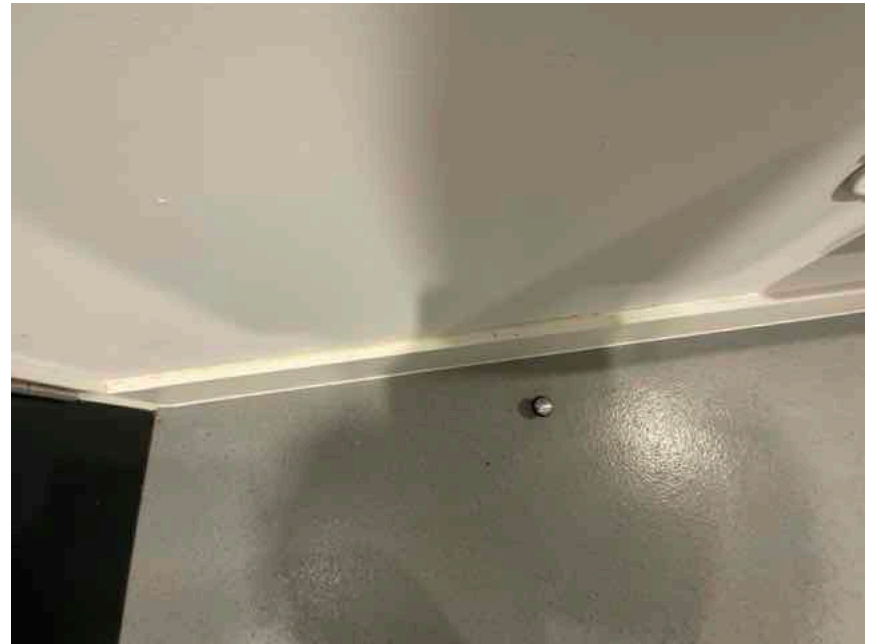
**Photo 173**

WWC  
Woodwork

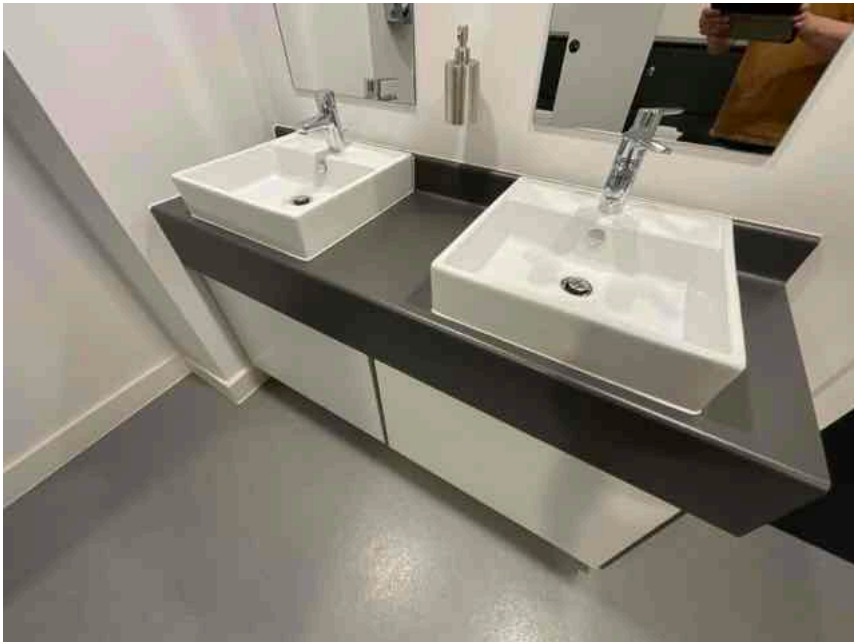
**Photo 174**

WWC  
Woodwork

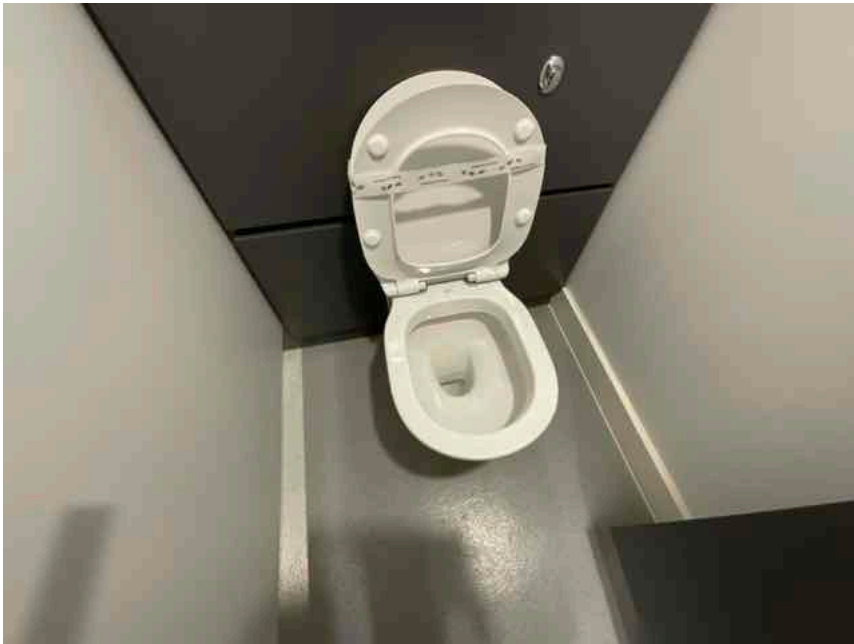
**Photo 176**

WWC  
Floor coverings

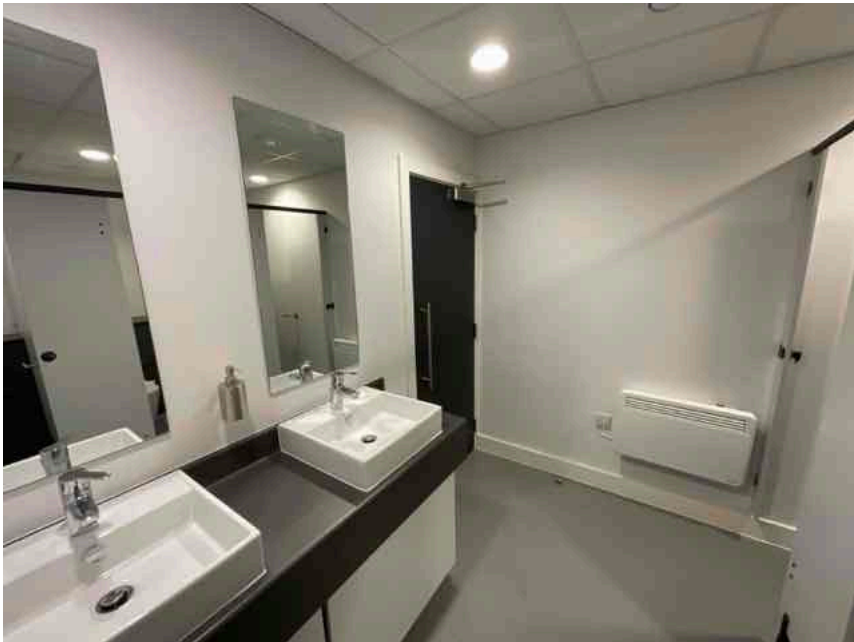
**Photo 178**

WWC  
Ceiling

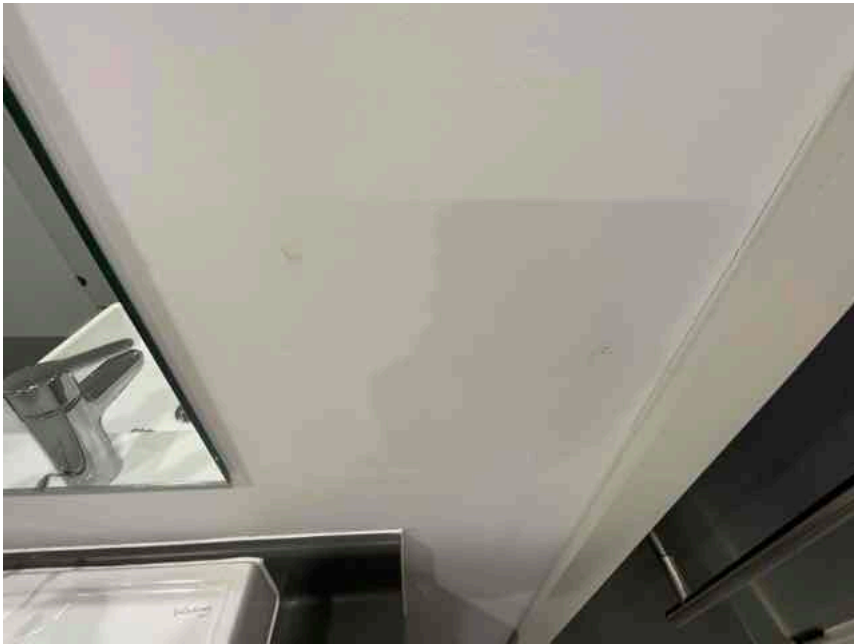
**Photo 180**

WWC  
Walls

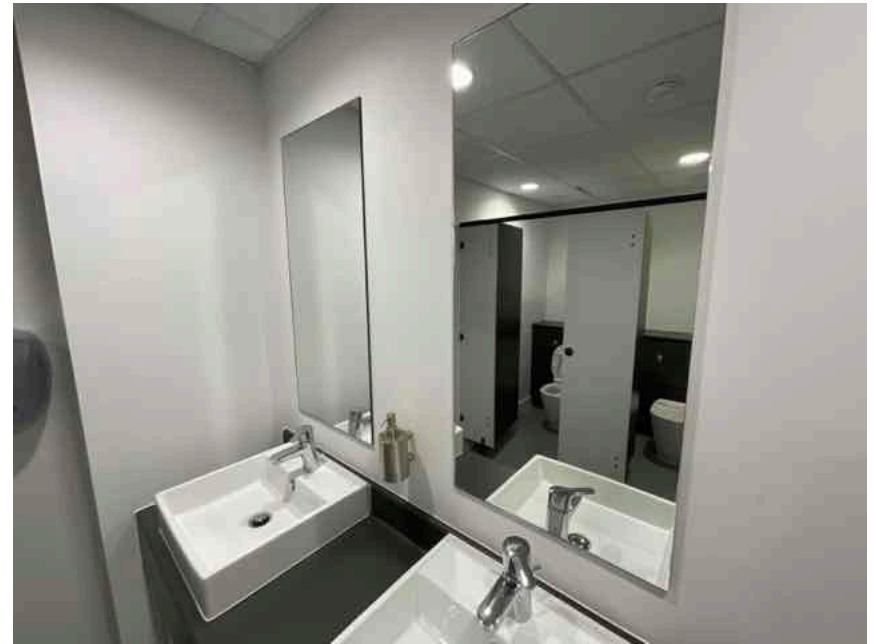
**Photo 181**

WWC  
Walls

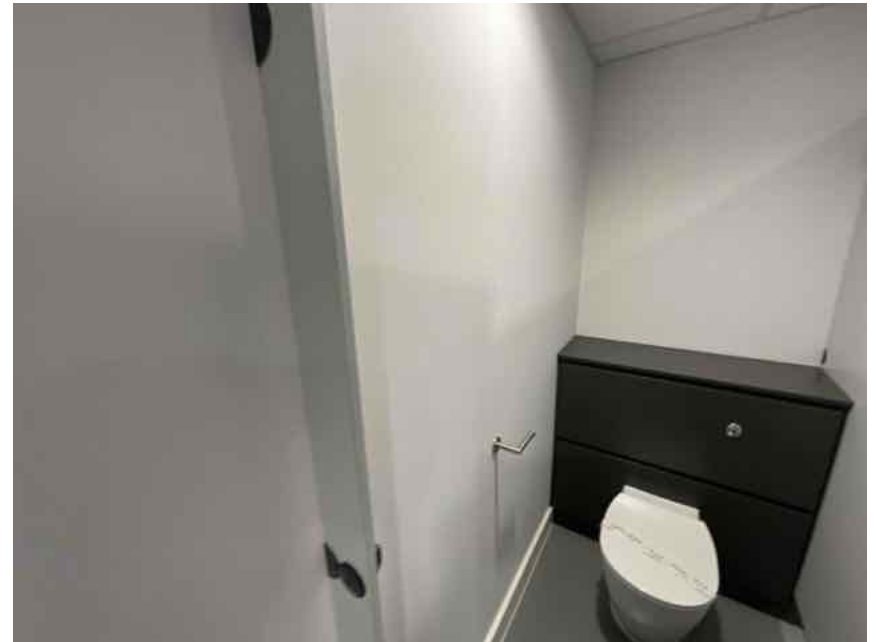
**Photo 183**

WWC  
IPS cubicles

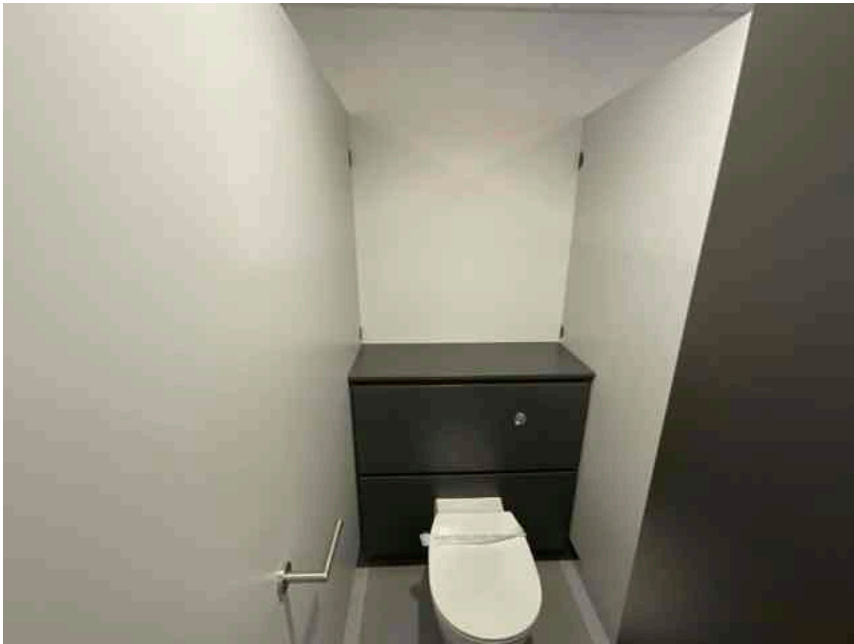
**Photo 184**

WWC  
IPS cubicles

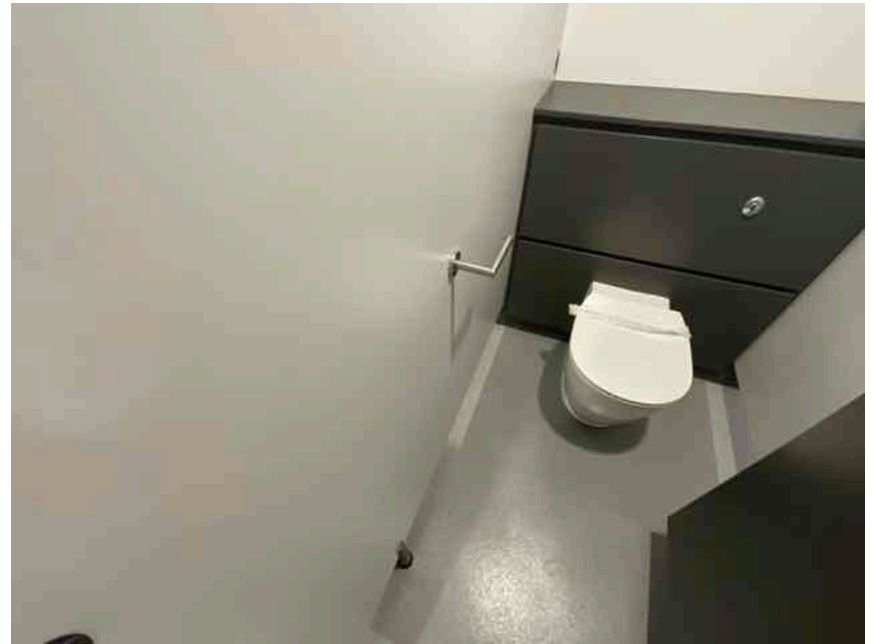
**Photo 185**

WWC  
IPS cubicles

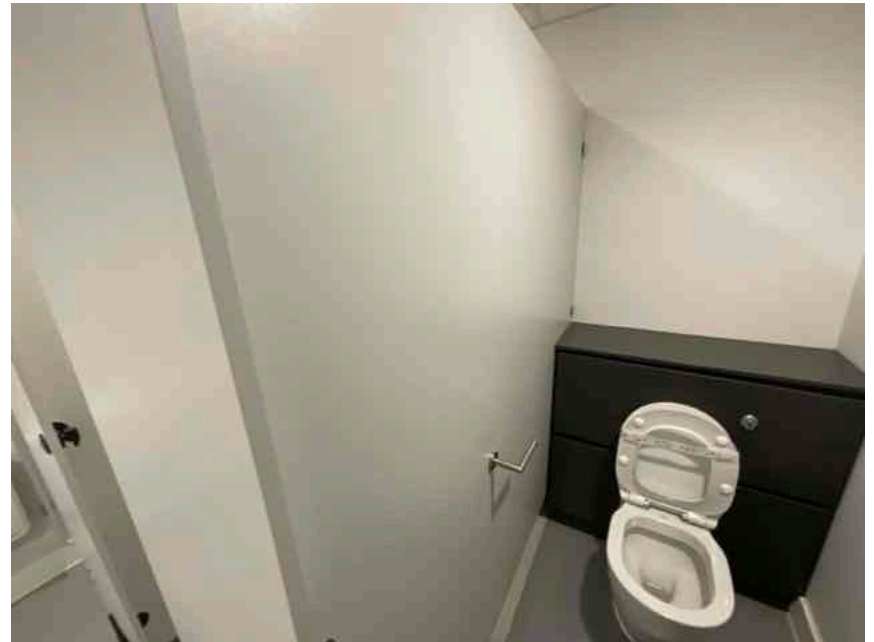
**Photo 187**

WWC  
IPS cubicles

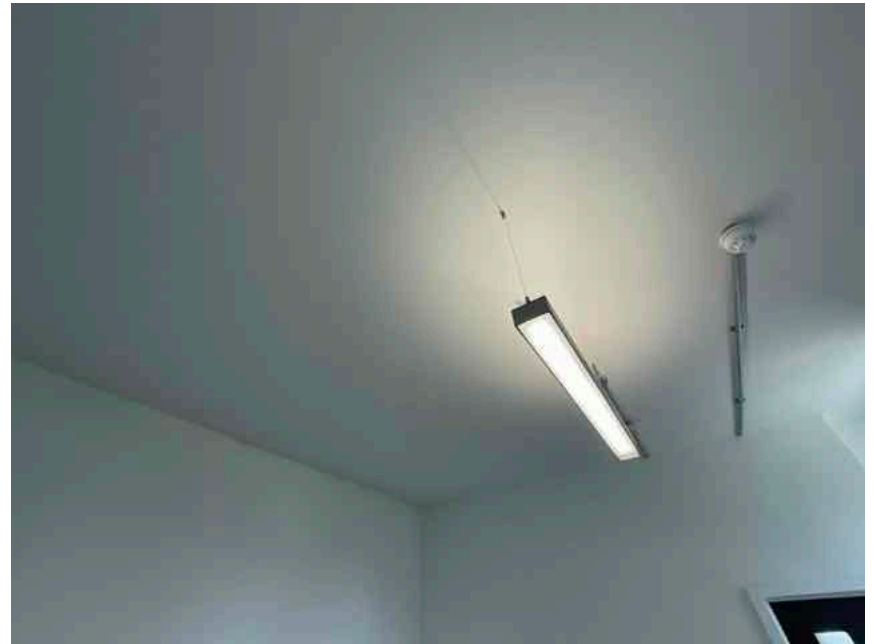
**Photo 189**

WWC  
IPS cubicles

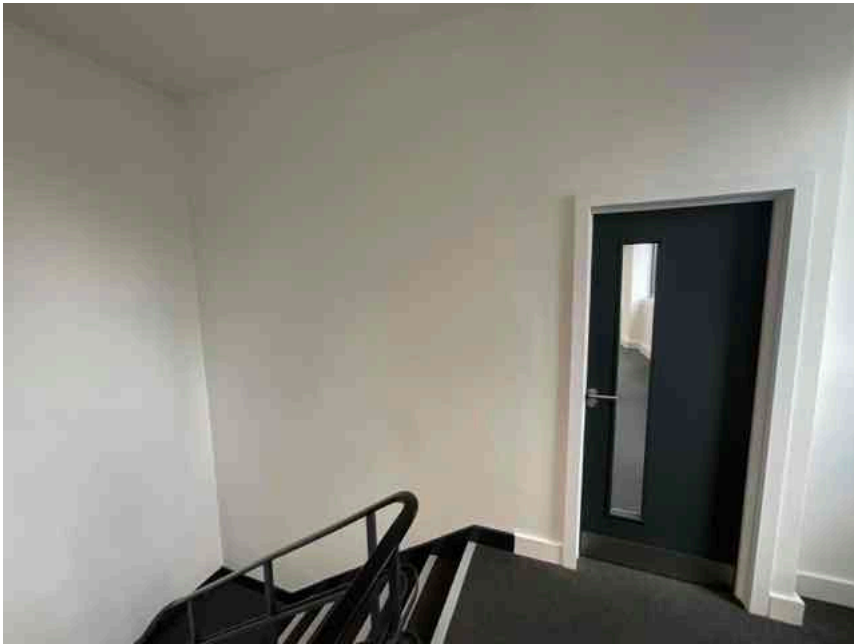
**Photo 192**

Stairwell and entrance  
Walls

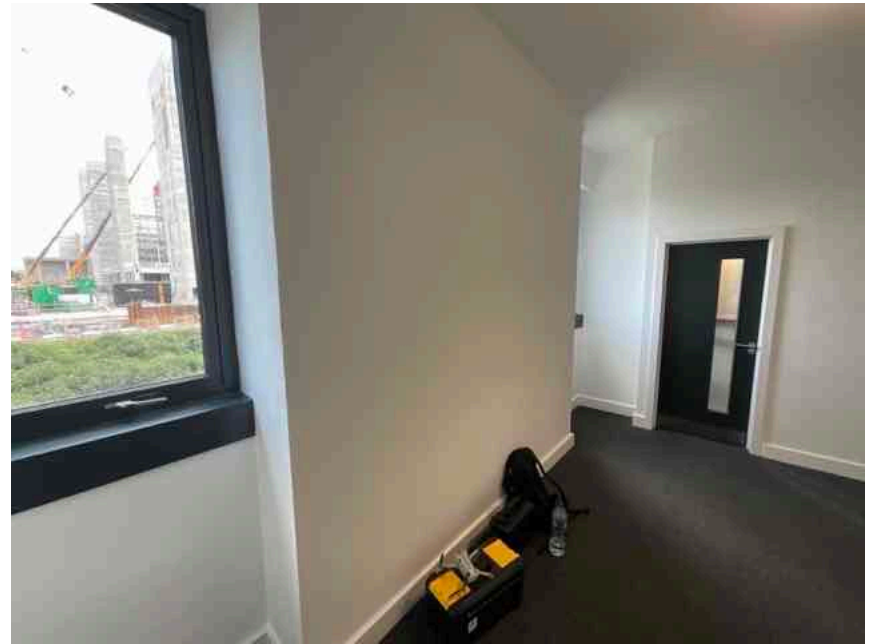
**Photo 193**

Stairwell and entrance  
Walls

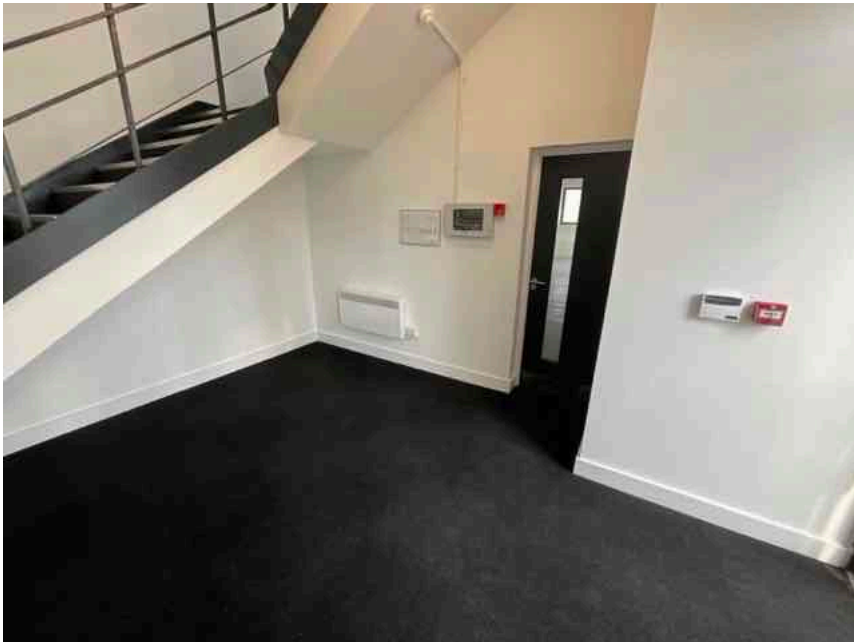
**Photo 194**

Stairwell and entrance  
Walls

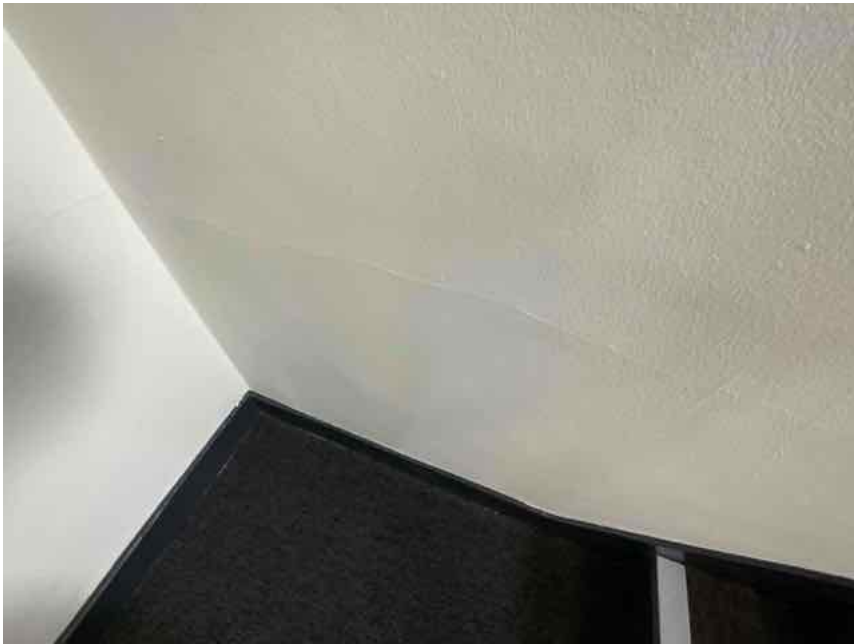
**Photo 196**

Stairwell and entrance  
Walls

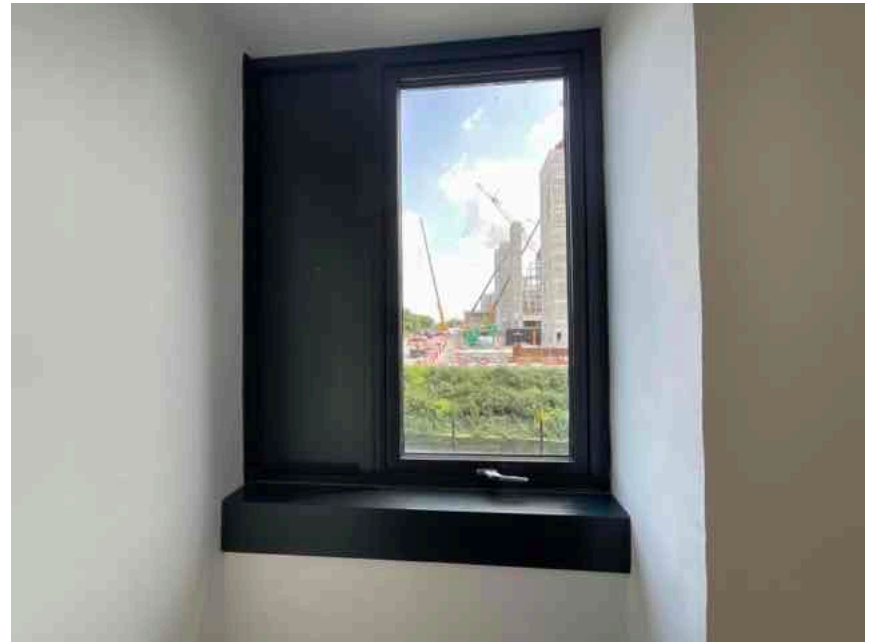
**Photo 207**

Floor coverings	Carpet tiles.	Good condition.	206 - 207
Windows	Aluminium double glazed casement windows.	Generally, in good condition.	208 - 209

Stairwell and entrance  
Floor coverings

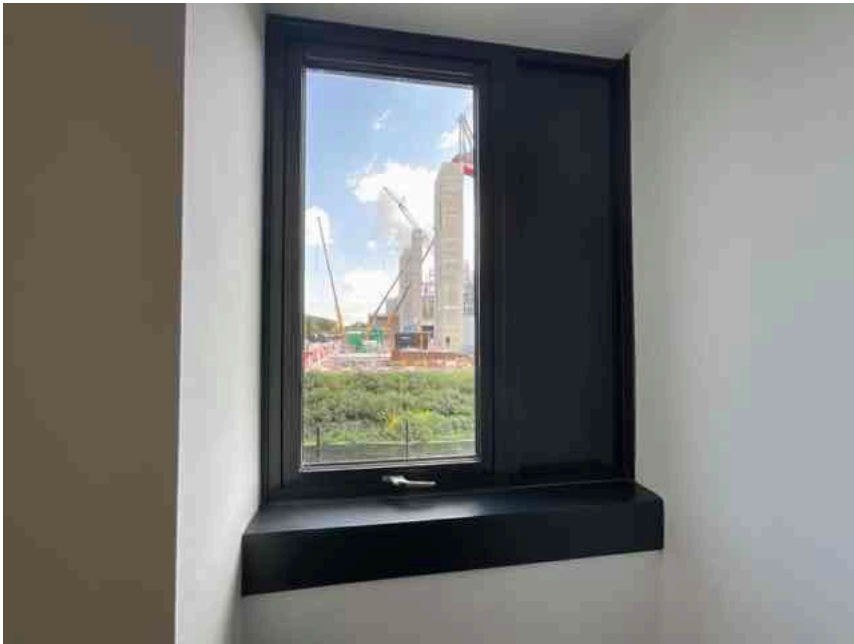
**Photo 208**

Stairwell and entrance  
Windows
