## Schedule of Condition

Date: 13<sup>th</sup> May 2025

## B Schedule of Condition Shop Floor

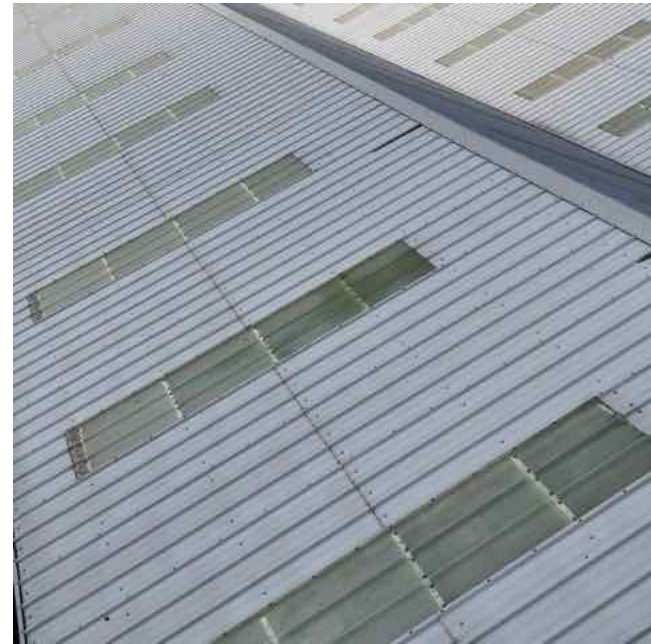
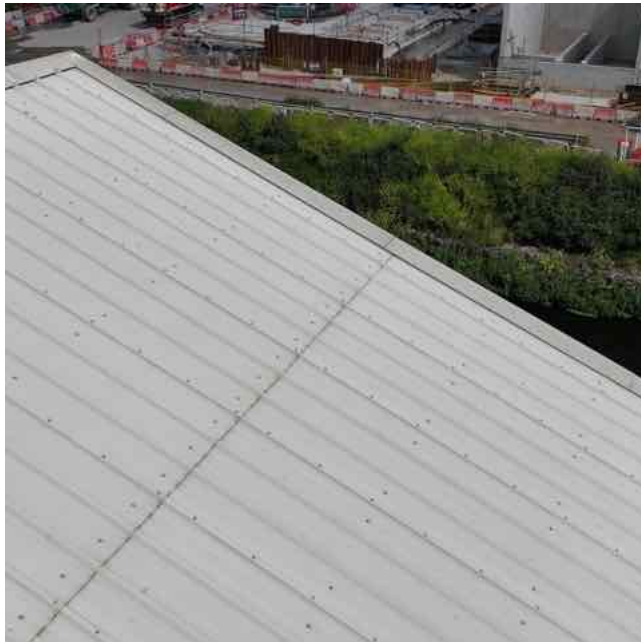
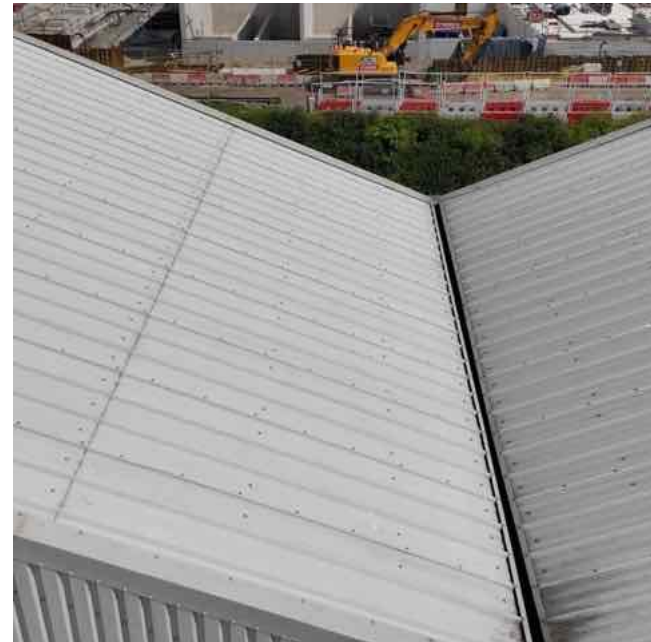
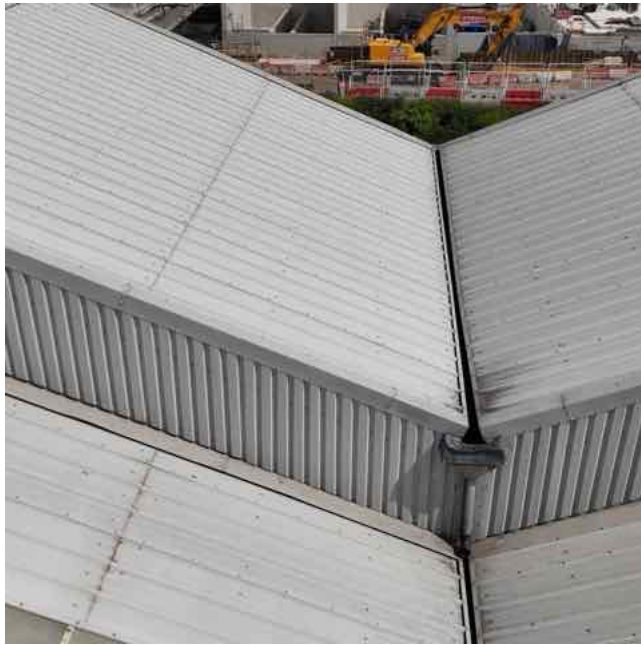
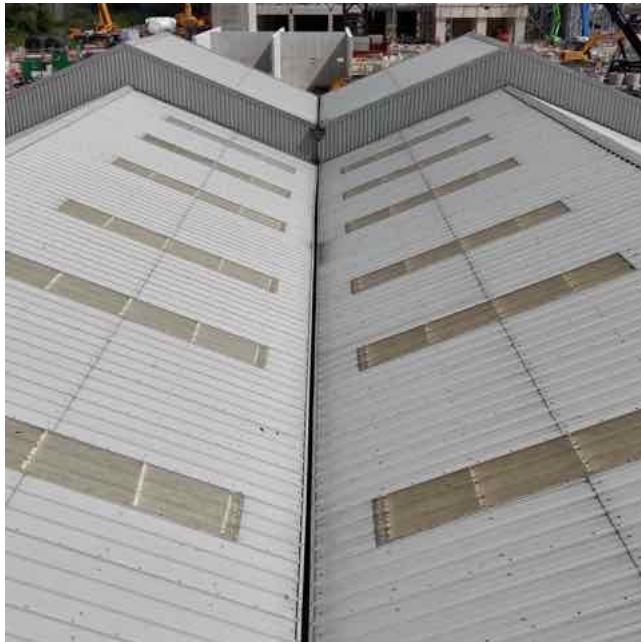
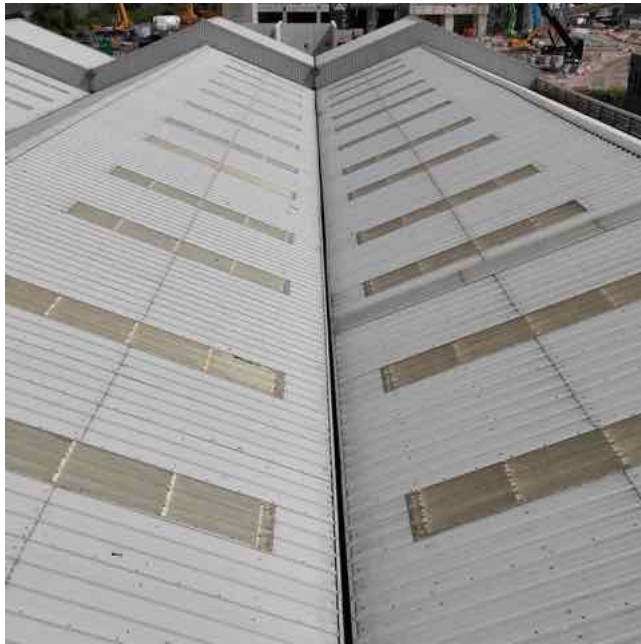
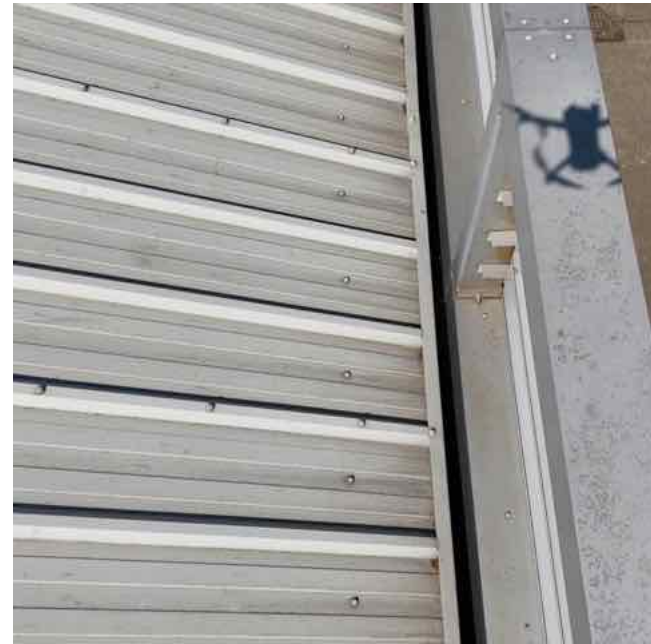
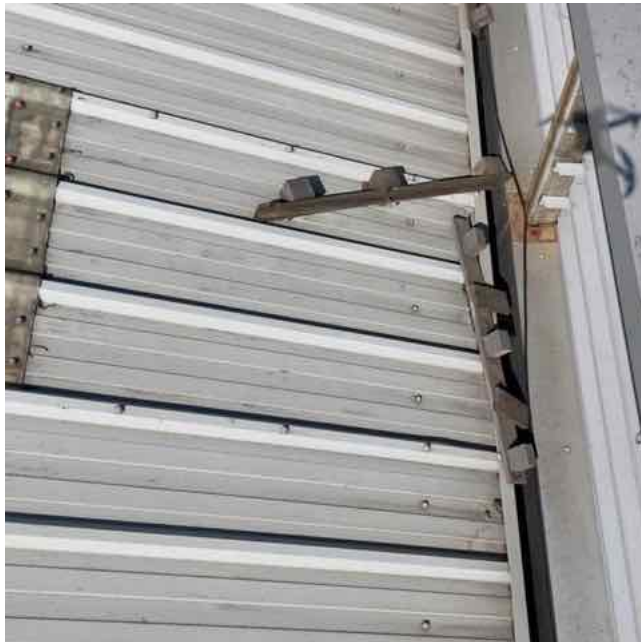
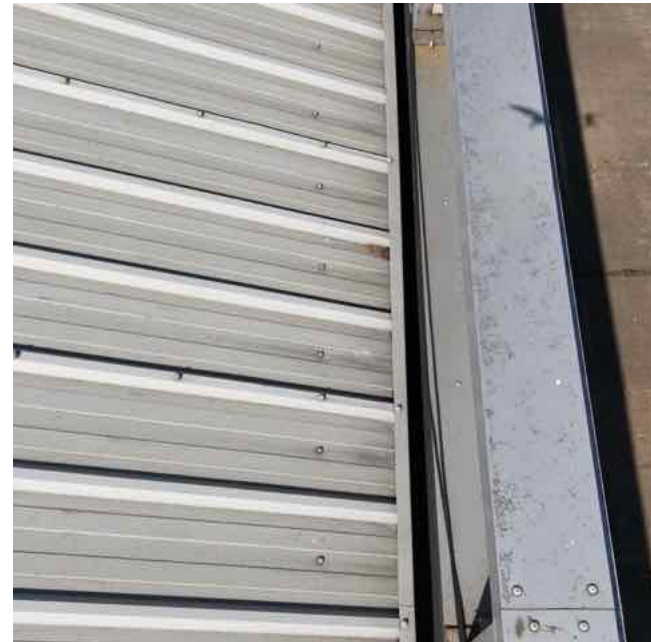
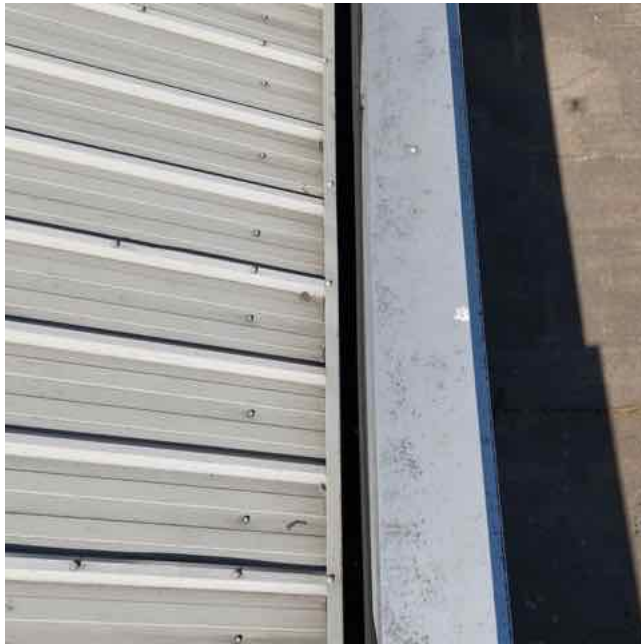
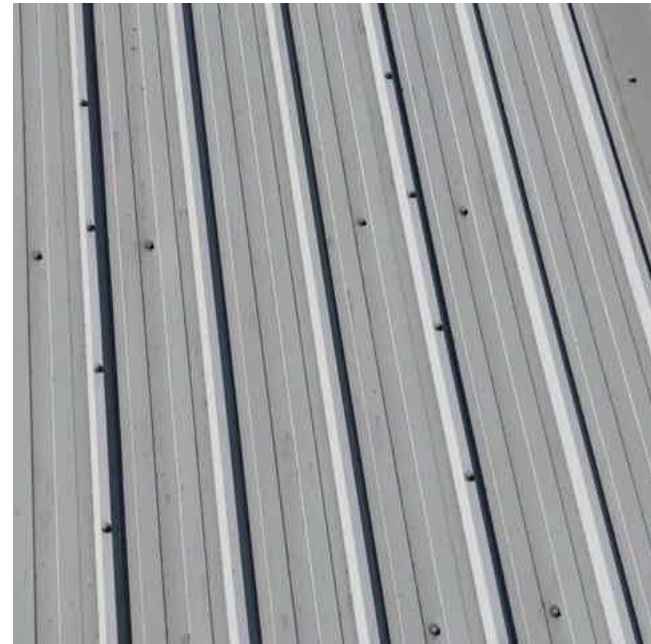
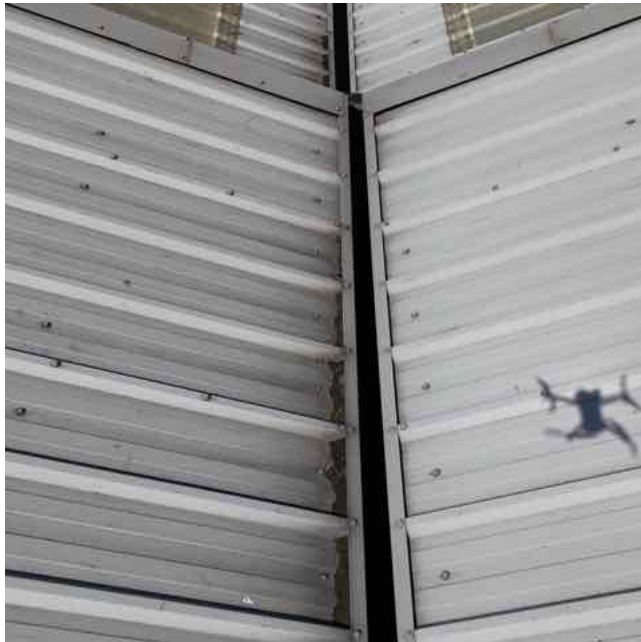
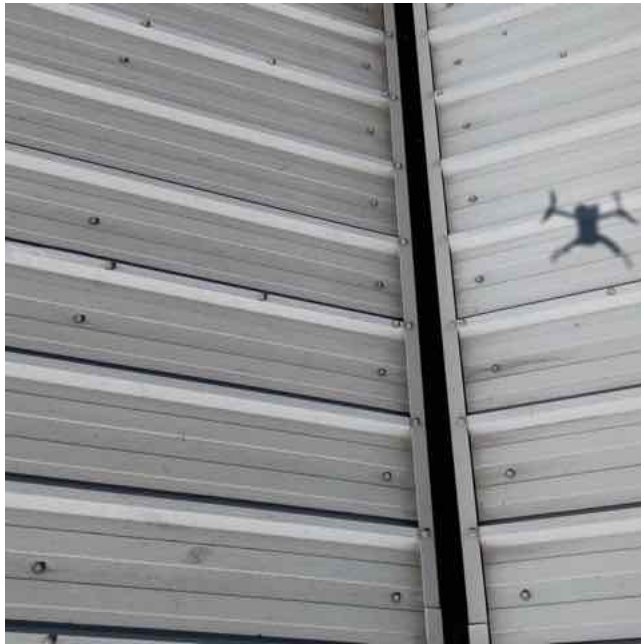
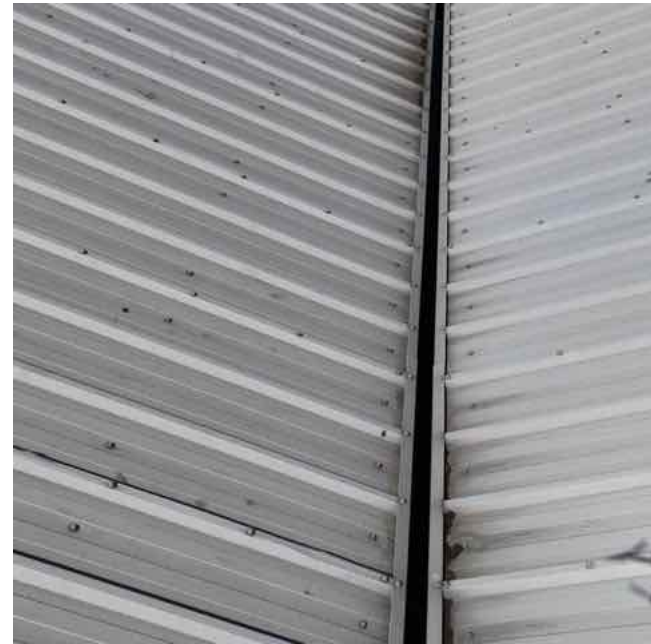
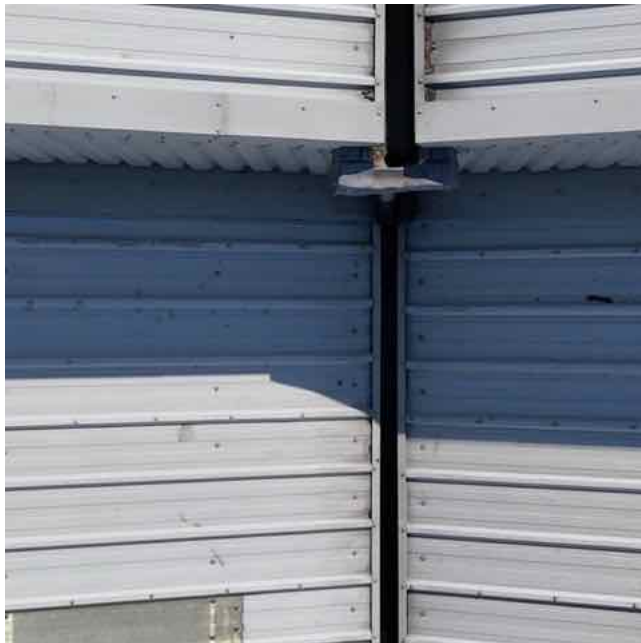
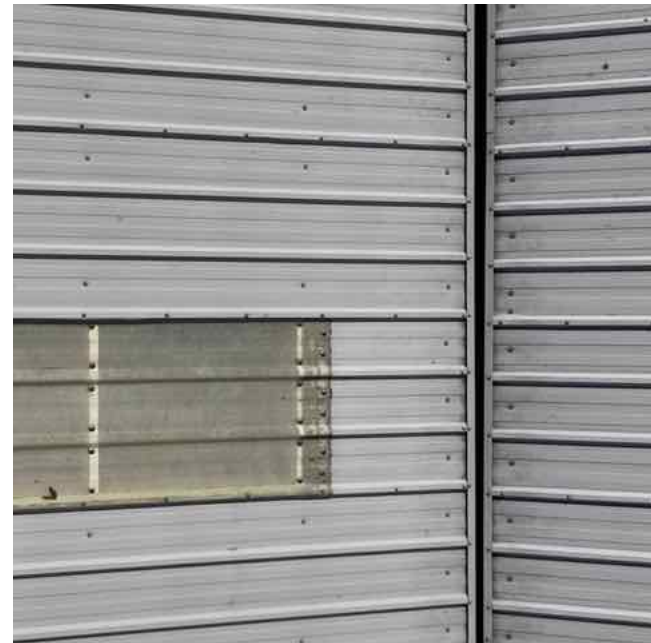
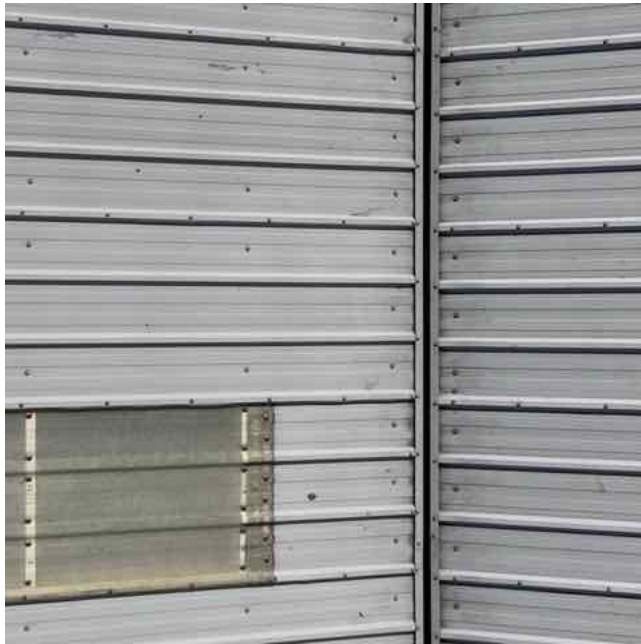
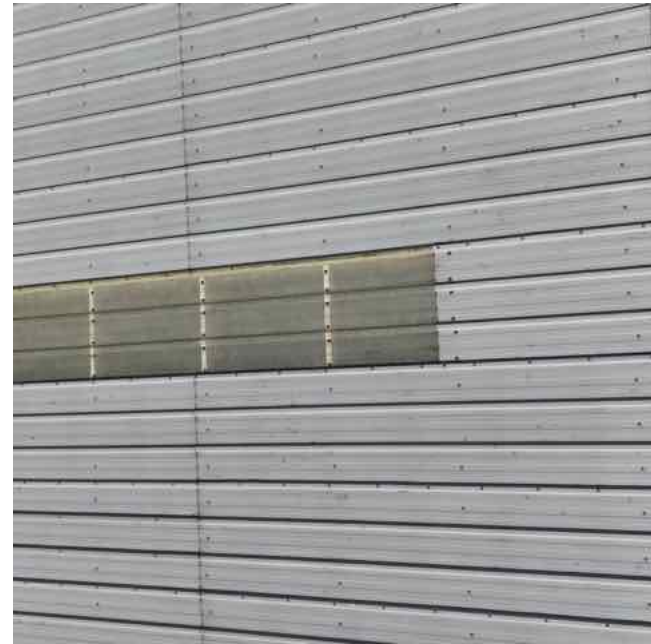
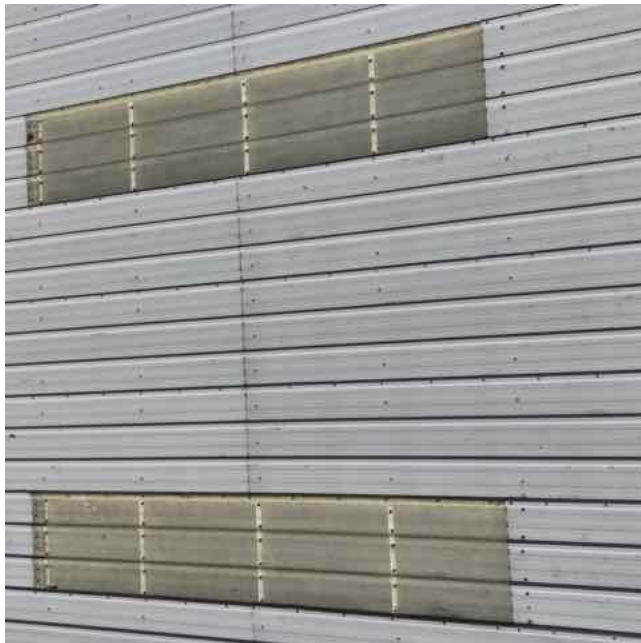
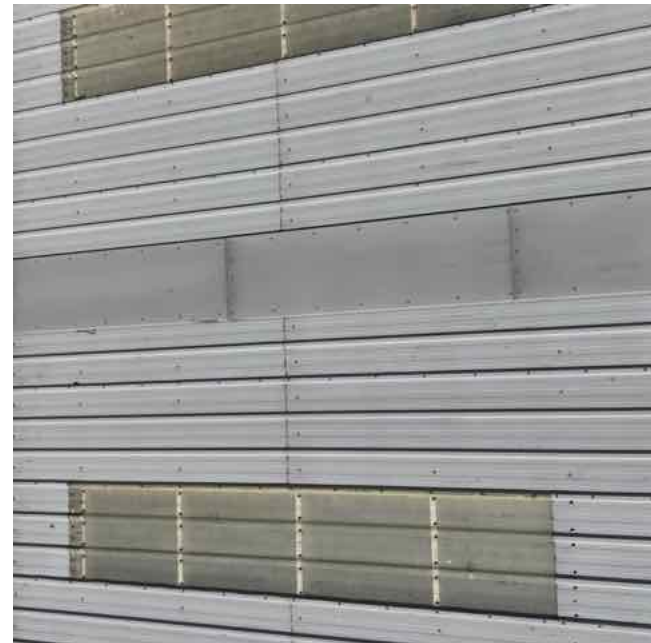
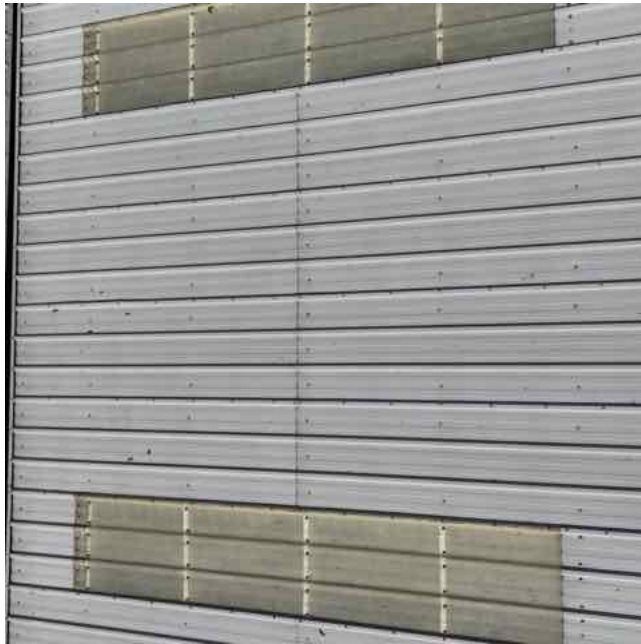
<b>Weather Conditions</b>	<b>Sunny and dry</b>
<b>Undertaken by:</b>	<b>Clayton Ayling of Ayling Associates Chartered Surveyors</b>	<b>Undertaken On:</b>	<b>12<sup>th</sup> May 2025</b>
<b>Location</b>	<b>Description</b>	<b>Condition</b>	<b>Photo No</b>
This Schedule of Condition is specific to the lease to which it is appended.			
<b>Roof 1</b>			
Roof covering and Rooflights	<p>Profiled metal sheet roof covering with metal ridge flashings fixed with rivets.</p> <p>The roof sheets have a single lap at half length.</p> <p>Tek screw fixings into purlins.</p>	<p>Cut edge corrosion does not appear to have set in.</p> <p>Dark spots were observed to the surface of the roof sheets in localised areas, most likely either rust spots or bird droppings.</p> <p>Tek screws appear to have deteriorated and screw gaskets are generally cracked.</p> <p>Rooflights appear aged and yellowed, and the gel coat has most likely broken down.</p>	1 - 70

Roof 1  
Roof covering and Rooflights

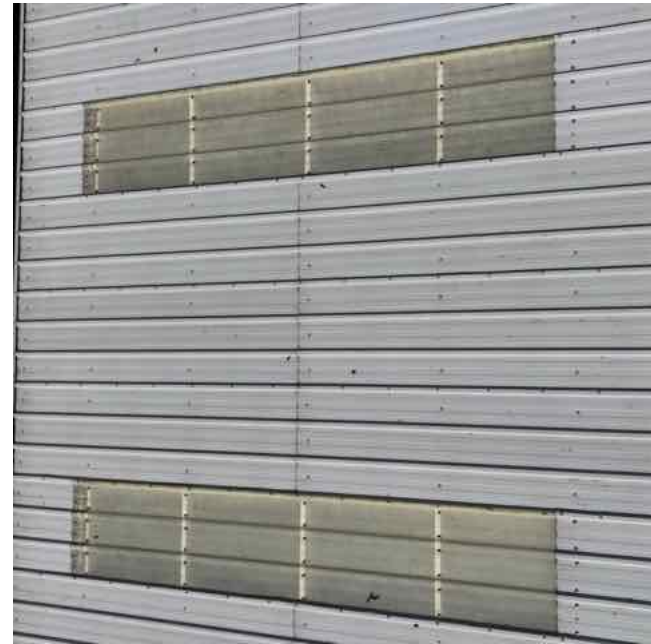
**Photo 25**

Roof 1  
Roof covering and Rooflights

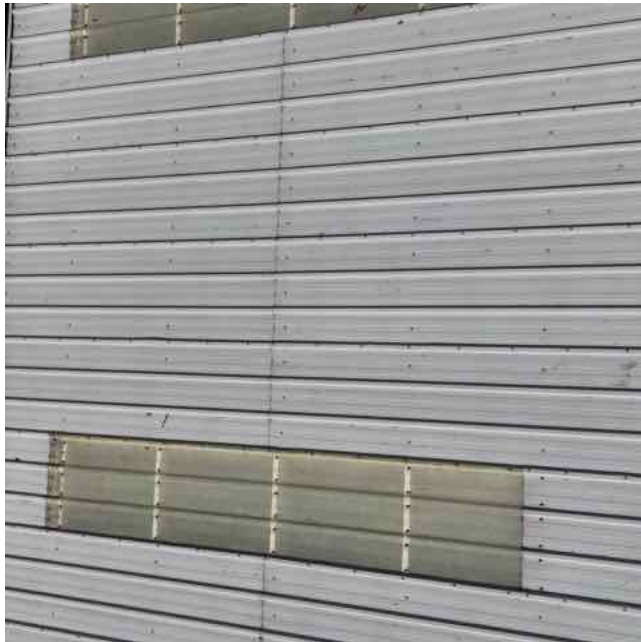
**Photo 26**

Roof 1  
Roof covering and Rooflights

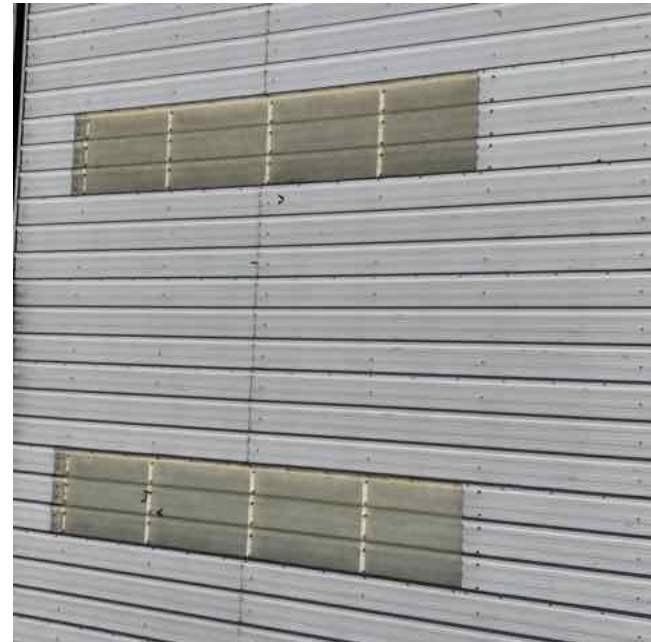
**Photo 27**

Roof 1  
Roof covering and Rooflights

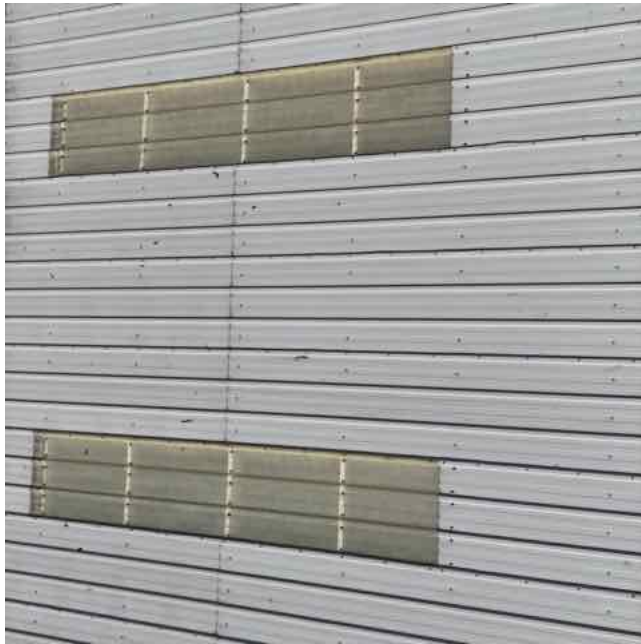
**Photo 28**

Roof 1  
Roof covering and Rooflights

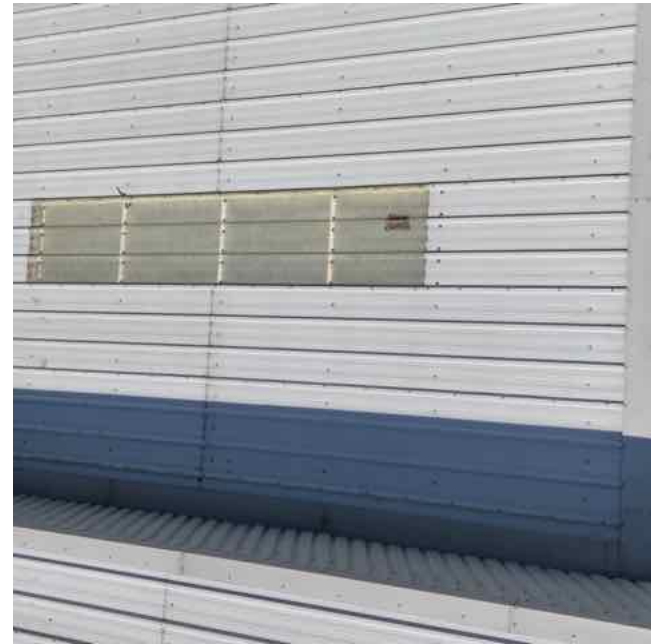
**Photo 29**

Roof 1  
Roof covering and Rooflights

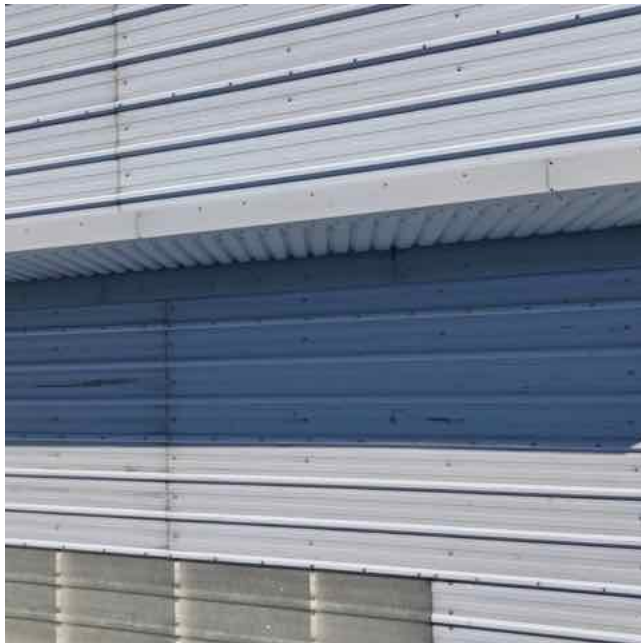
**Photo 30**

Roof 1  
Roof covering and Rooflights

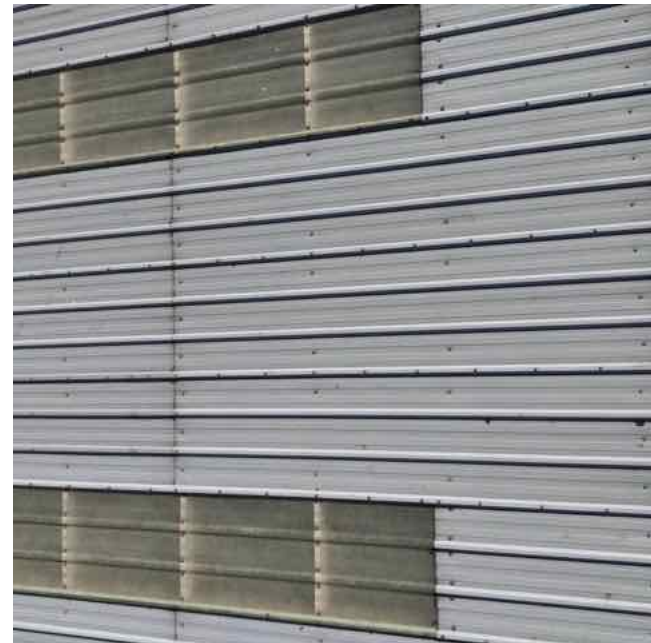
**Photo 31**

Roof 1  
Roof covering and Rooflights

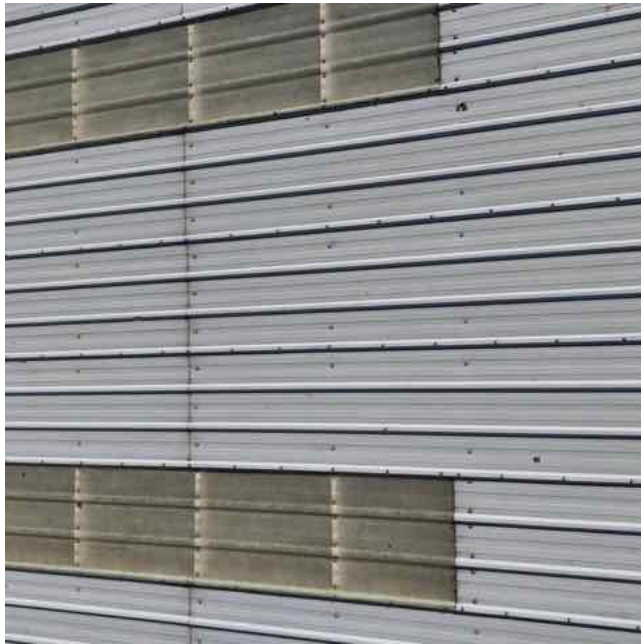
**Photo 32**

Roof 1  
Roof covering and Rooflights

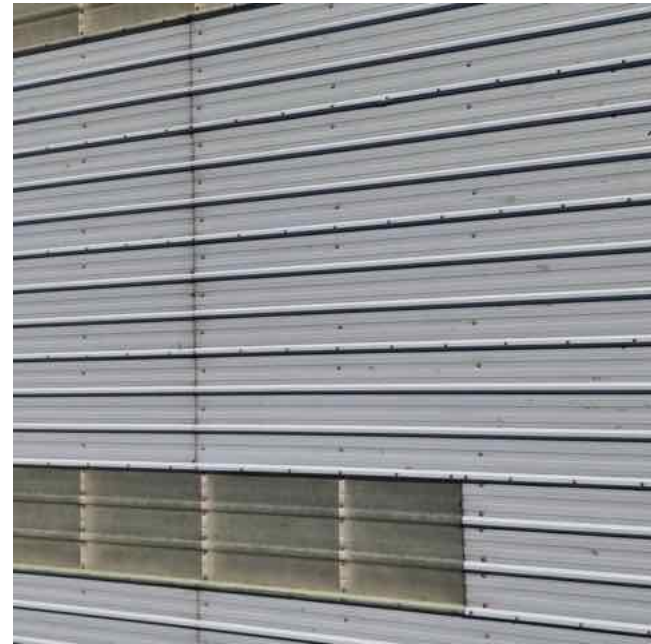
**Photo 33**

Roof 1  
Roof covering and Rooflights

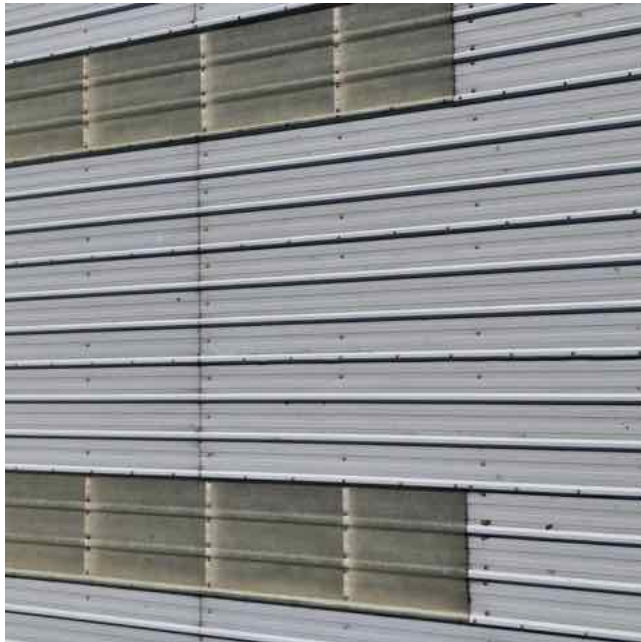
**Photo 34**

Roof 1  
Roof covering and Rooflights

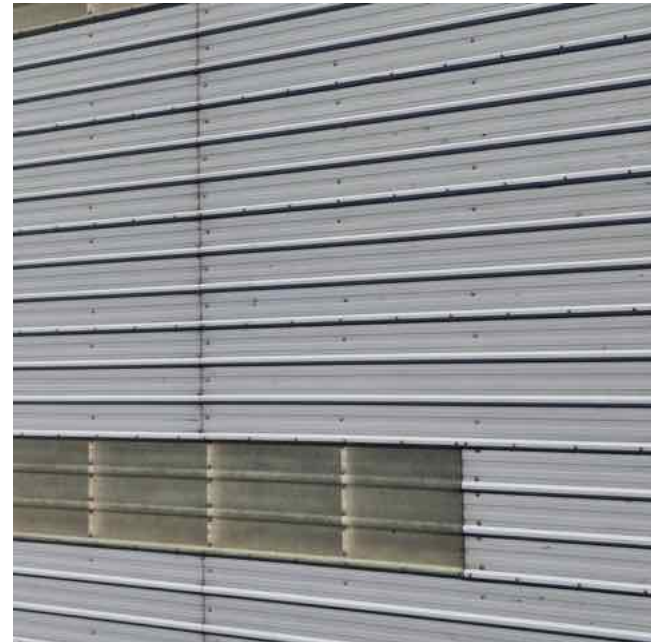
**Photo 35**

Roof 1  
Roof covering and Rooflights

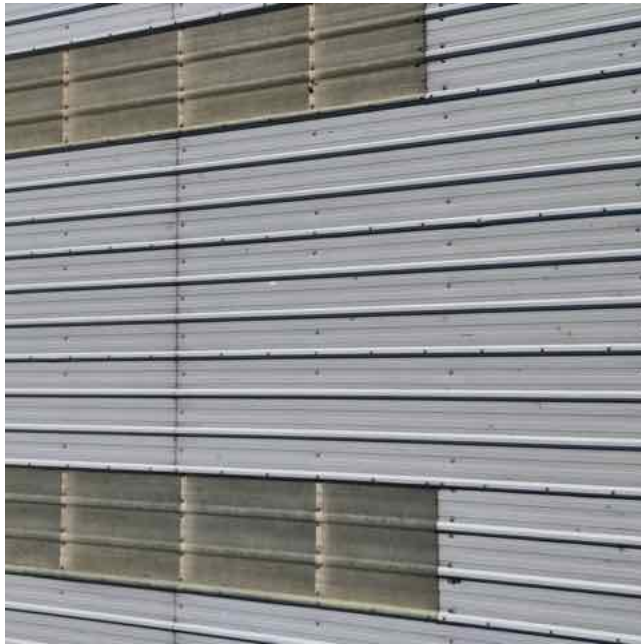
**Photo 36**

Roof 1  
Roof covering and Rooflights

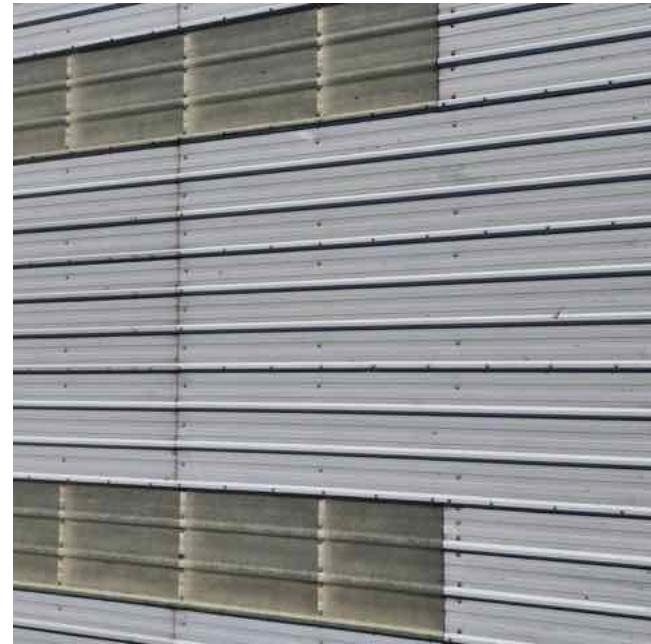
**Photo 37**

Roof 1  
Roof covering and Rooflights

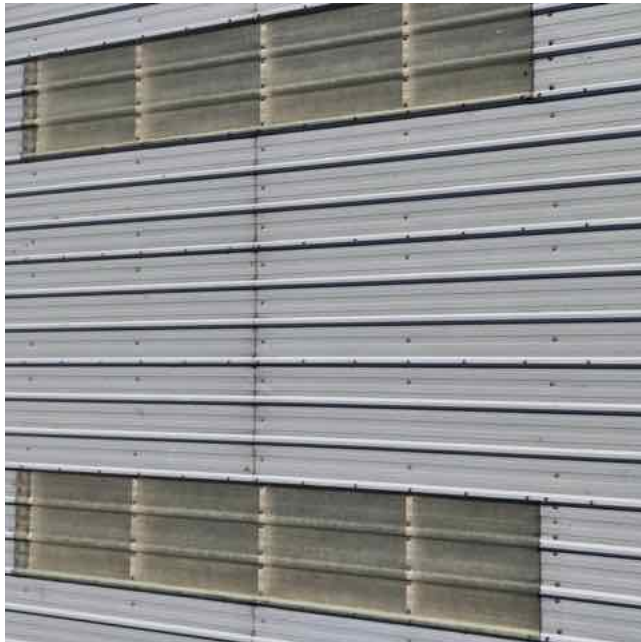
**Photo 38**

Roof 1  
Roof covering and Rooflights

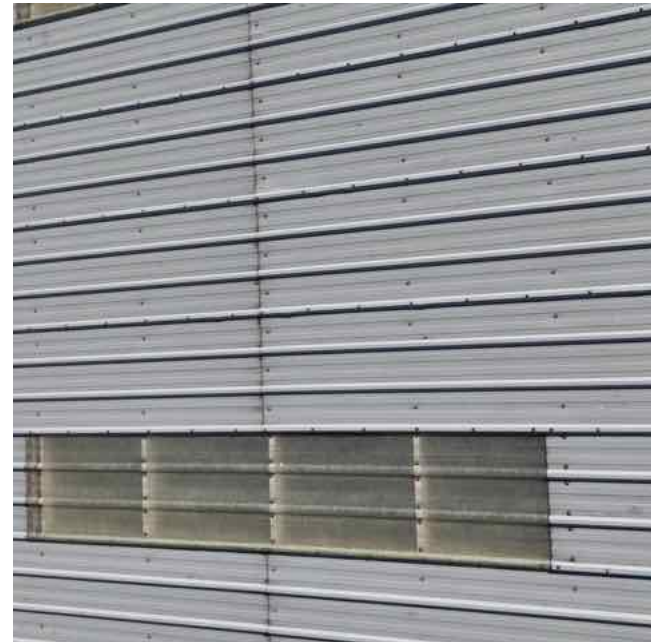
**Photo 39**

Roof 1  
Roof covering and Rooflights

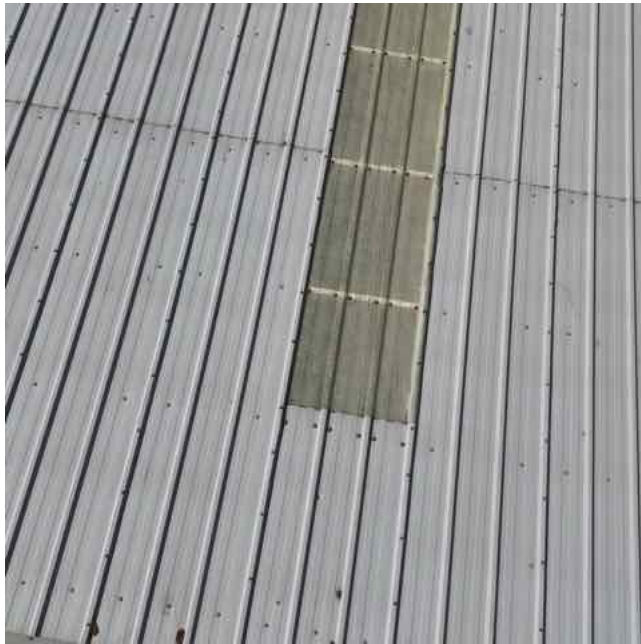
**Photo 40**

Roof 1  
Roof covering and Rooflights

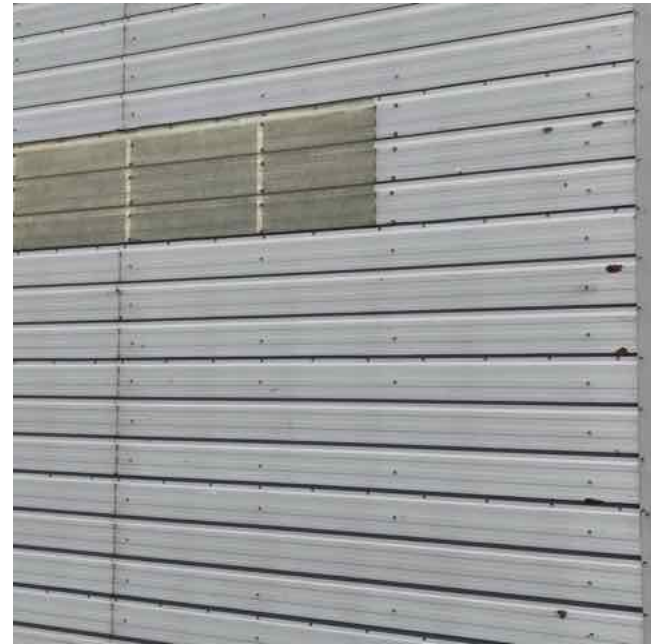
**Photo 41**

Roof 1  
Roof covering and Rooflights

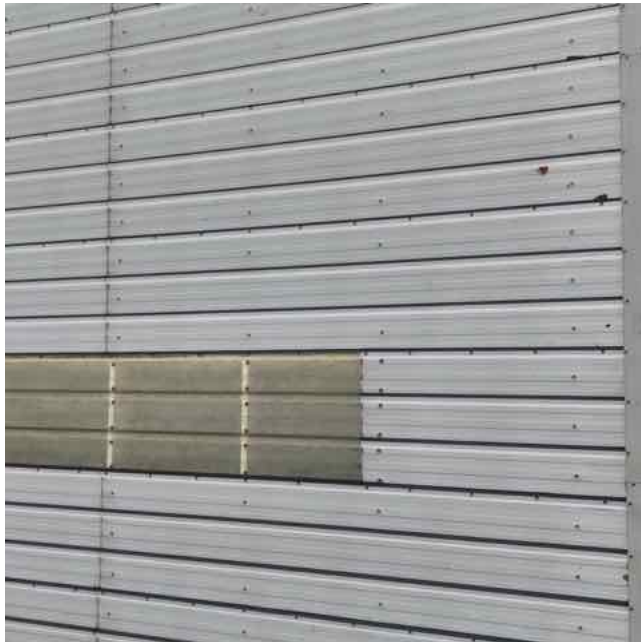
**Photo 42**

Roof 1  
Roof covering and Rooflights

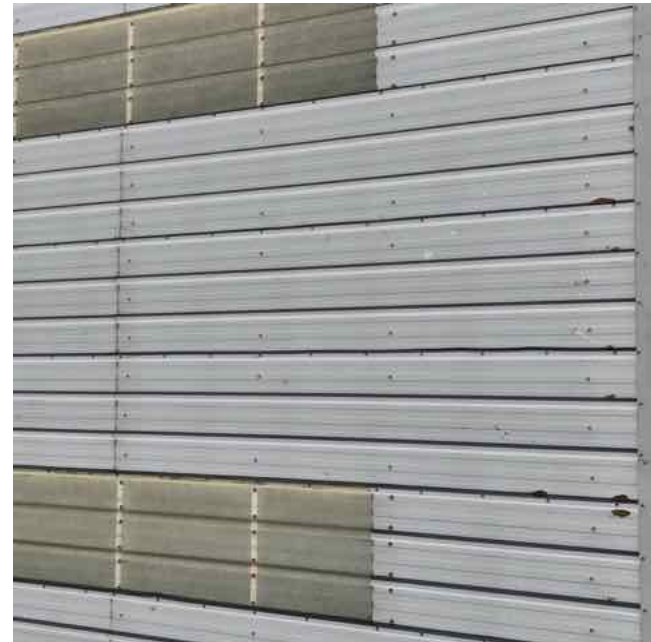
**Photo 43**

Roof 1  
Roof covering and Rooflights

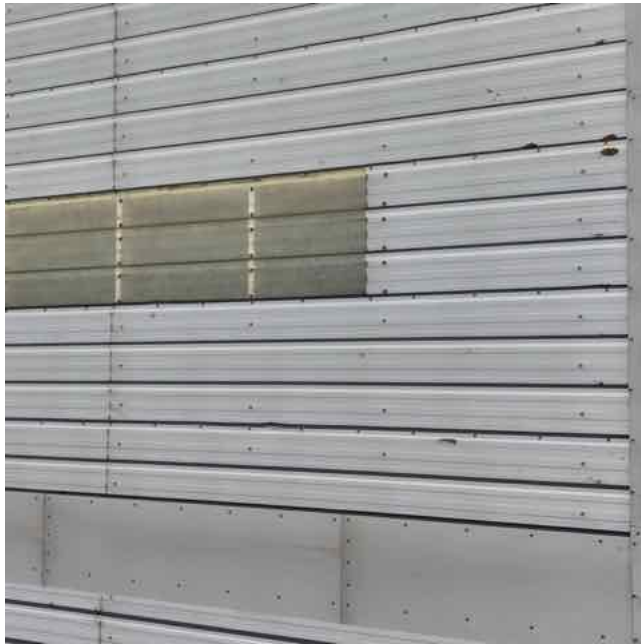
**Photo 44**

Roof 1  
Roof covering and Rooflights

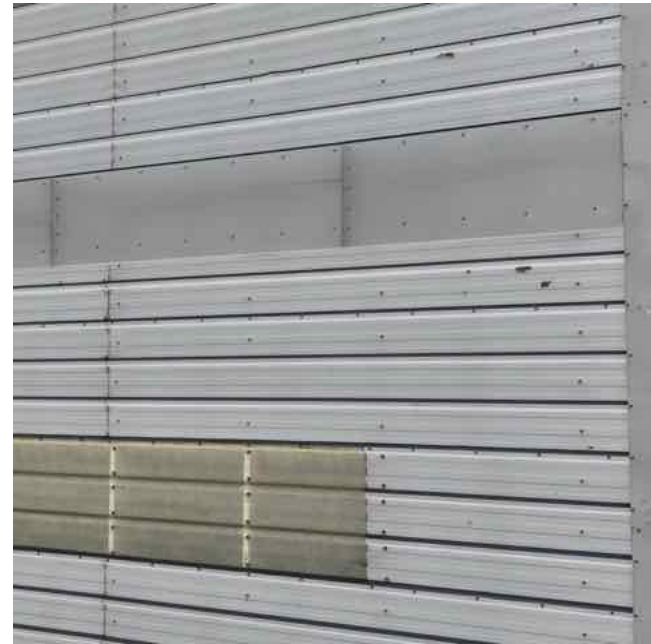
**Photo 45**

Roof 1  
Roof covering and Rooflights

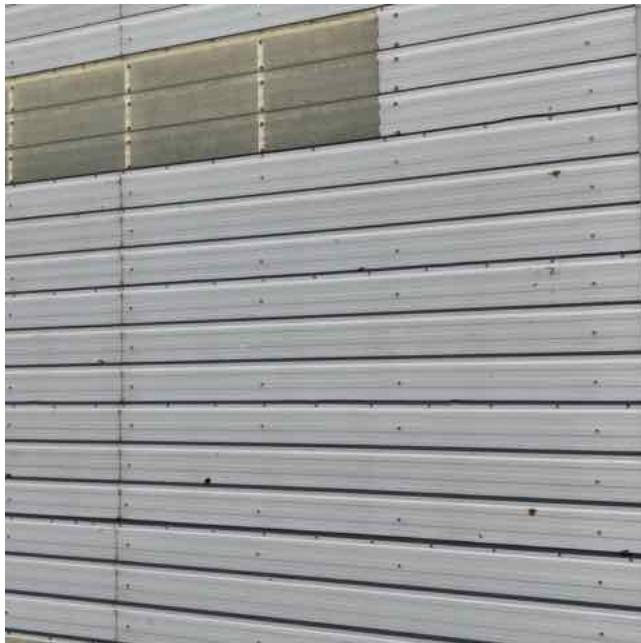
**Photo 46**

Roof 1  
Roof covering and Rooflights

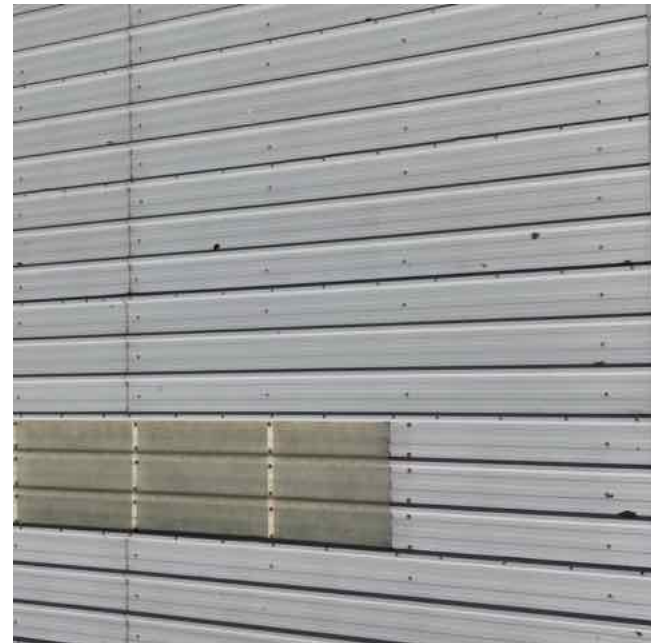
**Photo 47**

Roof 1  
Roof covering and Rooflights

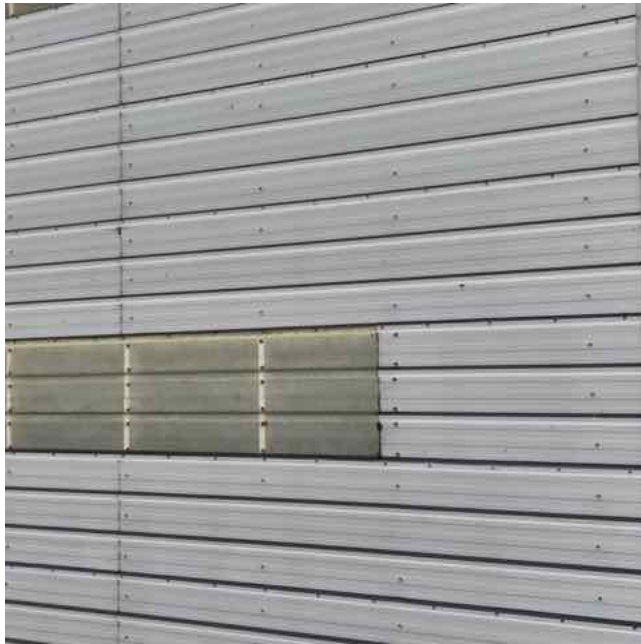
**Photo 48**

Roof 1  
Roof covering and Rooflights

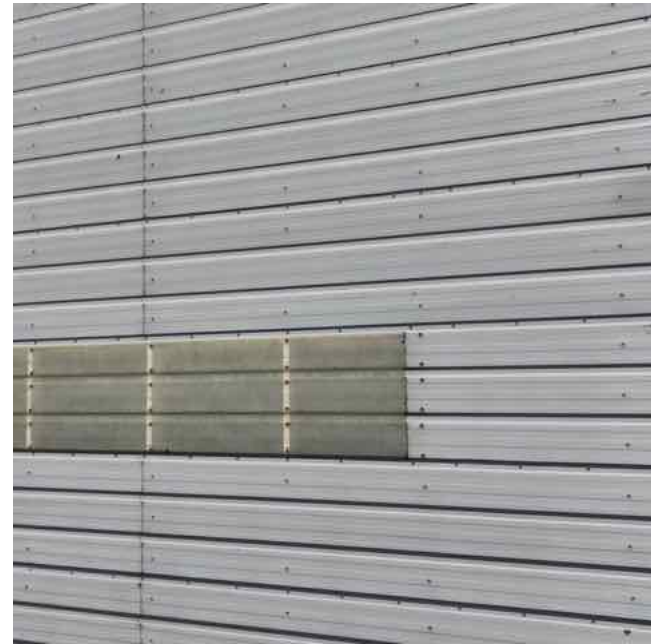
**Photo 49**

Roof 1  
Roof covering and Rooflights

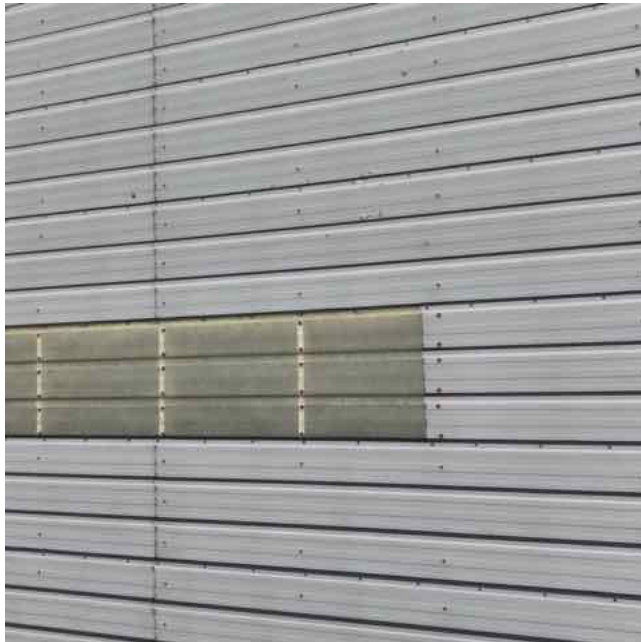
**Photo 50**

Roof 1  
Roof covering and Rooflights

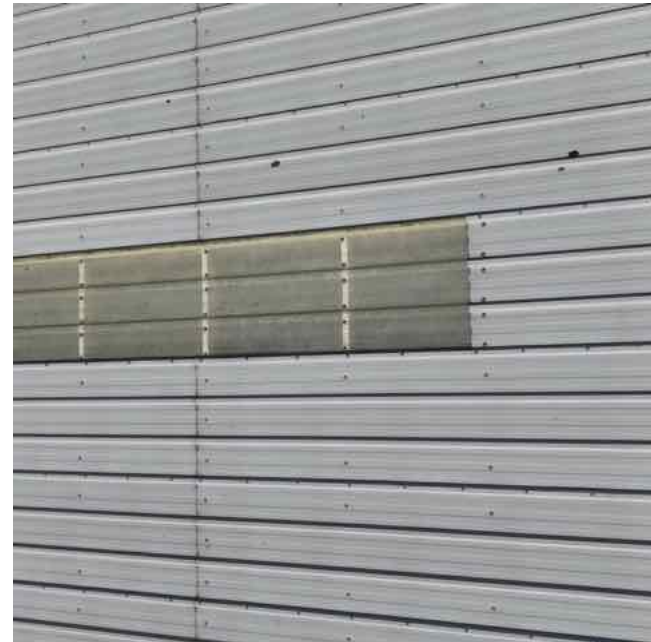
**Photo 51**

Roof 1  
Roof covering and Rooflights

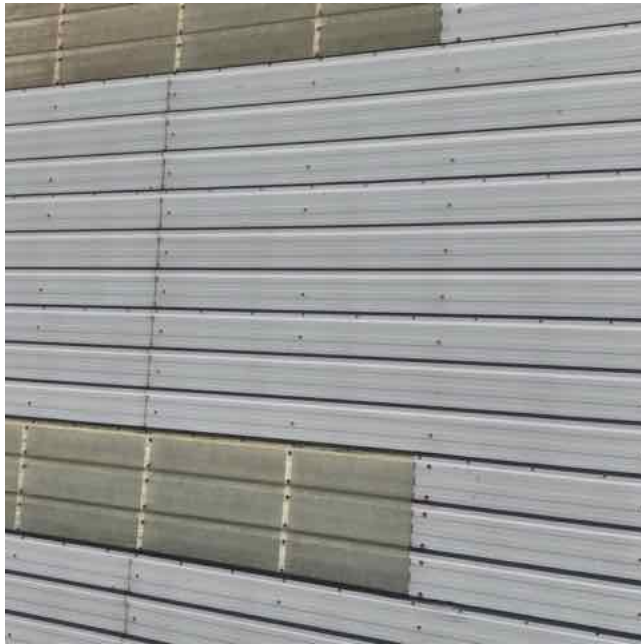
**Photo 52**

Roof 1  
Roof covering and Rooflights

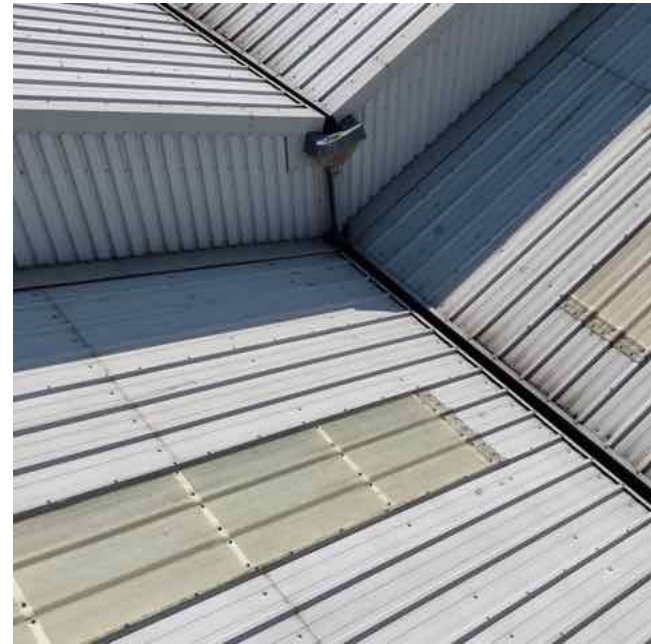
**Photo 53**

Roof 1  
Roof covering and Rooflights

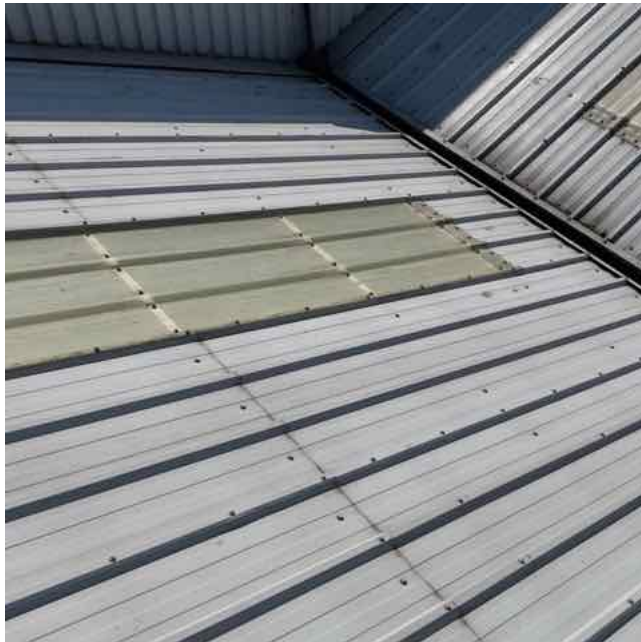
**Photo 54**

Roof 1  
Roof covering and Rooflights

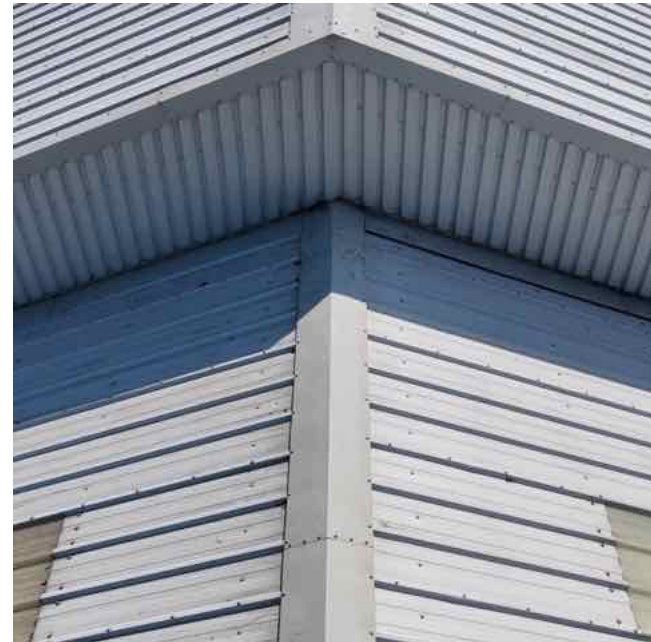
**Photo 55**

Roof 1  
Roof covering and Rooflights

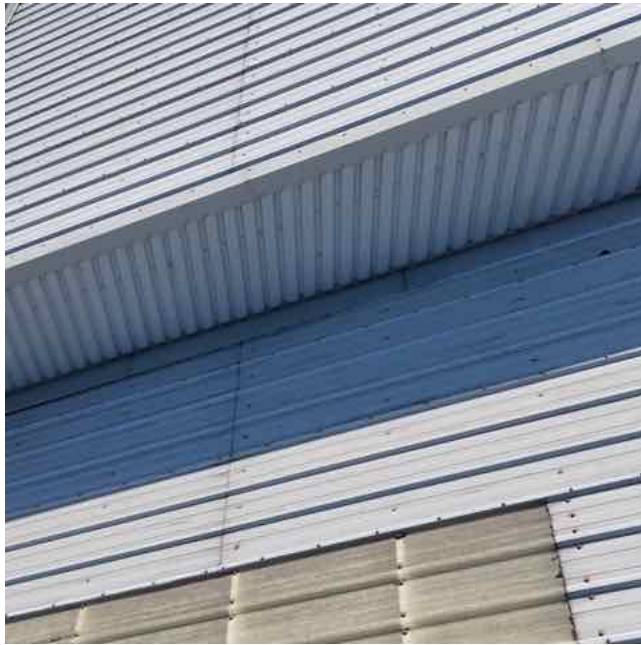
**Photo 56**

Roof 1  
Roof covering and Rooflights

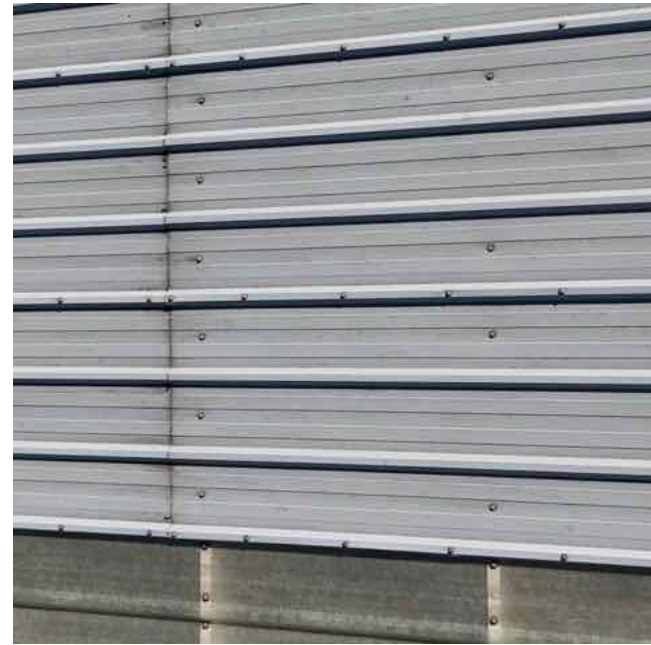
**Photo 57**

Roof 1  
Roof covering and Rooflights
