## Schedule of Condition

Date: 13<sup>th</sup> May 2025

## B Schedule of Condition Shop Floor

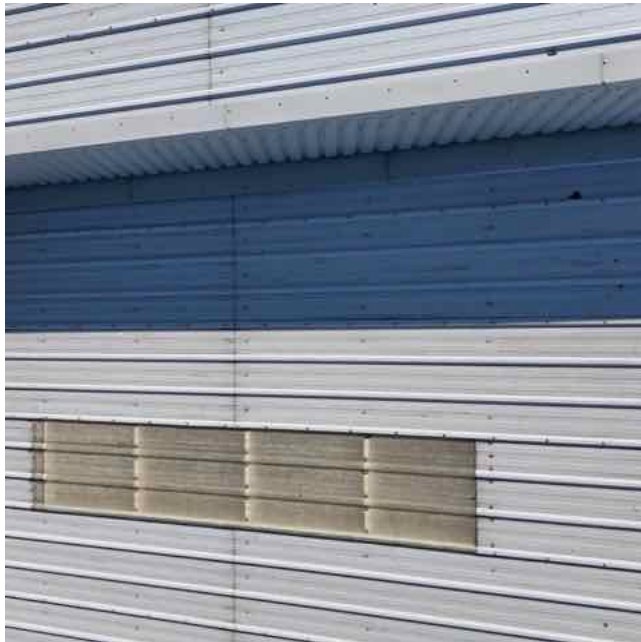
**Photo 58**

Roof 1  
Roof covering and Rooflights

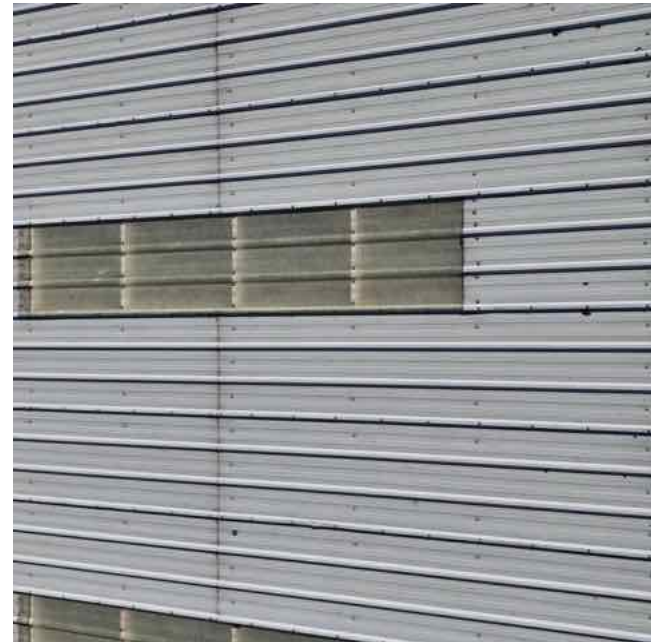
**Photo 59**

Roof 1  
Roof covering and Rooflights

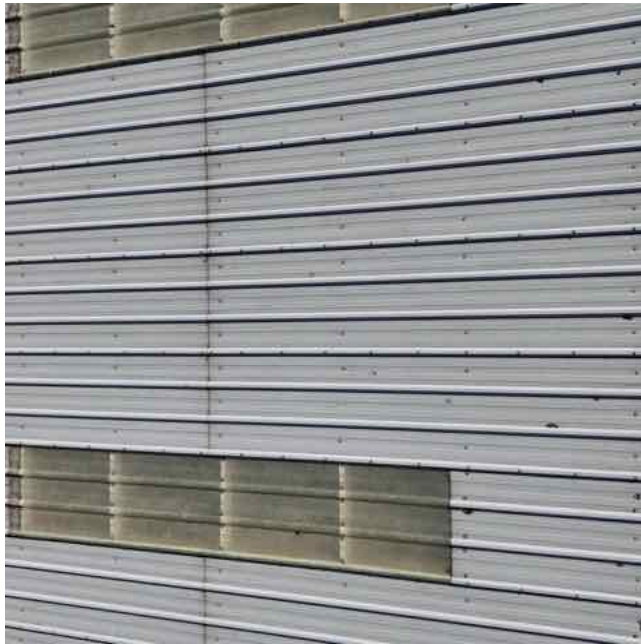
**Photo 60**

Roof 1  
Roof covering and Rooflights

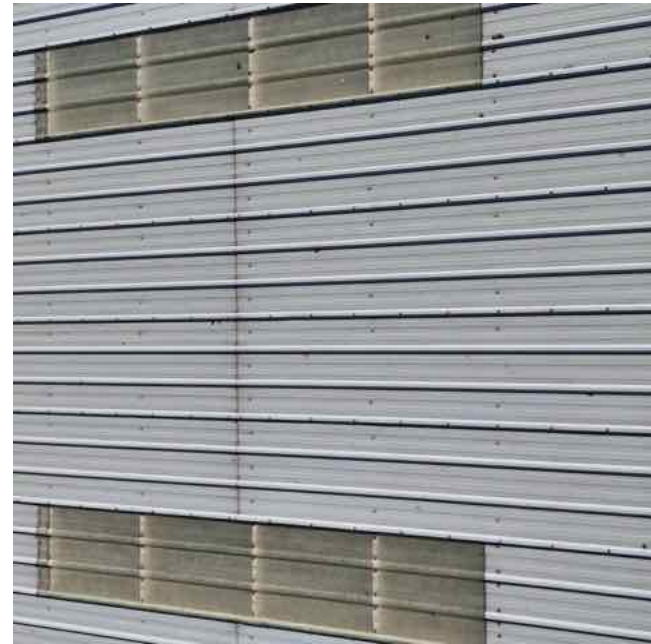
**Photo 61**

Roof 1  
Roof covering and Rooflights

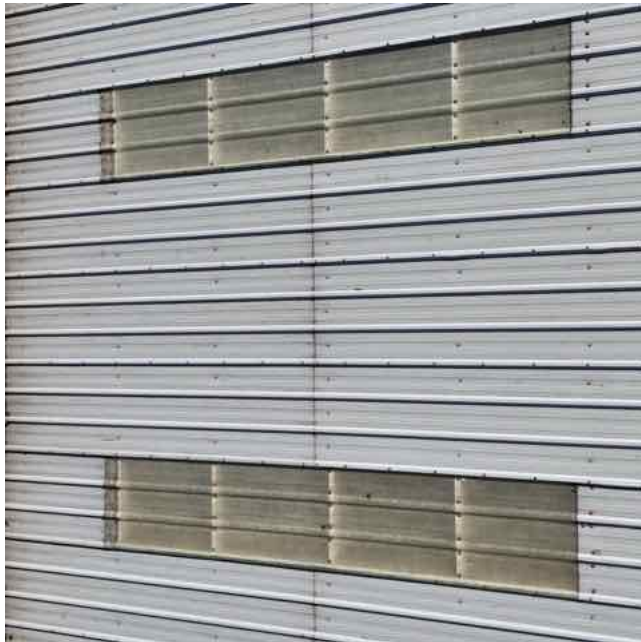
**Photo 62**

Roof 1  
Roof covering and Rooflights

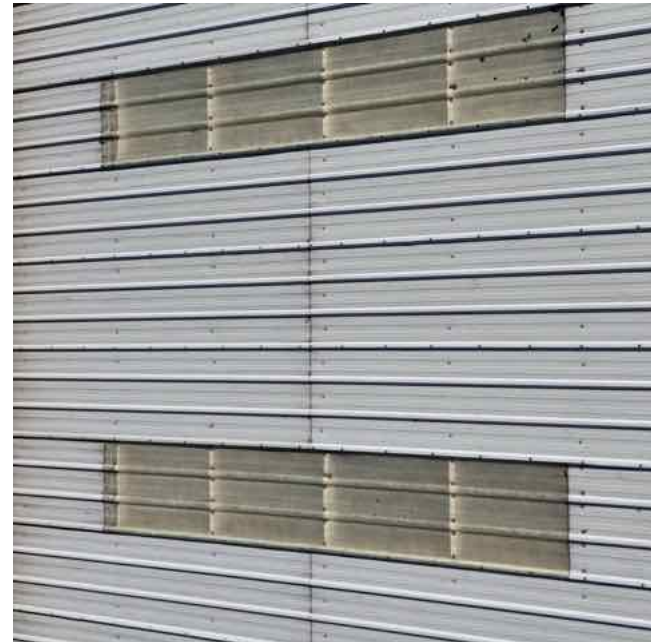
**Photo 63**

Roof 1  
Roof covering and Rooflights

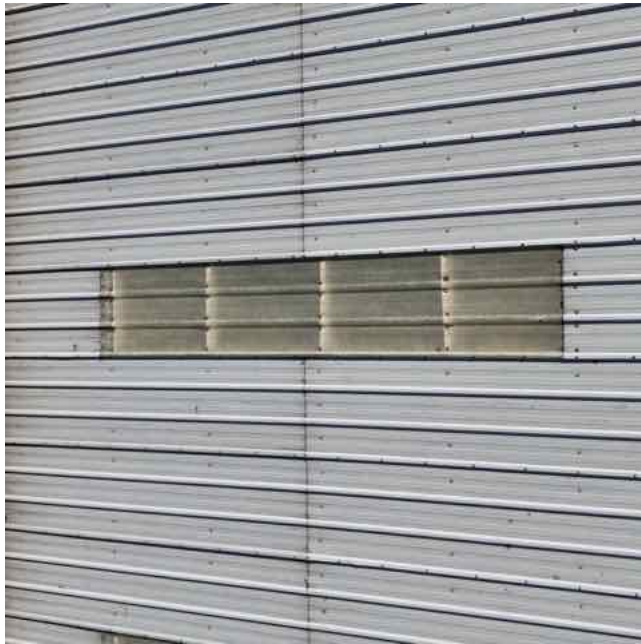
**Photo 64**

Roof 1  
Roof covering and Rooflights

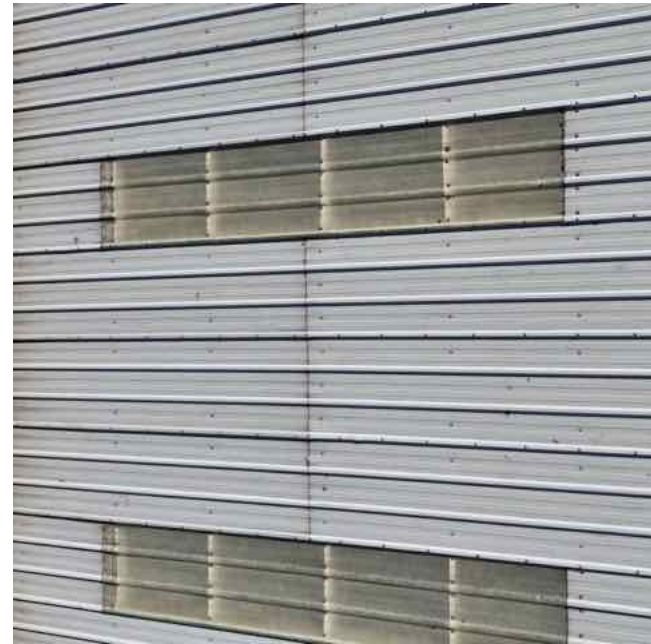
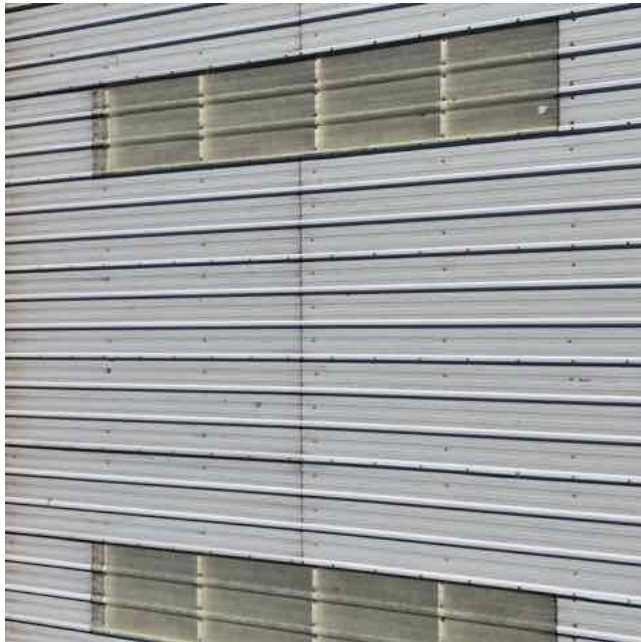
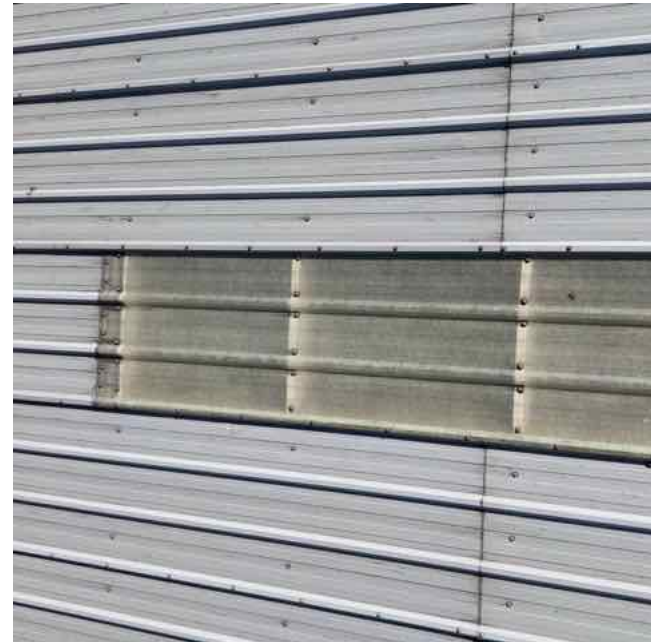
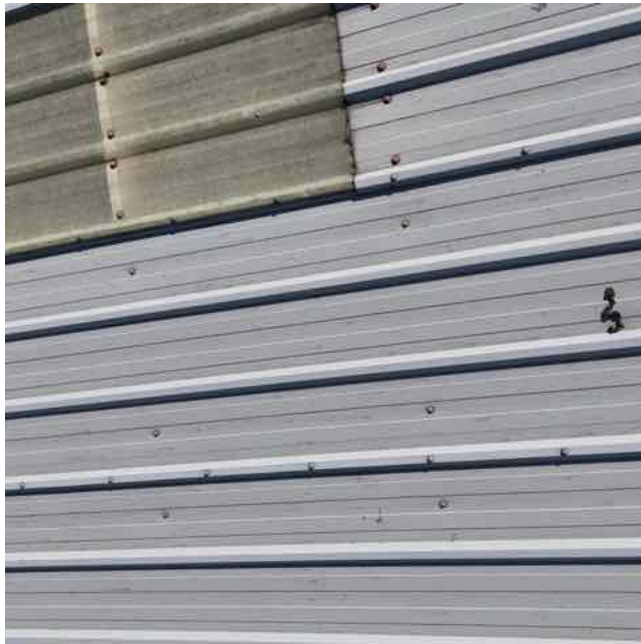
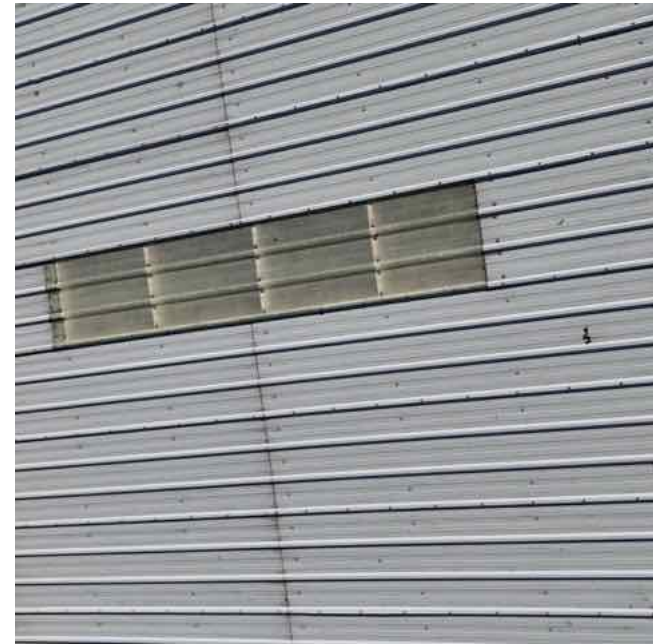
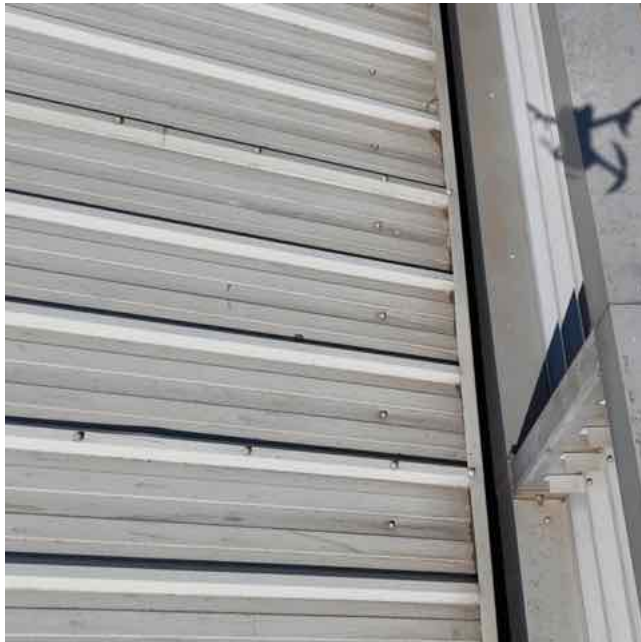
<b>Weather Conditions</b>	<b>Sunny and dry</b>
<b>Undertaken by:</b>	<b>Clayton Ayling of Ayling Associates Chartered Surveyors</b>	<b>Undertaken On:</b>	<b>12<sup>th</sup> May 2025</b>
<b>Location</b>	<b>Description</b>	<b>Condition</b>	<b>Photo No</b>
This Schedule of Condition is specific to the lease to which it is appended.			
<b>Roof 1</b>			
Roof covering and Rooflights	<p>Profiled metal sheet roof covering with metal ridge flashings fixed with rivets.</p> <p>The roof sheets have a single lap at half length.</p> <p>Tek screw fixings into purlins.</p>	<p>Cut edge corrosion does not appear to have set in.</p> <p>Dark spots were observed to the surface of the roof sheets in localised areas, most likely either rust spots or bird droppings.</p> <p>Tek screws appear to have deteriorated and screw gaskets are generally cracked.</p> <p>Rooflights appear aged and yellowed, and the gel coat has most likely broken down.</p>	1 - 70

Roof 1  
Roof covering and Rooflights

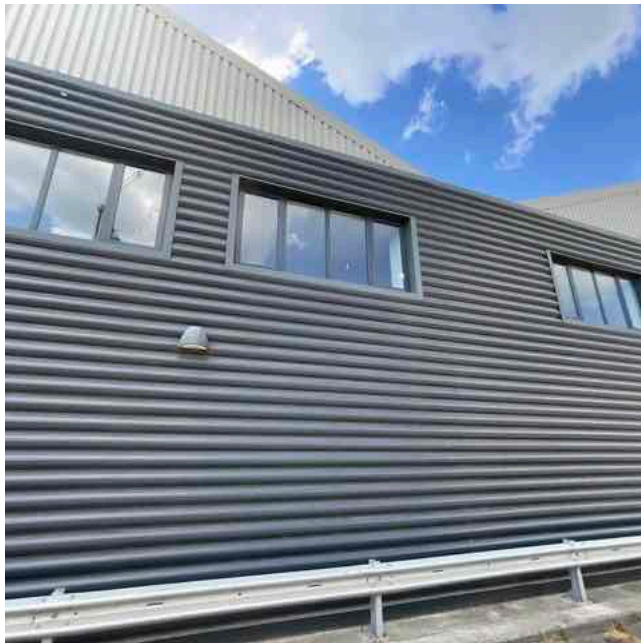
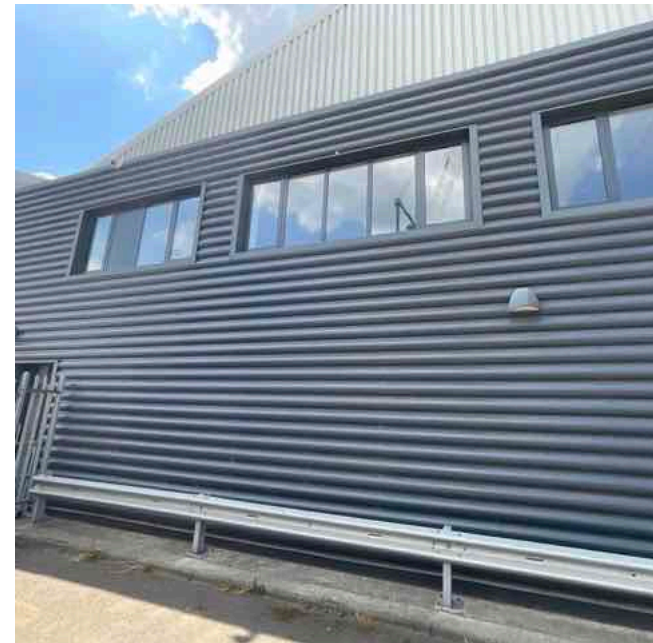
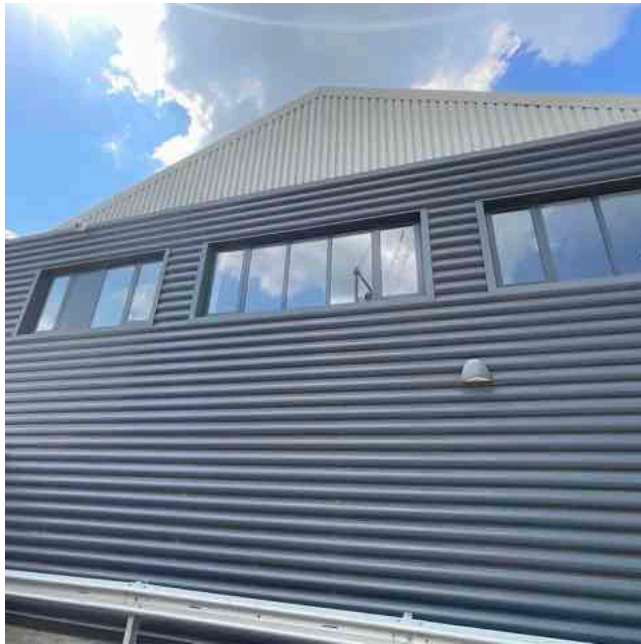
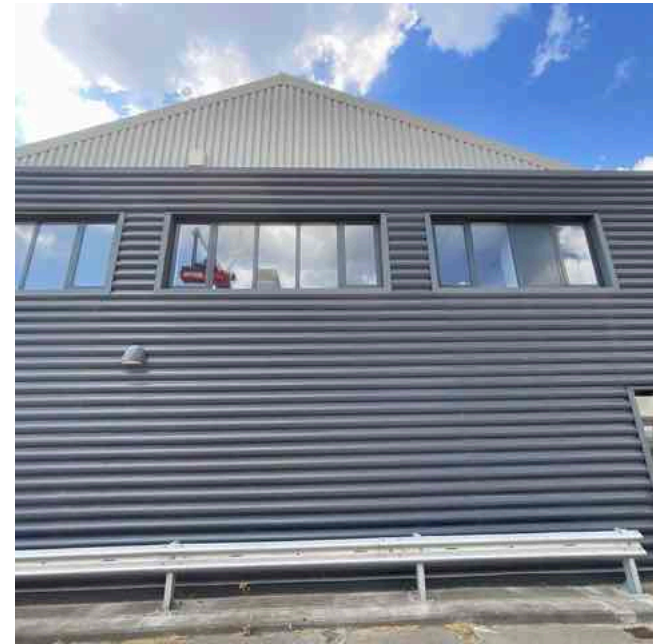
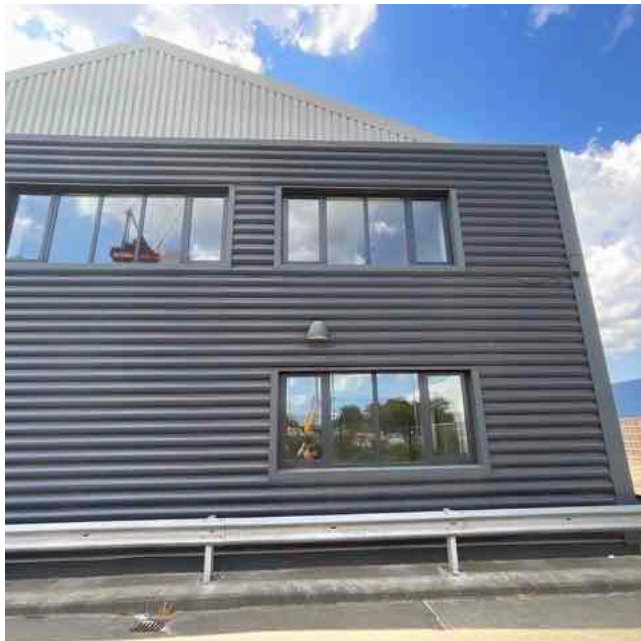
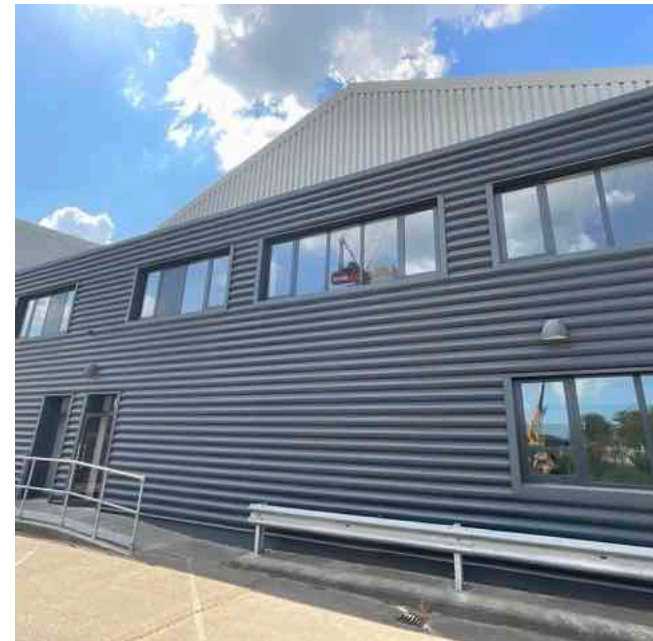
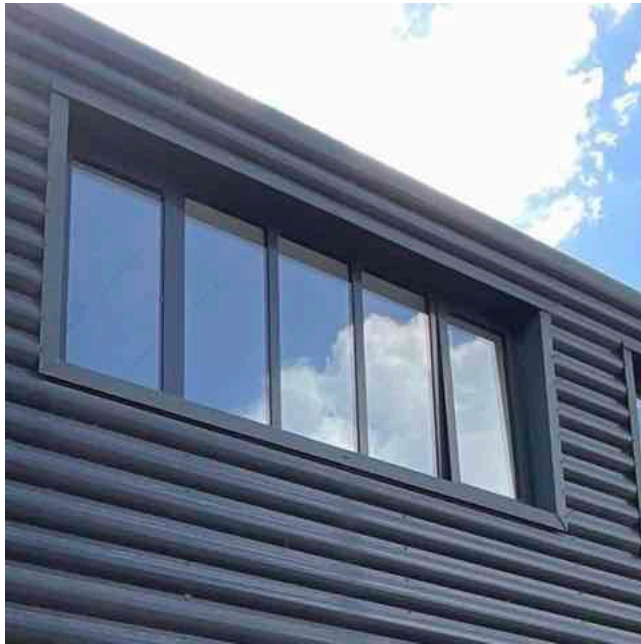
East elevation cladding	Profiled metal cladding with factory finished coating, matching edge trims.	Satisfactory decorative condition.	90 - 96
<b>Aluminium double glazed windows</b>			
Glazing	Double glazed. Frosted glazing to ground floor.	Satisfactory.	97 - 98
Frames	Powder coated aluminium glazing.	Satisfactory.	99 - 100
Reveals	Aluminium trims.	Satisfactory	101

External wall cladding  
East elevation cladding

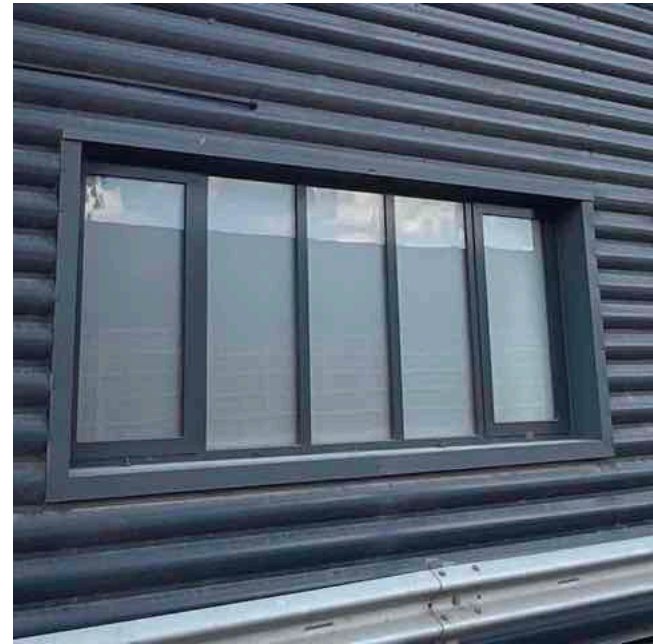
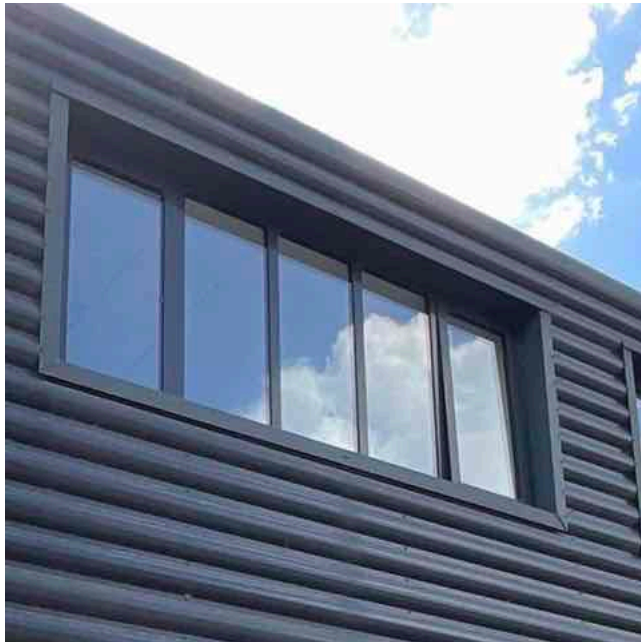
Aluminium double glazed window  
Glazing

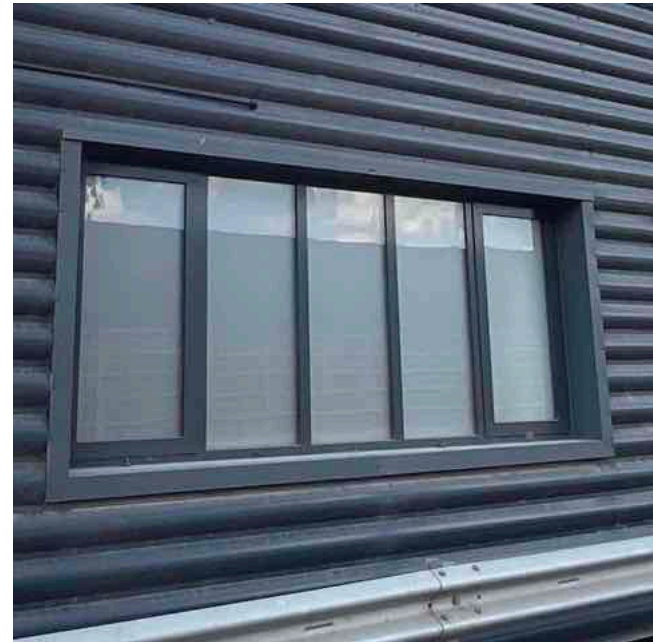
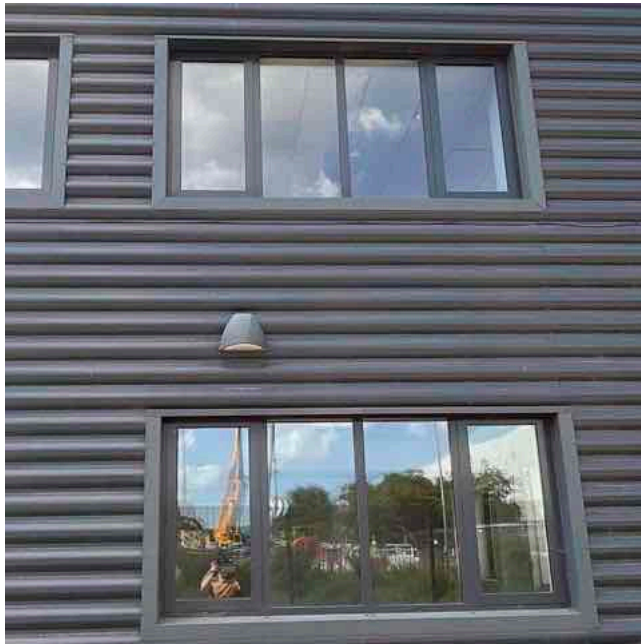
Aluminium double glazed window  
Frames

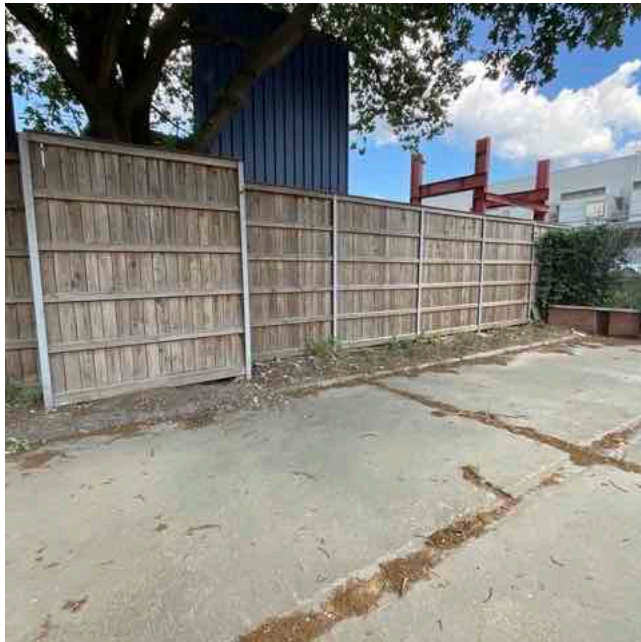
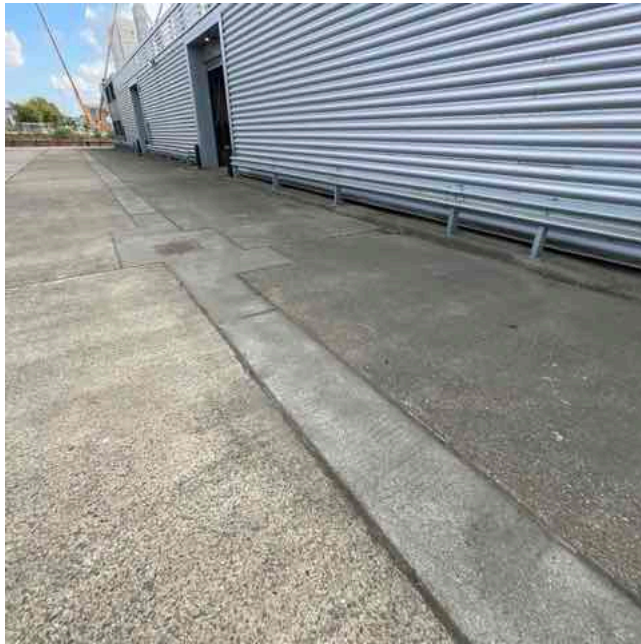
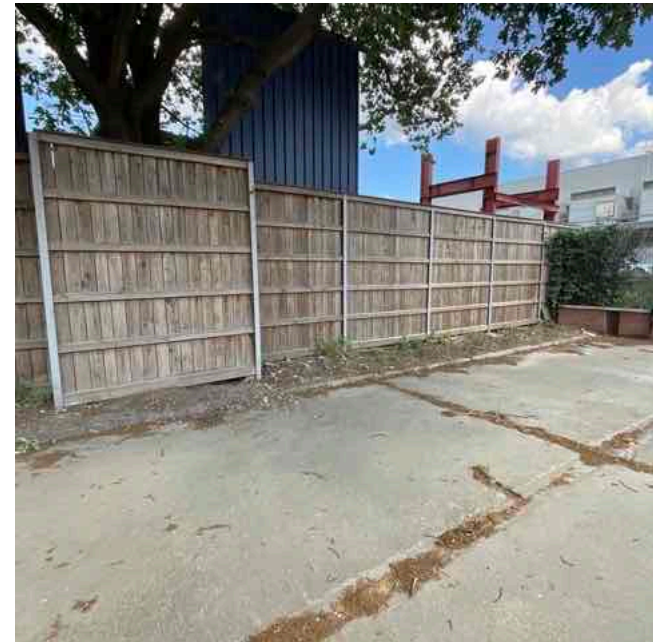
<b>Weather Conditions</b>	<b>Sunny and dry</b>
<b>Undertaken by:</b>	<b>Clayton Ayling of Ayling Associates Chartered Surveyors</b>	<b>Undertaken On:</b>	<b>12<sup>th</sup> May 2025</b>
<b>Location</b>	<b>Description</b>	<b>Condition</b>	<b>Photo No</b>
<b>External roller doors</b>			
Door leaf	Metal segmental roller door.	Generally, in good condition although soiling may conceal surface defects.  Roller door electrically operated mechanisms were found to be working.	102 - 106
<b>Office entrance doors</b>			
Glazing	Double glazed	Satisfactory.	154
Frames	Aluminium powder coated doors.	Good	155
<b>External doors to shop floor</b>			
Door leaf	Factory finished metal door.	Satisfactory.	156
<b>Grounds</b>			
Surfaces	Concrete hard standings set out in bays with asphalt concrete section adjacent to East elevation.	Generally aged and soiled with grass and plant growth between bays.	107 - 115

Grounds  
Surfaces

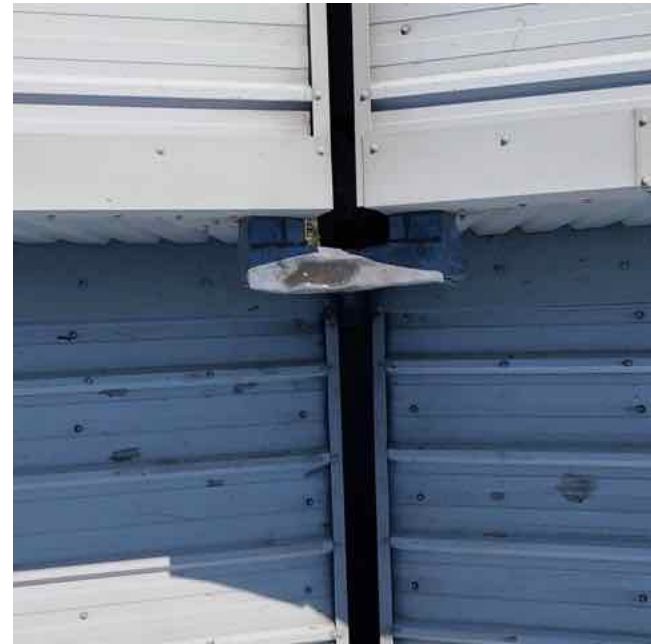
**Photo 120**

<b>Weather Conditions</b>	<b>Sunny and dry</b>	
<b>Undertaken by:</b>	<b>Clayton Ayling of Ayling Associates Chartered Surveyors</b>	<b>Undertaken On:</b>	<b>12<sup>th</sup> May 2025</b>	
<b>Location</b>	<b>Description</b>	<b>Condition</b>		<b>Photo No</b>
East boundary	Short wall with metal fence affixed.	Satisfactory condition.		120 - 121

Grounds  
East boundary

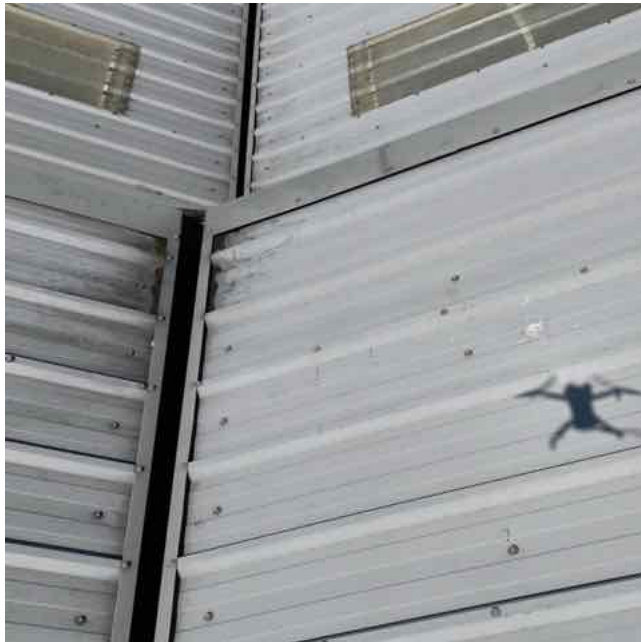
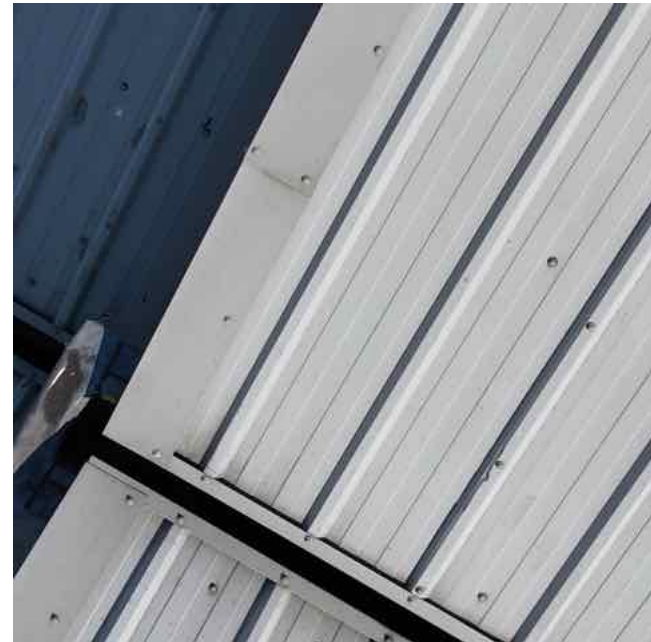
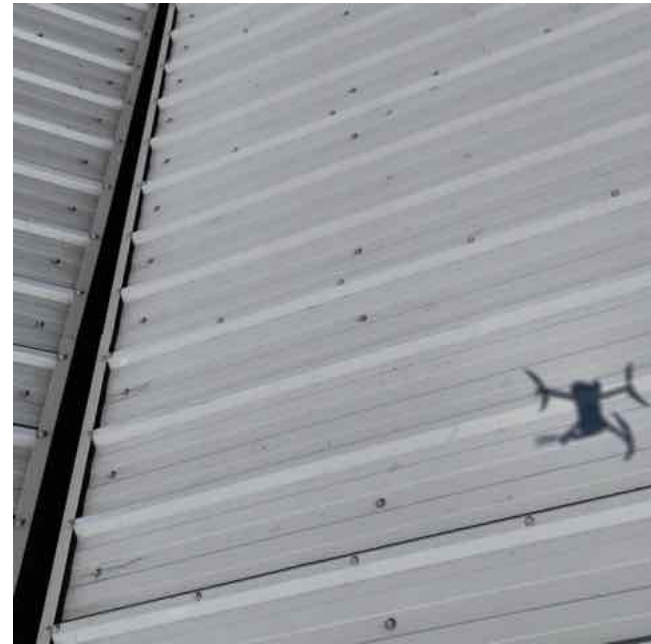
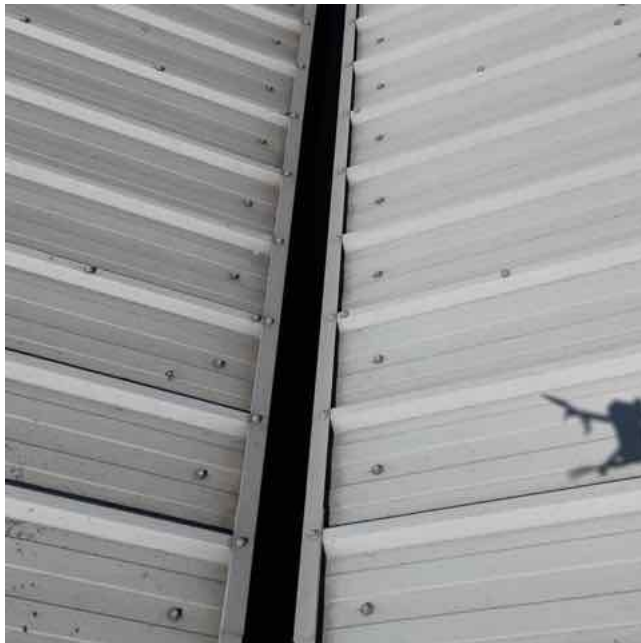
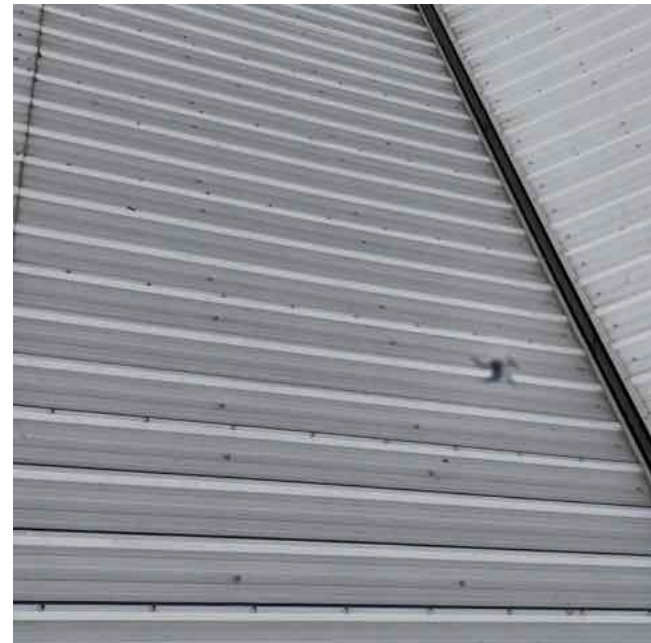
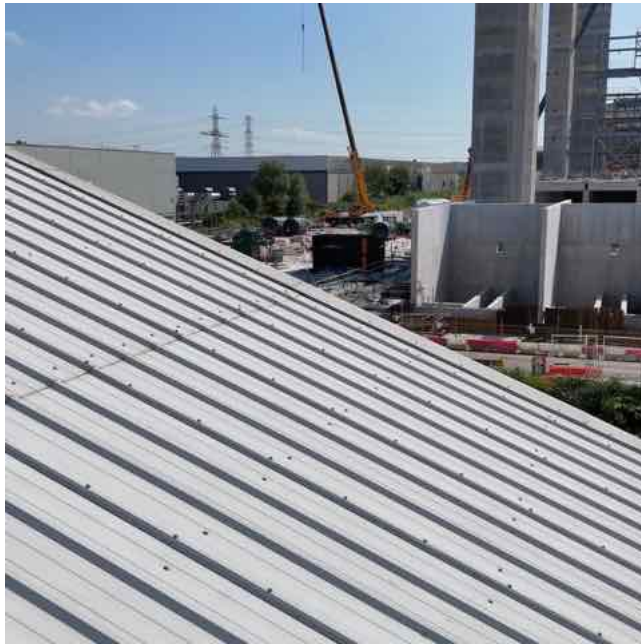
Parapet walls	Metal edge balustrade.	Corrosion noted at base of stanchion.	71 - 73
Rainwater goods	Gutters are concealed from view by narrow opening.	Not inspected.	74 - 81
<b>Roof 2</b>			
Rainwater goods	<p>Gutters are concealed from view by narrow opening.</p> <p>Drainage via hopper at gutter and then into the gutters to Roof 1.</p>	Appears satisfactory.	122 - 128

Roof 2  
Rainwater goods

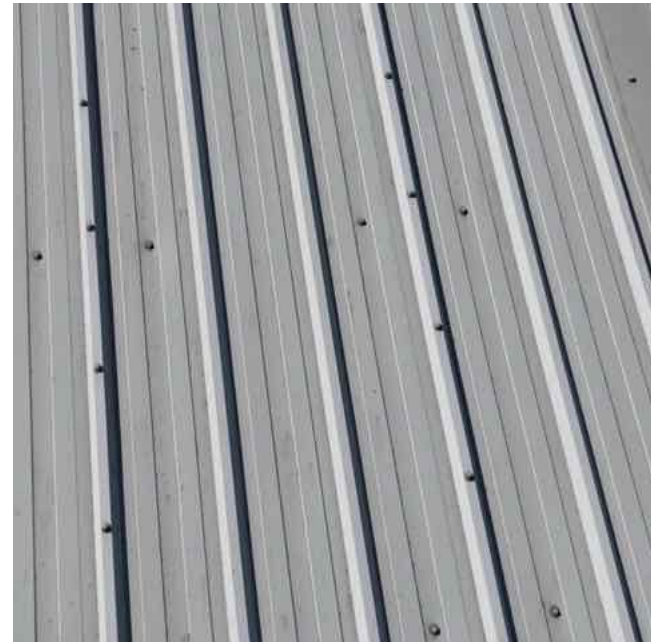
**Photo 151**

Roof 2  
Roof covering.

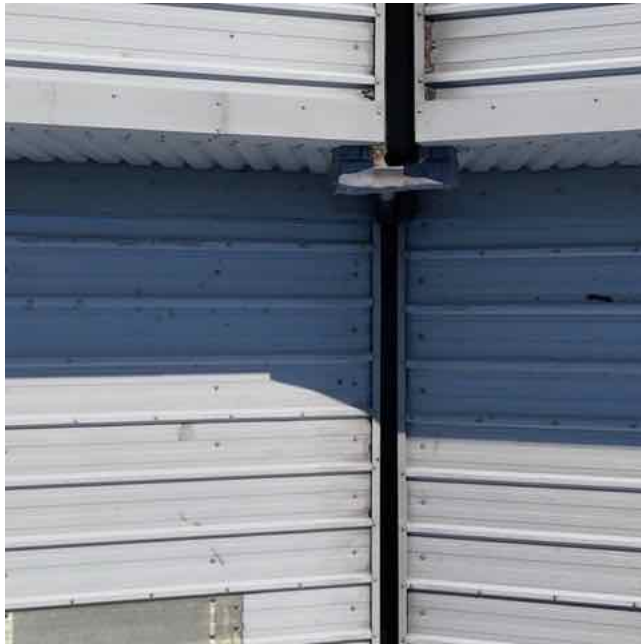
**Photo 152**

Roof 2  
Roof covering.

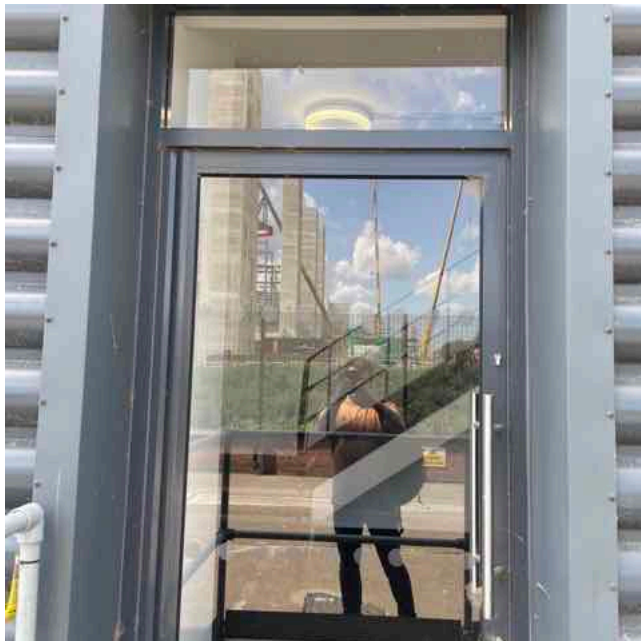
**Photo 154**

Office entrance doors  
Glazing
